St. Andrew's Church Condition Survey

St. Andrew's Church

Groves-Raines Architects Studios Ltd. (GRAS) have been appointed for architectural and conservation consultancy services to carry out a condition survey of St. Andrew's Church.

The intention of this report is to describe the current condition of the building fabric, identify any issues, establish a priority rating for each issue and make recommendations on the methodology for maintenance and repair where required.

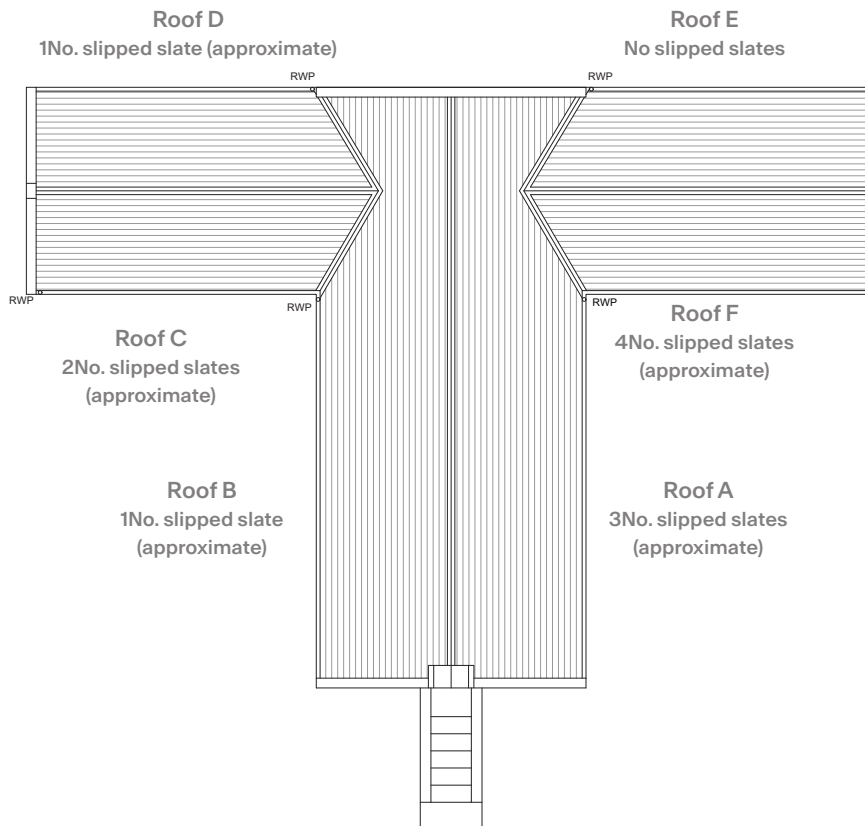
Roof

The roof is slated with West Highland slates and has stone ridges, cavetto skewputts and crow-stepped gables. The North and South wings were added in 1729-30 resulting in the lead valley gutters. The West gable has a small turret with an open bell which was added in the 19th century.

The roofs appear, on the face of it, to be in fair condition. However, there are several slipped or missing slates requiring reinstatement on five of the six roofs, approximate numbers are noted above. On close inspection, it was found that although the slates, on the whole, are tight and well bedded, there is clear evidence of nail sickness which may become more apparent when repairs to the slipped slates are carried out. Severe corrosion of the slating nails was seen in an area of loose slating by the eaves above the Vestry door. There is also widespread evidence of past repairs utilising lead hooks. There appears to be no roofing felt over the sarking or insulation in any of the roof spaces.

Leadwork to the valleys is generally carried out in one single length, which inevitably leads to cracking and splitting of the lead due to metal fatigue, caused by repeated heating and cooling. All leadwork should be closely inspected to determine the extent of repairs required. No evidence of current leaks were seen, however, recent repairs to the interior suggest that water ingress has occurred in the past. Cracks and splits in the lead flashing are visible at the bottom outlet ends of the valleys. A complete scheme of reslating will likely be required in the medium (10 year) term.

Close inspection from a scaffold will be required to elaborate on the condition of the roof and other elements. The stone ridges should be inspected and any gaps and cracks repointed. The abutment between the slate and the crowstep will need to be monitored as

there appears to have been cement based repairs to the mortar fillet. Any cracks will need to be repaired and filled to prevent water ingress.

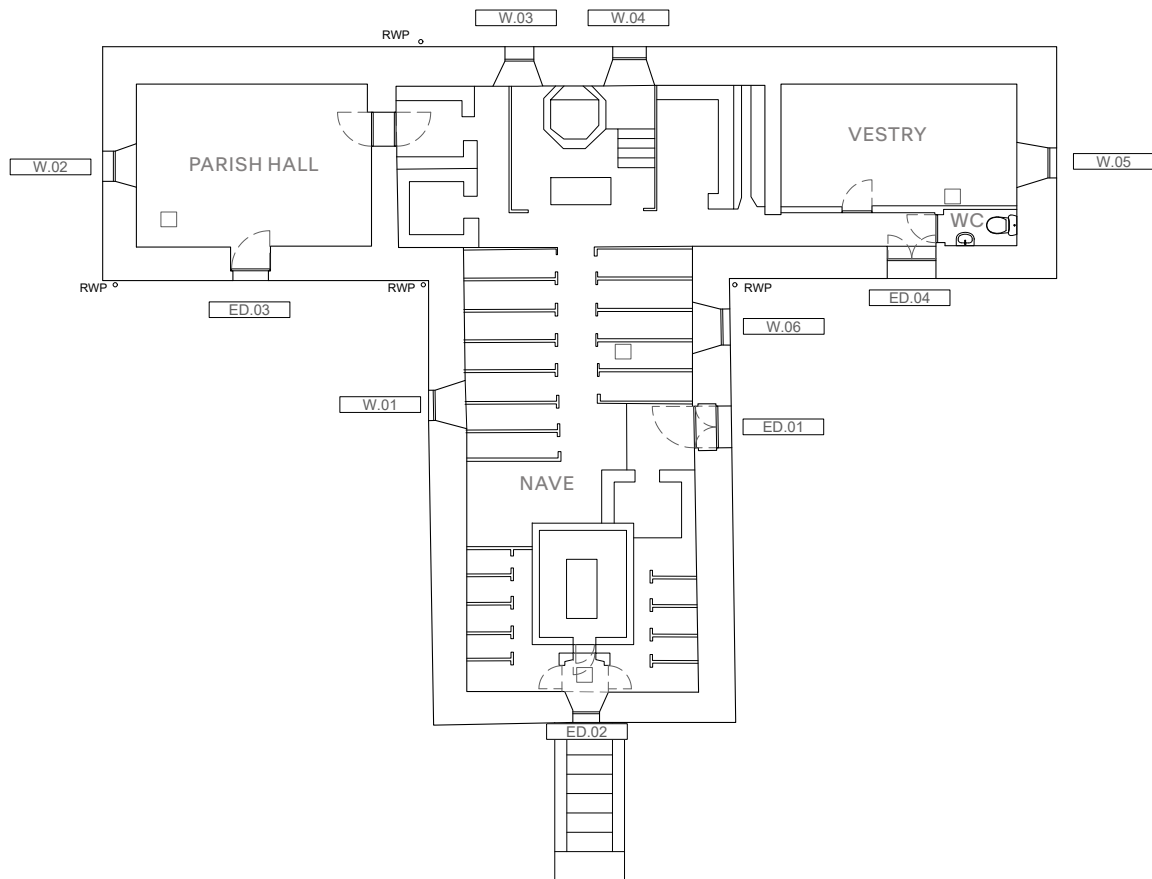
External Walls

The external walls were originally harled with natural stone surrounds to the door and window openings. There have been a number of repairs to the lime harl over the years, and it appears that some repairs have been carried out using cement. There have also been a number of localised cement repairs to the stone dressings around door and window openings. Areas of deterioration should be monitored and made good using appropriate materials.

The final coat on the external walls is paint, understood to be Keim paint, rather than limewash. Keim paint is a breathable mineral paint and is acceptable for use on listed buildings. However, the current overall appearance is patchy so it is therefore recommended that the building is recoated in Keim paint. This should be carried out to the manufacturer's exact requirements, particularly in terms of preparation.

Where seen, the cast iron grilles to the solum vents at the base of the walls are rusting, missing or blocked. There are solum vents on the West and North wings of the church but there are no vents on the South wing. New vents are urgently required to the Vestry wing to the South to prevent further deterioration and rot under the floor of

the WC. Cast iron vents with stainless steel vermin mesh should be installed immediately.

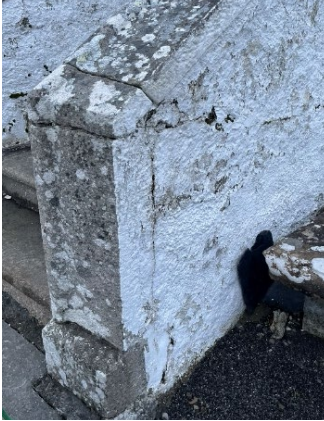
Stairs (West Elevation)	<p>There are several cracks in the stonework forming the stair at the West entrance door. Any large gaps and cracks should be infilled with a suitable hydraulic lime mortar.</p> <p>The mineral paint and original external lime harl has eroded leaving exposed patches across the West elevation.</p> <p>It is recommended that the building is recoated in Keim paint, to their exact requirements, particularly in terms of preparation.</p>	Necessary
6

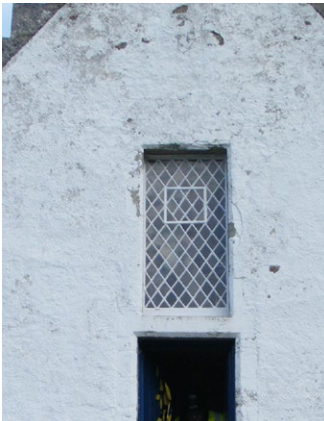
Window above Laird's Loft (West Elevation)	All windows will require repainting, it is essential that this work is carried out with care as zinc can be brittle. The paint specification must be suitable for zinc windows.	Urgent

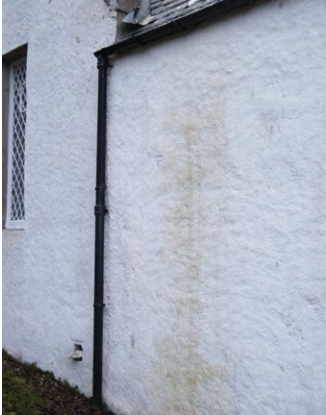
Facade (East Elevation)	<p>Uneven colour and evidence of staining from leaks and overflow from the gutters. The mineral paint and original external lime harl has eroded leaving exposed patches across the West elevation.</p> <p>It is recommended that the building is recoated in Keim paint, to their exact requirements, particularly in terms of preparation.</p> <p>Check gutters for any cracks or fractures above stained areas.</p>	Necessary
2

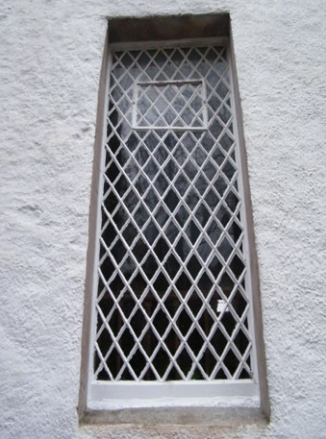
W.03 and W.04 (East Elevation)	<p>All windows will require repainting, it is essential that this work is carried out with care as zinc can be brittle. The paint specification must be suitable for zinc windows.</p> <p>The seized vents should be opened for ventilation purposes.</p>	Urgent

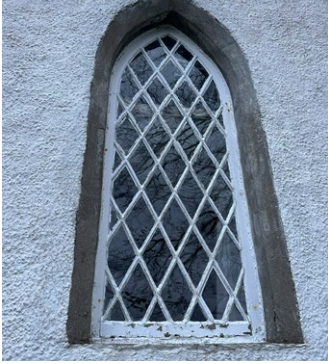
W.02 (North Elevation)	All windows will require repainting, it is essential that this work is carried out with care as zinc can be brittle. The paint specification must be suitable for zinc windows.	Urgent
6

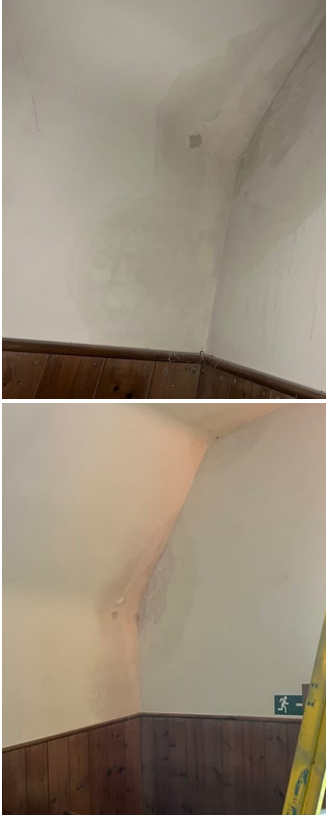
<p>Nave (South-West Corner)</p>	<p>There are internal moisture patches likely caused by water ingress from the defective skew above. This area should be opened up for further inspection and the skew above closely inspected at roof level to determine whether this is the cause of the internal staining.</p> <p>Additional coats of paint are required internally. The existing plaster should be assessed and only replaced if the plaster is found to have perished, the laths rotted or keys broken off. The internal work should ideally be carried out once the external issues have been addressed and the interior has dried out.</p>	Necessary
2

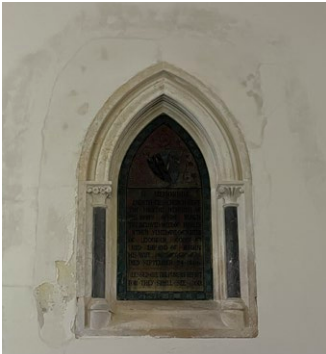
<p>Nave (North Elevation)</p>	<p>Evidence of moisture staining around the memorial plaque to Hon. Sophia Aylmer, daughter of Alexander Mackay, 8th Lord Reay, as noted in the report by HRI Munro in 2021. It is likely that the cause of the dampness is the proximity of the leaking hopper in the corner behind the memorial plaque.</p> <p>This area of the North internal wall remains damp and there are internal moisture patches as a result of water ingress.</p> <p>Additional coats of paint are required internally. The internal work should ideally be carried out once the external issues have been addressed and the interior has dried out. The area should be monitored once the external defect has been fixed.</p>	Necessary

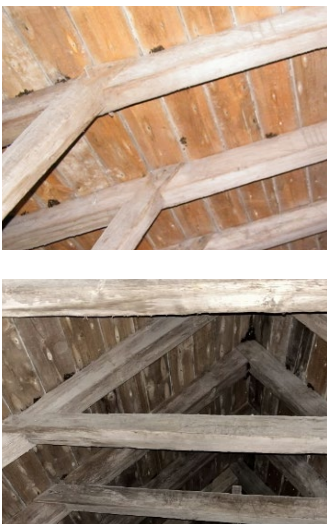
Roof Space (Nave West)	<p>There appears to be evidence of insects gathering in between the sarking and the rafters. Access into the roof space was limited at the time of inspection making identification difficult. It is expected that these are likely cluster flies which often shelter in roof spaces in the Autumn.</p> <p>There are limited solutions to prevent cluster flies from entering roof spaces.</p>	Urgent
2

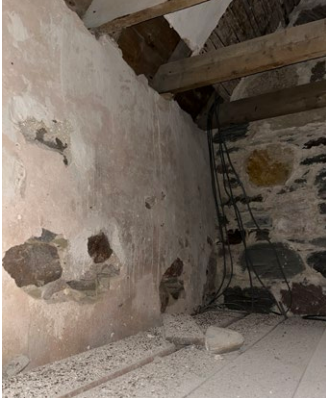
Attic Space (Above corridor)	<p>Areas of the original lath and plaster have debonded and fallen onto the later suspended ceiling over the corridor. Any loose sections of plaster should be removed.</p> <p>The original ceiling might be exposed in the future to restore the space to its original appearance. This may be done as part of the general upgrading, perhaps when the roofworks are done, so retention of the original material is important.</p>	Urgent
2

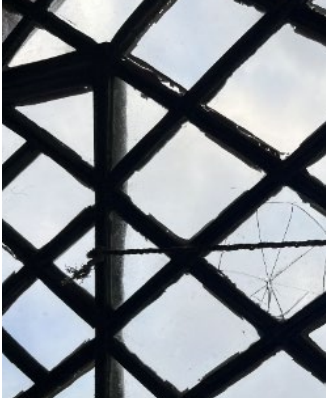
W.05 (Vestry)	<p>There is a crack in a pane of W.05. This should be replaced by a specialist.</p>	Urgent

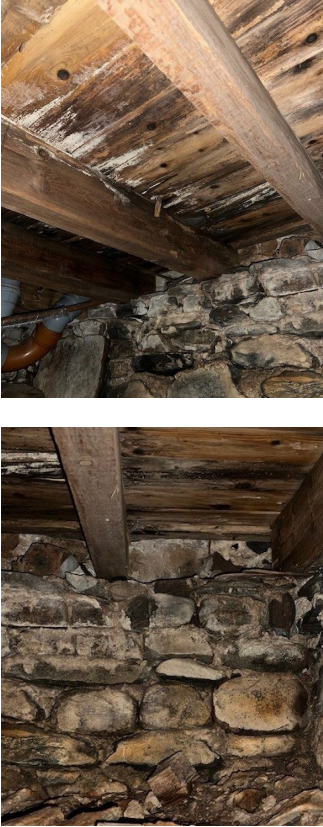
Solum (WC)	<p>GRAS inspected the solum below the WC via a hatch in the Vestry floor. There is evidence of damp and fungal growth to the underside of the floorboards, presumably as a result of an ongoing leak. The floor in the WC is tiled so cannot breathe.</p> <p>The cause of the leak should be identified, the area should be fully dried out and the floor should be replaced. The affected floorboards should be removed carefully along the edges. Install replacement boards to suit.</p> <p>There are no solum vents in this wing of the church. It is recommended that new solum vents and cast iron grilles are installed to improve ventilation.</p>	Immediate
2

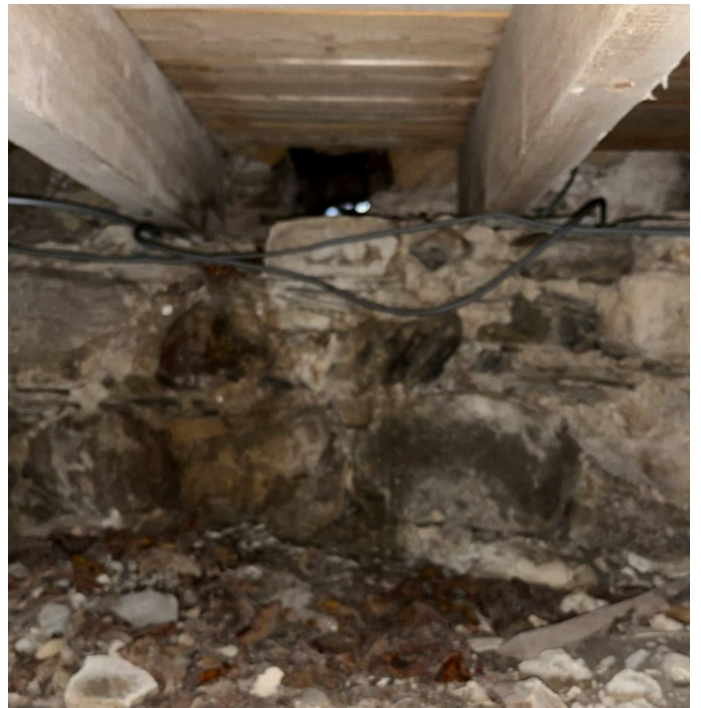
Solum vent blocked with steel mesh to prevent rodent access (28.10.2025)
