# WICK CHURCH - BUILDING CONDITION & DAMAGES REPORT

Former Bridge Street Church

16 Bridge Street, Wick KW1 4NG, Scotland

Category B Listed Building

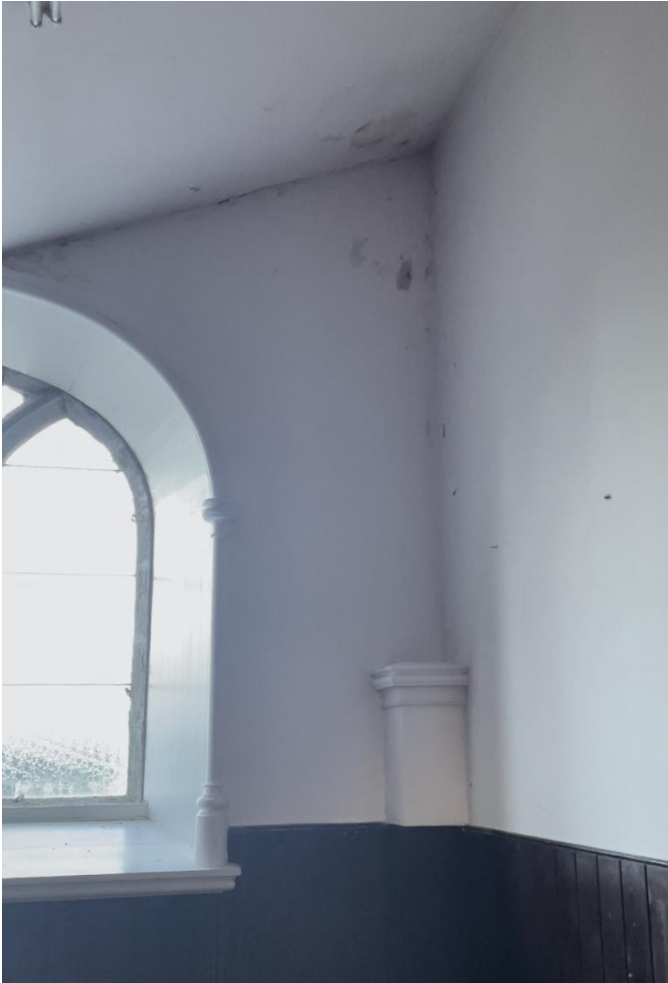
Photo 1

Observed condition: Visible evidence of moisture ingress, plaster deterioration, staining and building fabric defects. Condition Rating: Poor. Recommended action: Investigate source of water ingress and undertake conservation-led repairs.

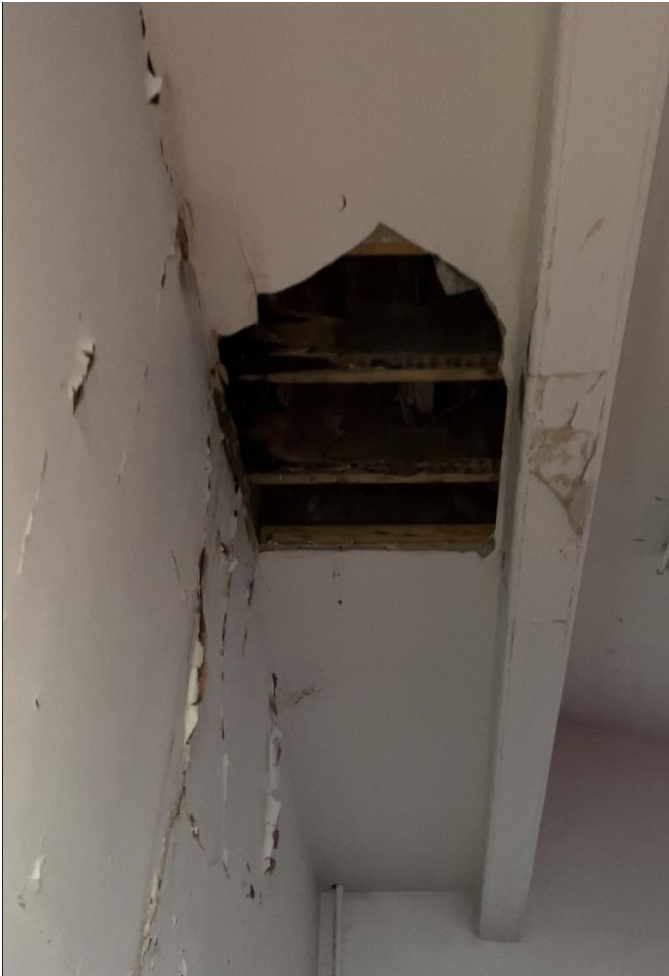
Photo 2

Observed condition: Visible evidence of moisture ingress, plaster deterioration, staining and building fabric defects. Condition Rating: Poor. Recommended action: Investigate source of water ingress and undertake conservation-led repairs.

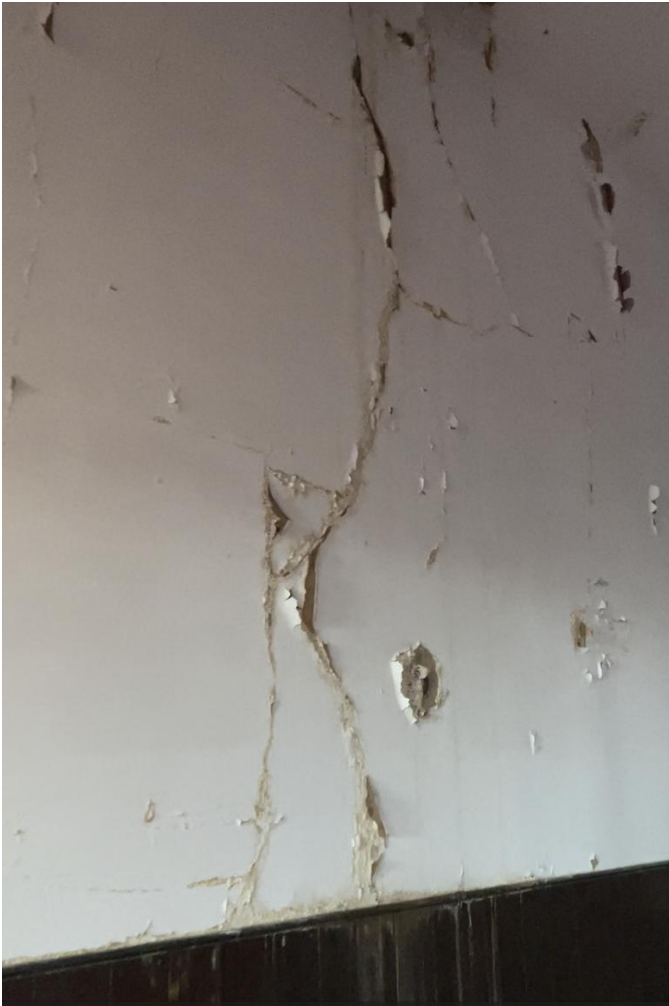
Photo 3

Observed condition: Visible evidence of moisture ingress, plaster deterioration, staining and building fabric defects. Condition Rating: Poor. Recommended action: Investigate source of water ingress and undertake conservation-led repairs.

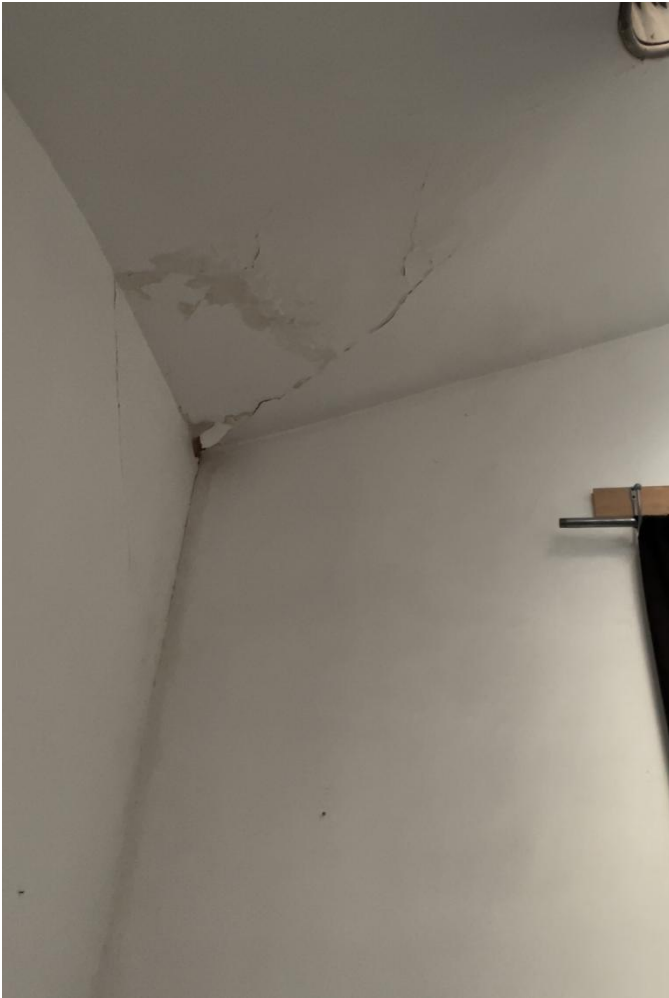
Photo 4

Observed condition: Visible evidence of moisture ingress, plaster deterioration, staining and building fabric defects. Condition Rating: Poor. Recommended action: Investigate source of water ingress and undertake conservation-led repairs.

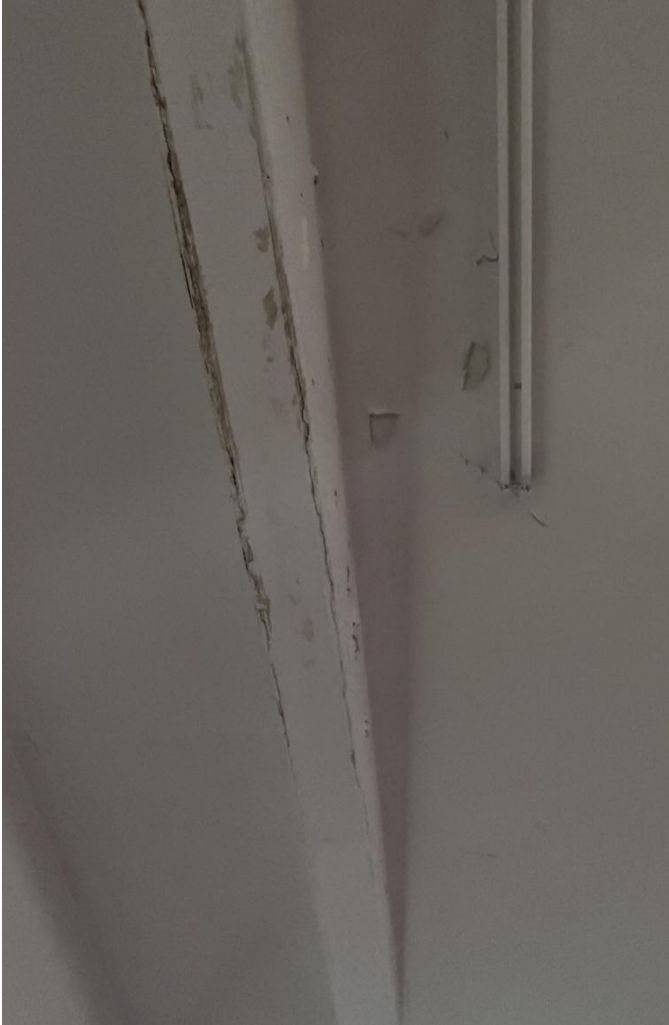
Photo 5

Observed condition: Visible evidence of moisture ingress, plaster deterioration, staining and building fabric defects. Condition Rating: Poor. Recommended action: Investigate source of water ingress and undertake conservation-led repairs.

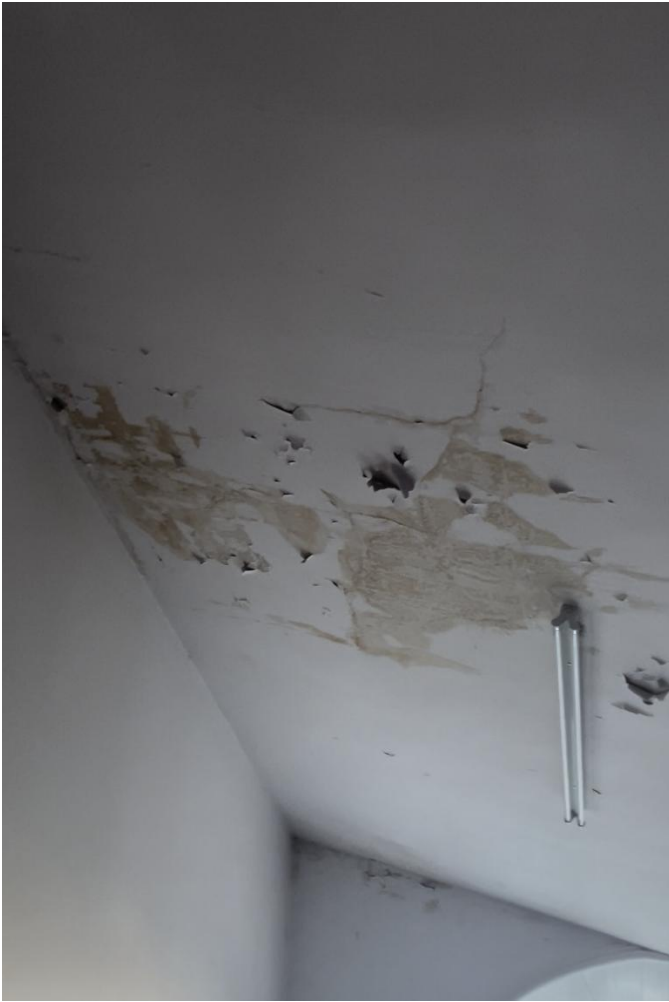
Photo 6

Observed condition: Visible evidence of moisture ingress, plaster deterioration, staining and building fabric defects. Condition Rating: Poor. Recommended action: Investigate source of water ingress and undertake conservation-led repairs.

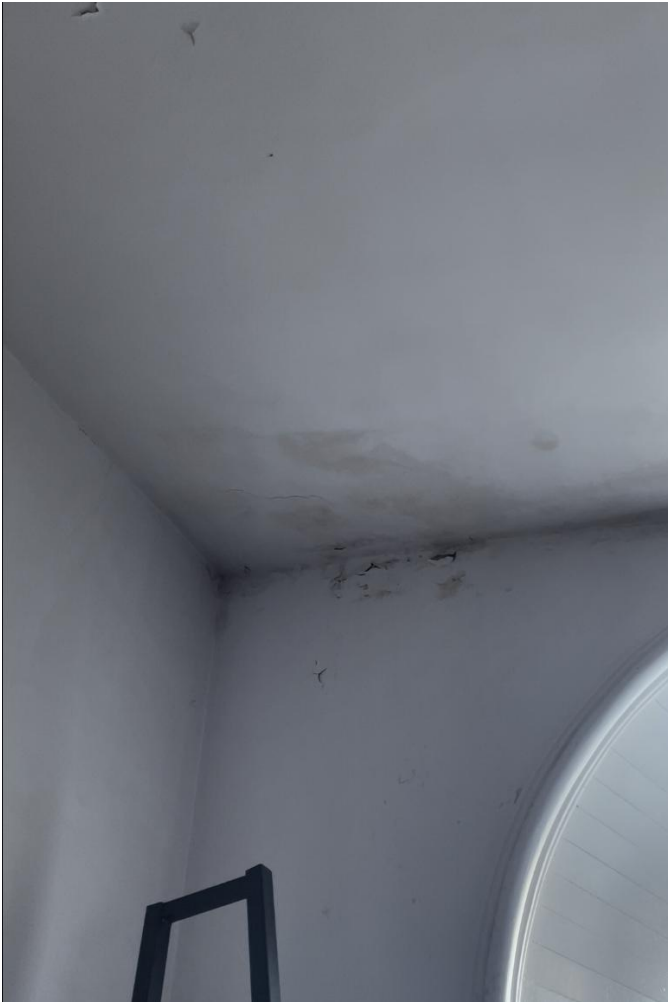
Photo 7

Observed condition: Visible evidence of moisture ingress, plaster deterioration, staining and building fabric defects. Condition Rating: Poor. Recommended action: Investigate source of water ingress and undertake conservation-led repairs.

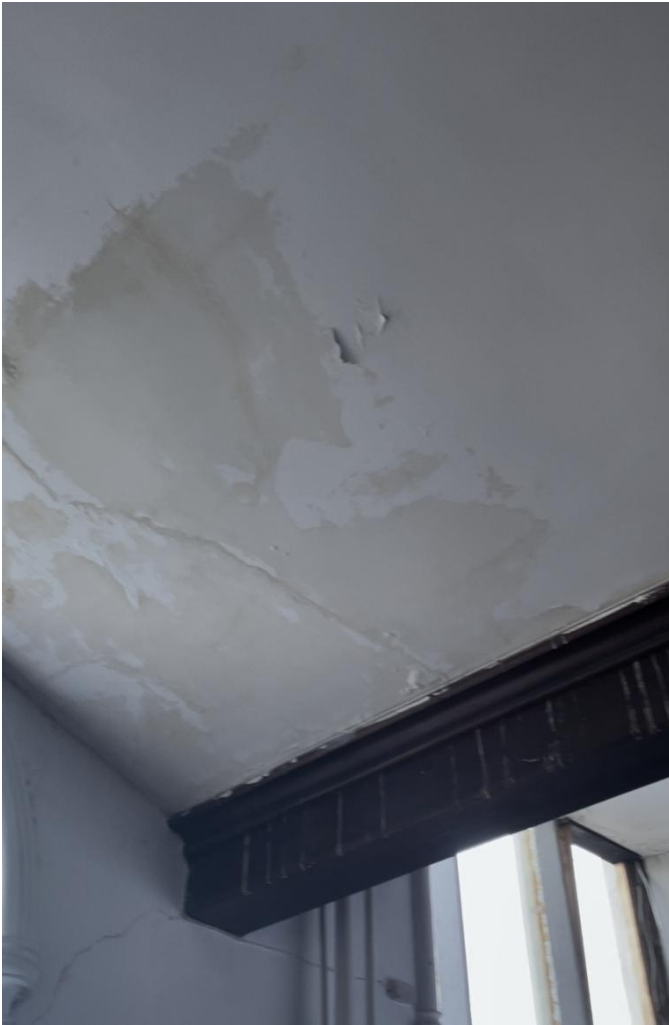
Photo 8

Observed condition: Visible evidence of moisture ingress, plaster deterioration, staining and building fabric defects. Condition Rating: Poor. Recommended action: Investigate source of water ingress and undertake conservation-led repairs.

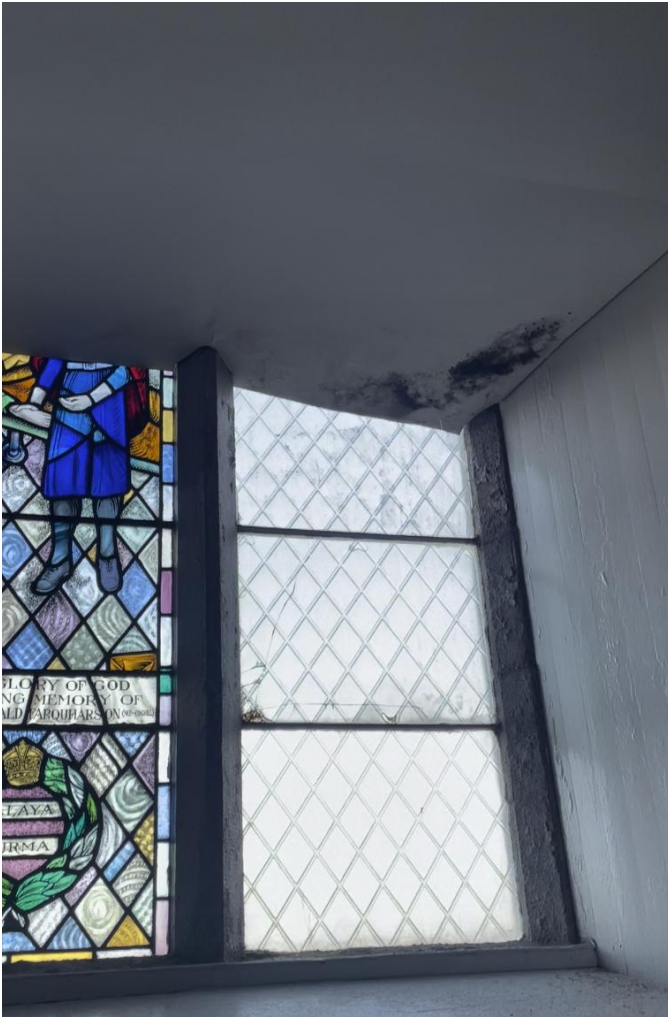
Photo 9

Observed condition: Visible evidence of moisture ingress, plaster deterioration, staining and building fabric defects. Condition Rating: Poor. Recommended action: Investigate source of water ingress and undertake conservation-led repairs.

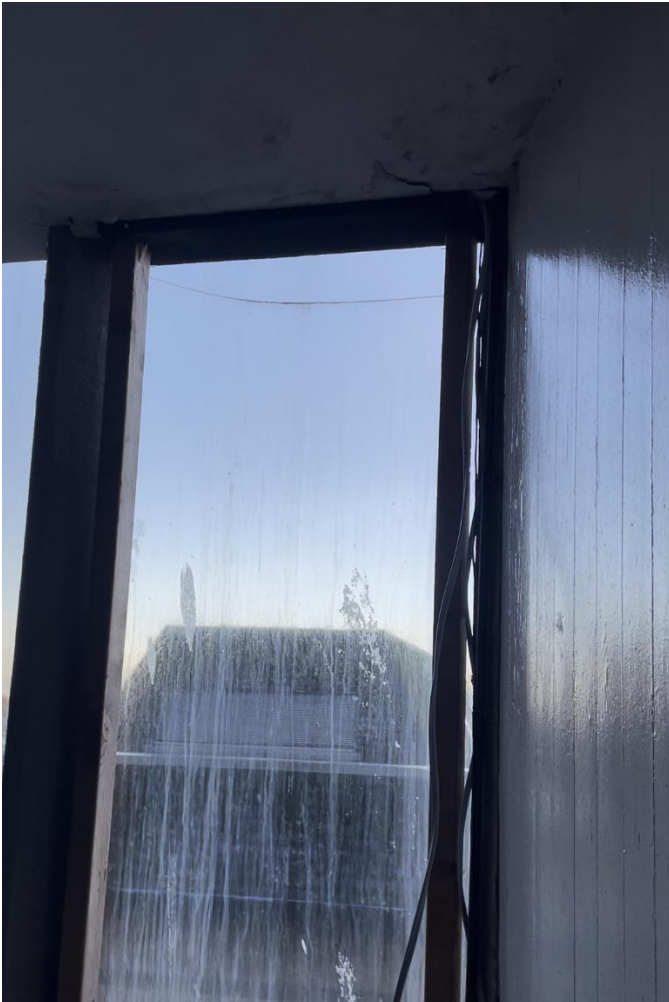
Photo 10

Observed condition: Visible evidence of moisture ingress, plaster deterioration, staining and building fabric defects. Condition Rating: Poor. Recommended action: Investigate source of water ingress and undertake conservation-led repairs.

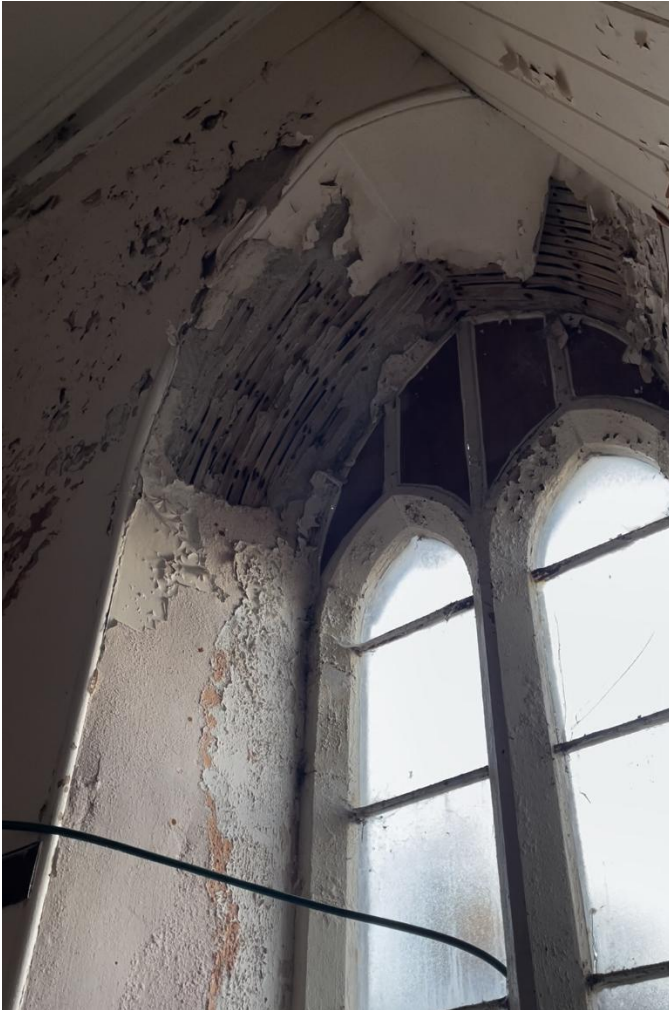
Photo 11

Observed condition: Visible evidence of moisture ingress, plaster deterioration, staining and building fabric defects. Condition Rating: Poor. Recommended action: Investigate source of water ingress and undertake conservation-led repairs.

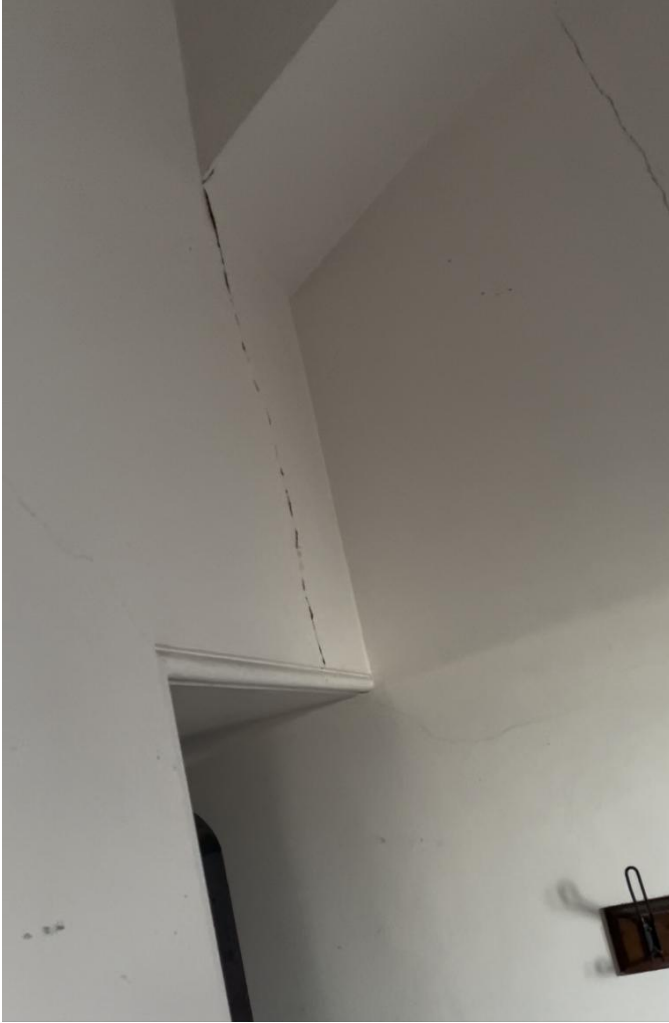
Photo 12

Observed condition: Visible evidence of moisture ingress, plaster deterioration, staining and building fabric defects. Condition Rating: Poor. Recommended action: Investigate source of water ingress and undertake conservation-led repairs.

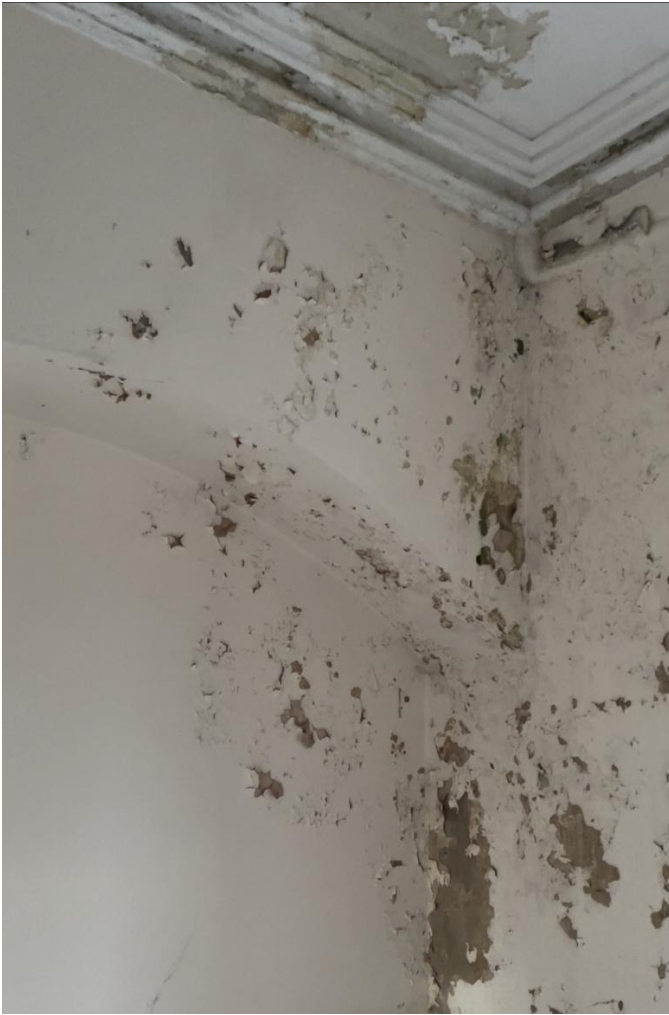
Photo 13

Observed condition: Visible evidence of moisture ingress, plaster deterioration, staining and building fabric defects. Condition Rating: Poor. Recommended action: Investigate source of water ingress and undertake conservation-led repairs.

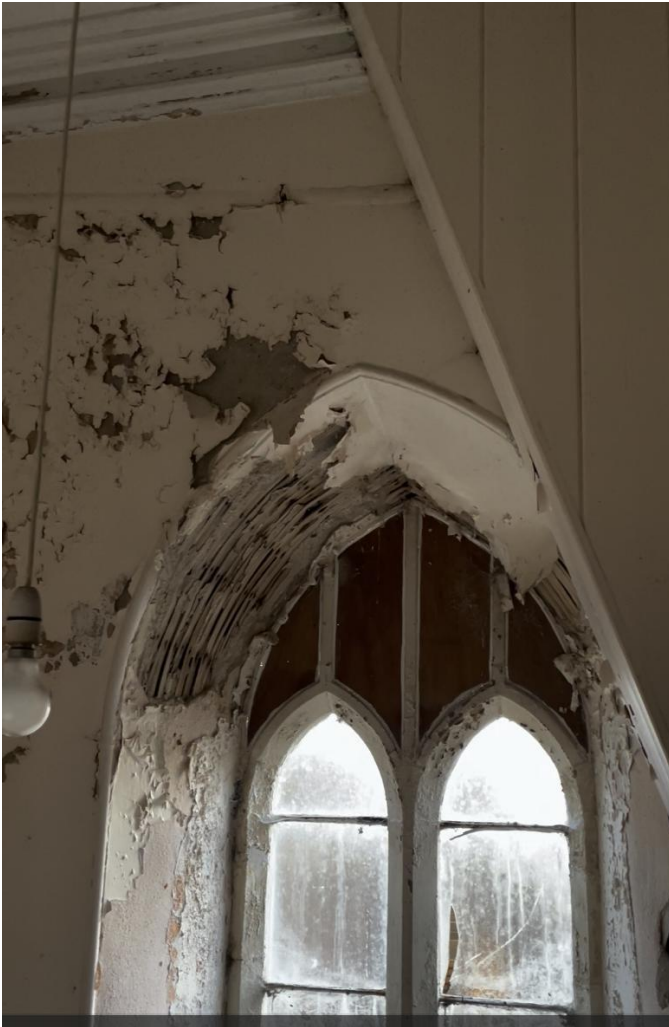
Photo 14

Observed condition: Visible evidence of moisture ingress, plaster deterioration, staining and building fabric defects. Condition Rating: Poor. Recommended action: Investigate source of water ingress and undertake conservation-led repairs.

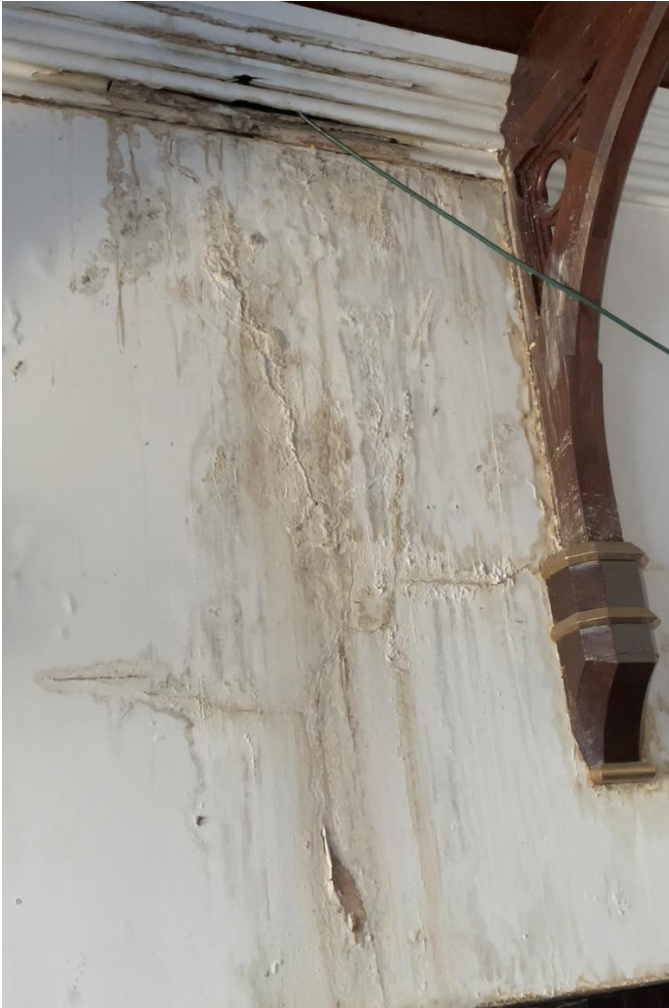
Photo 15

Observed condition: Visible evidence of moisture ingress, plaster deterioration, staining and building fabric defects. Condition Rating: Poor. Recommended action: Investigate source of water ingress and undertake conservation-led repairs.

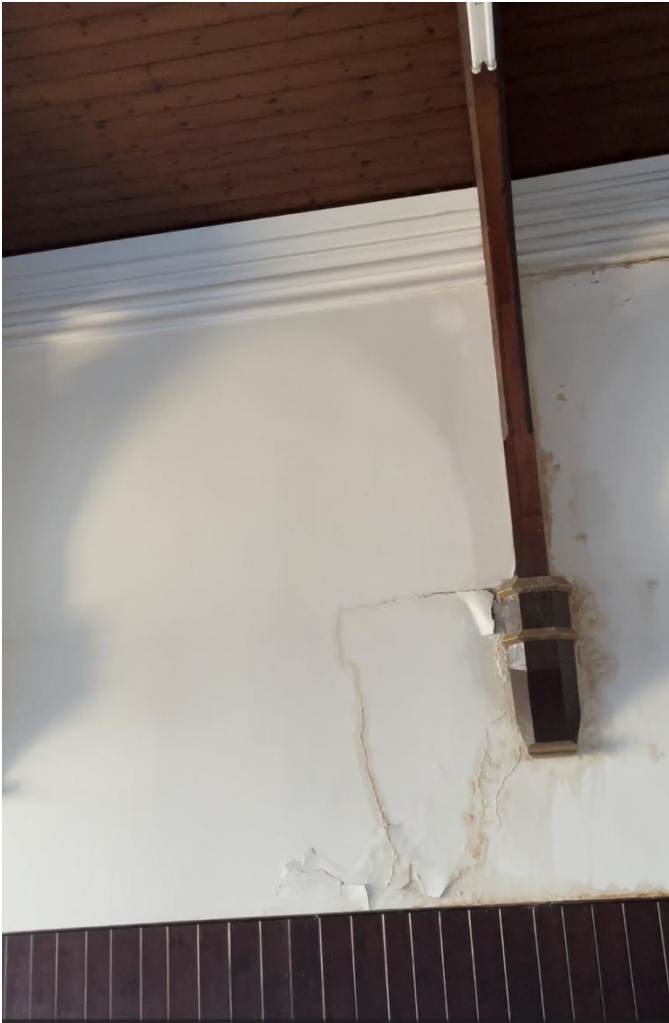
Photo 16

Observed condition: Visible evidence of moisture ingress, plaster deterioration, staining and building fabric defects. Condition Rating: Poor. Recommended action: Investigate source of water ingress and undertake conservation-led repairs.

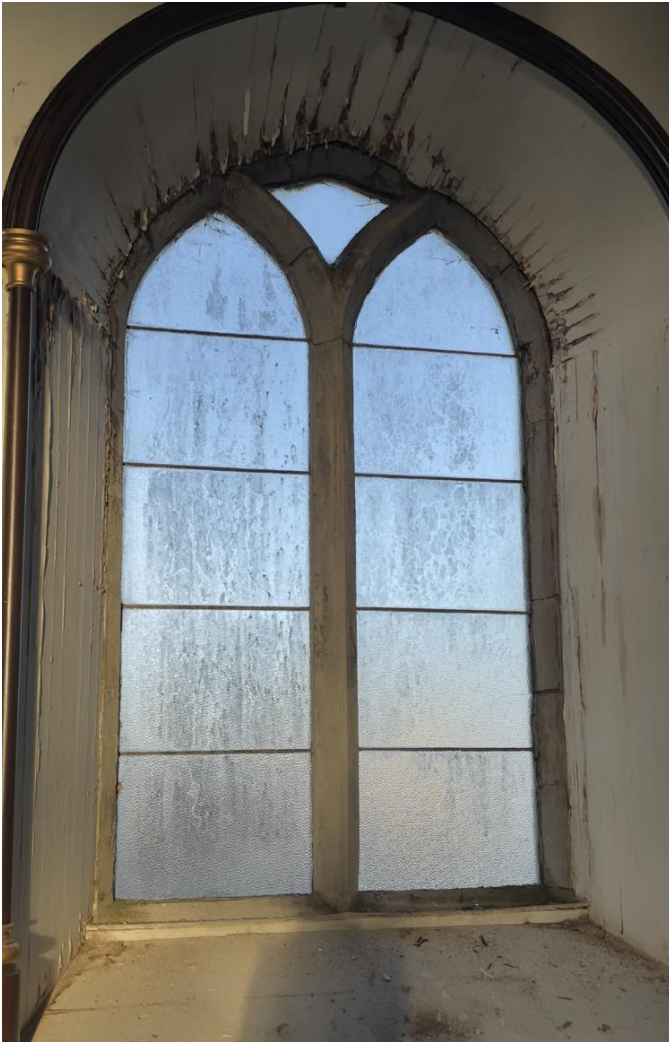
Photo 17

Observed condition: Visible evidence of moisture ingress, plaster deterioration, staining and building fabric defects. Condition Rating: Poor. Recommended action: Investigate source of water ingress and undertake conservation-led repairs.

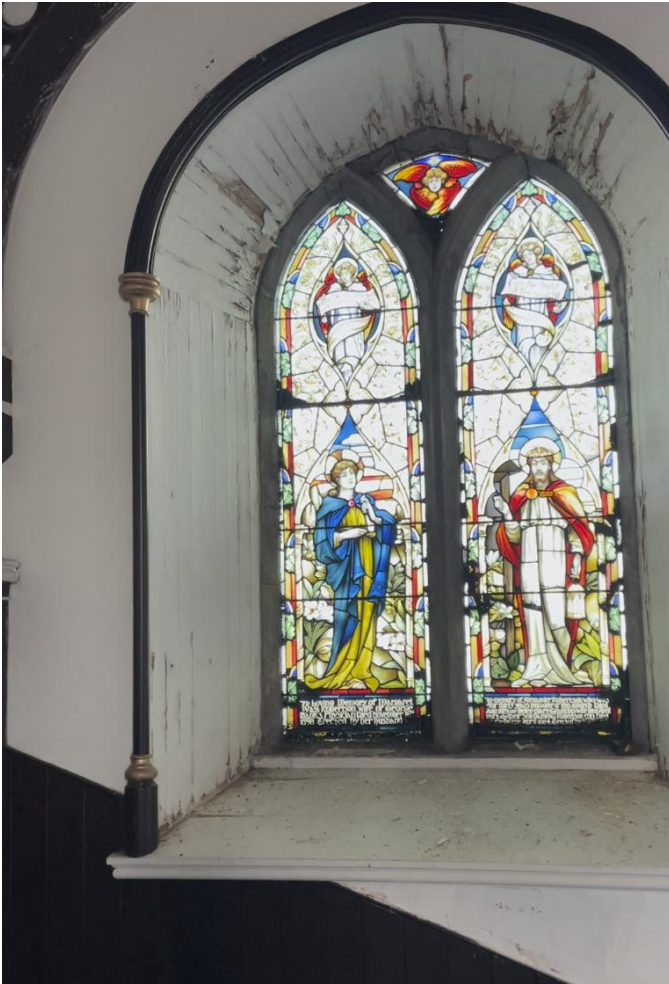
Photo 18

Observed condition: Visible evidence of moisture ingress, plaster deterioration, staining and building fabric defects. Condition Rating: Poor. Recommended action: Investigate source of water ingress and undertake conservation-led repairs.

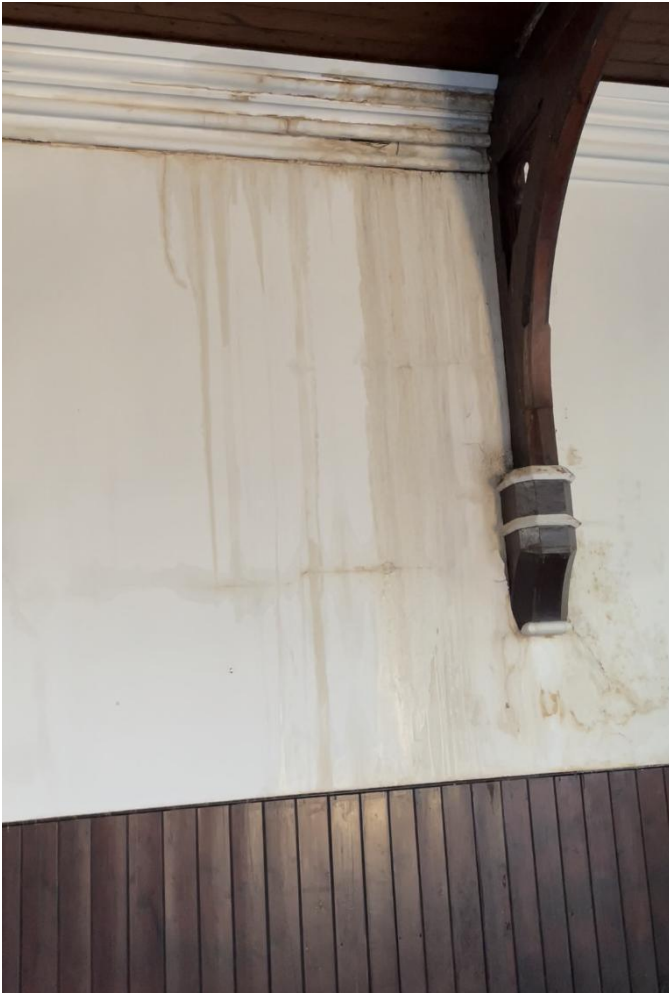
Photo 19

Observed condition: Visible evidence of moisture ingress, plaster deterioration, staining and building fabric defects. Condition Rating: Poor. Recommended action: Investigate source of water ingress and undertake conservation-led repairs.

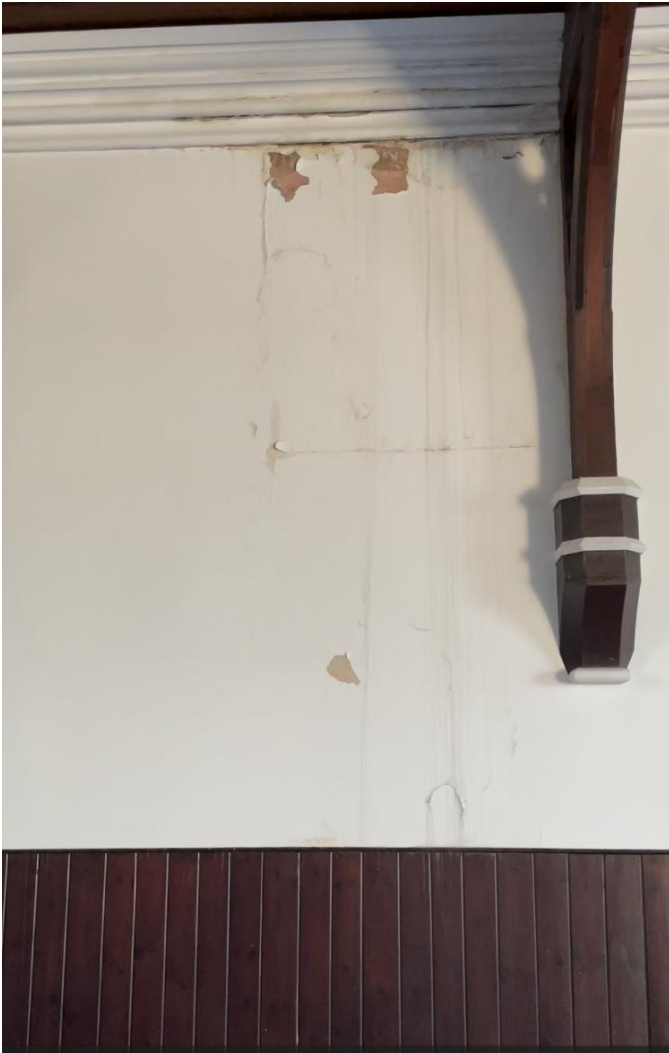
Photo 20

Observed condition: Visible evidence of moisture ingress, plaster deterioration, staining and building fabric defects. Condition Rating: Poor. Recommended action: Investigate source of water ingress and undertake conservation-led repairs.

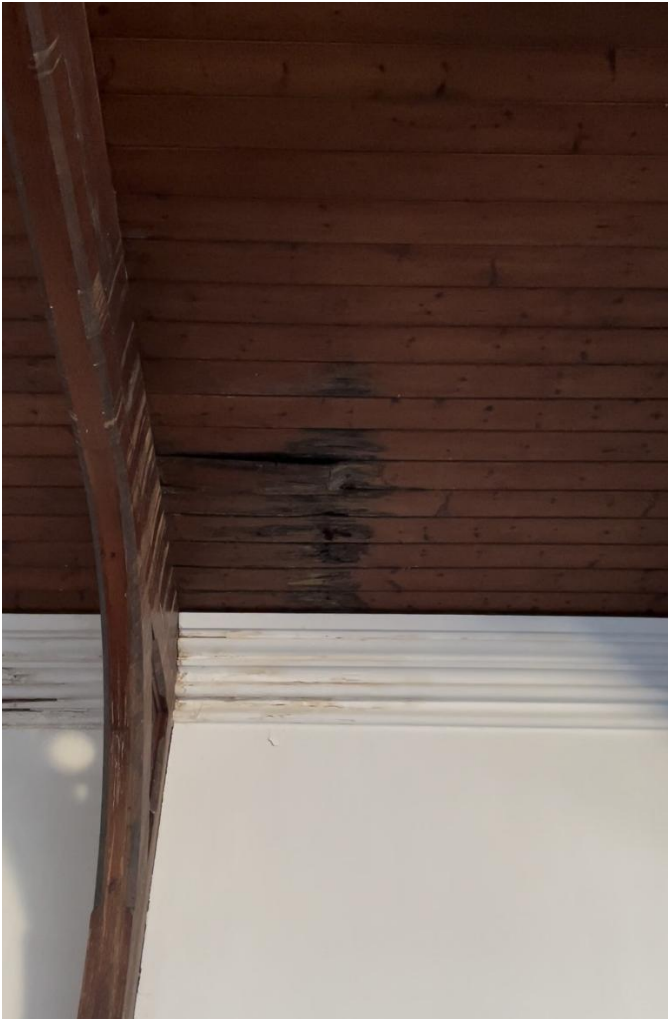
Photo 21

Observed condition: Visible evidence of moisture ingress, plaster deterioration, staining and building fabric defects. Condition Rating: Poor. Recommended action: Investigate source of water ingress and undertake conservation-led repairs.

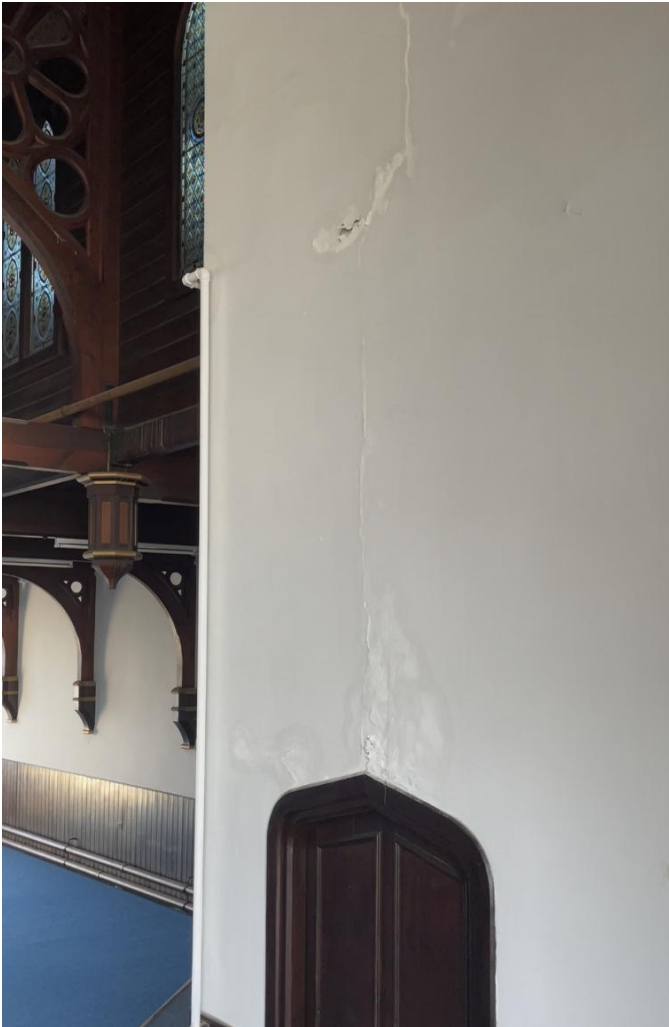
Photo 22

Observed condition: Visible evidence of moisture ingress, plaster deterioration, staining and building fabric defects. Condition Rating: Poor. Recommended action: Investigate source of water ingress and undertake conservation-led repairs.

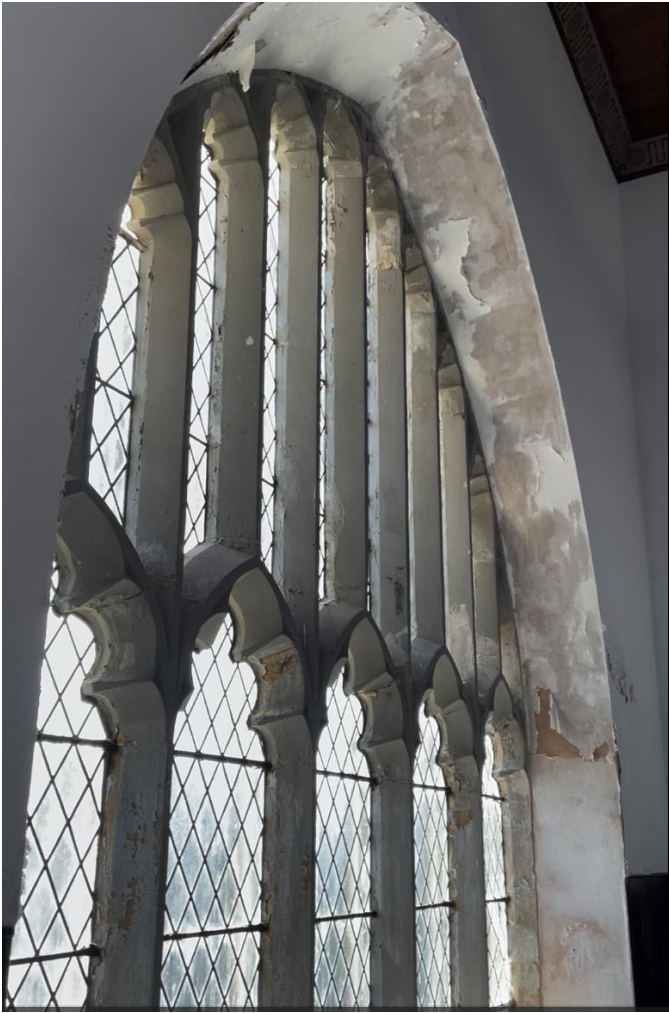
Photo 23

Observed condition: Visible evidence of moisture ingress, plaster deterioration, staining and building fabric defects. Condition Rating: Poor. Recommended action: Investigate source of water ingress and undertake conservation-led repairs.
