# **CONSERVATION STATEMENT**

**BRIDGE STREET CHURCH, WICK**

**PROPOSED CHANGE OF USE  
TO  
RETAIL FURNITURE OUTLET**

**PLANNING REFERENCE: 14/04527/FUL & 14/04528/LBC**

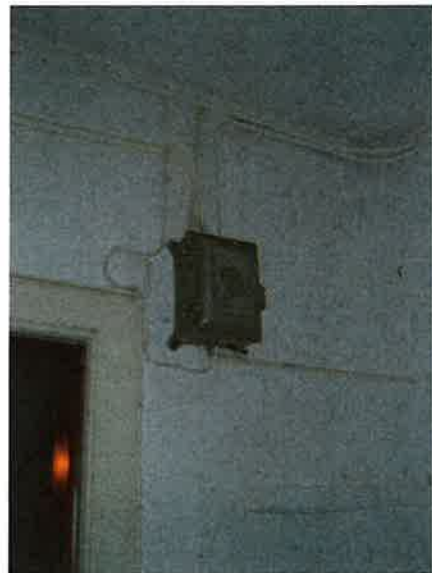
| Fig. 8 | Store off hall, old electrical fuse box (wall mounted) |

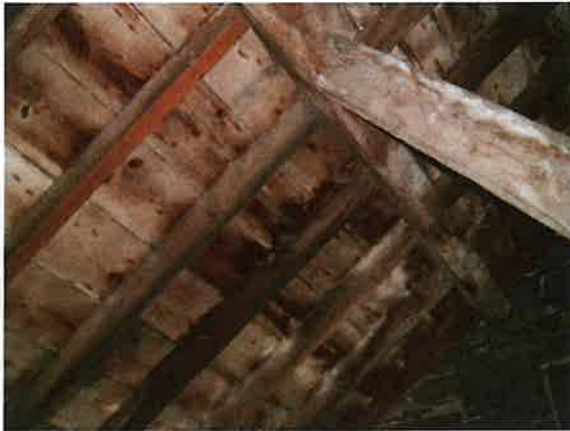
| Fig. 13 | Sarking above stair tower adj. to Residential Home |

The existing roof is welsh slate on timber sarking, and from visual inspection at street level, seems to be in good condition. Investigations of water ingress revealed that vegetation growth was causing capillary water movement up under the slate and over the top of the lead valley gutter's edge, and into the attic space below. There are four roof lights on either side of the roof and the light has two panes of patent glass in each. Some of the patent glazing has been replaced to make the building secure. The lead valleys require investigation after cleaning to check for expansion splits and excessive trough wear. The internal face of the sarking boards, where inspected visually from the ceiling access hatch, revealed some discolouration but on the whole, was sound and dry.

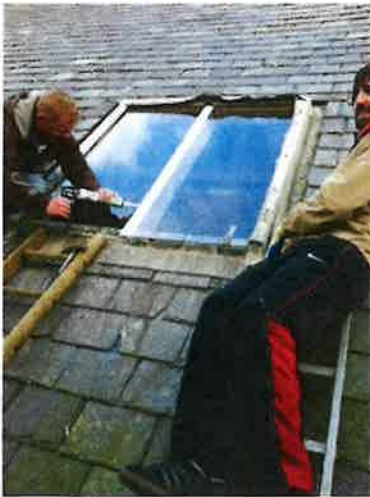
| Fig. 15 | Maintenance Repairs to Light Well roof windows |

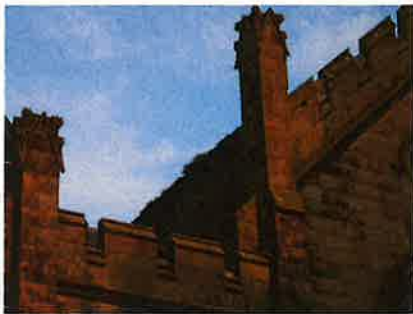
| Fig. 17 | Front Elevation - Crenellation to parapets |

The East gable is the more decorative of the two, and comprises the two entrance doors with stairs leading to the Gallery seating above. The stairwells are framed by stepped buttresses as 45 degree protrusion from the gable wall. The North tower extends a storey further and capped with an impressive dressed stone steeple. This elevation is formed from dressed sandstone in its entirety, with a coursed rubble stone to the inner face, trapped and lined with lathe and plaster above vertical timber wainscoting. The external stonework is in very good condition, with no signs of delamination, settlement, erosion, or plastic repairs. The finite cornicing above the gothic archways of the doors and windows has suffered some erosion, particularly at expected locations of water drainage runs from features above, but not detrimental to structure or aesthetics.

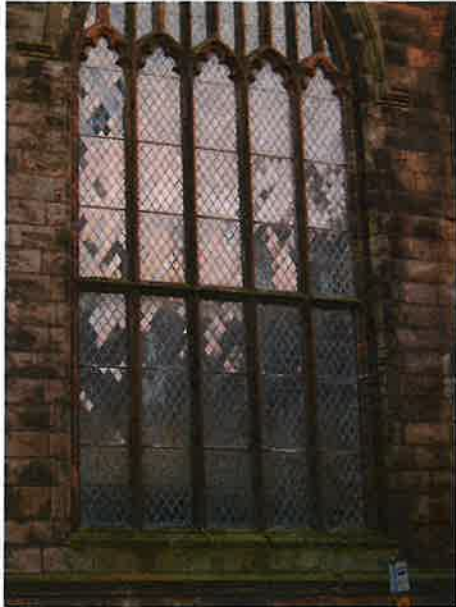
| Fig. 22 | Front Elevation – Main Window (Congregation Area) |

The eight main church windows have sandstone Y-tracery astragals, and glazed with reinforced leaded glass panels. The main congregation area window facing out onto Bridge Street is the most ornate masonry wise, and comprises of ten main panels of diamond embossed patterned glass. The accompanying stairwell windows comprise of only two main panels but replicate the patterns of the central window adjacent. The remaining window at second floor level, and the rose window above the congregational area, has been fashioned

into a ventilator panel using scalloped welsh slate fins backed with predator netting. Some fins are now missing and the predator netting has rusted away, allowing free access to pigeons and smaller bird life.

The Bridge Street Elevation main window requires no glazing work however, the splayed sill and side ingoos require significant refurbishment work, along with making good the wall area where the Kirk Plaque used to be, directly under the sill.

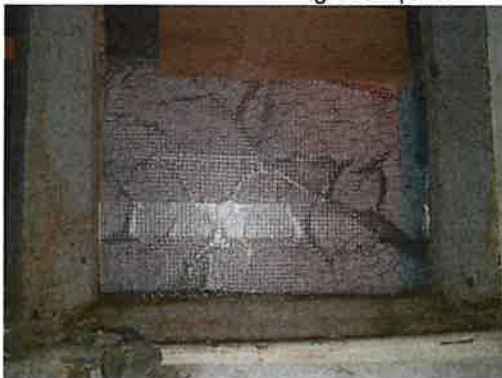
| Fig. 24 | Rear Elev. Window – Applied Film to Inner Face |

The rear elevation facing out onto Kirks Lane features one rose ventilator (to the attic space), one rose window to the stepped ceiling area above the gallery, two small, two panel arched windows to the gallery seating level (the southern of the two is glazed in stained glass depicting a Saint on each panel). Two large six panel windows are the central focal point shouldering the pulpit between them. The large northern central window depicts two stained glass scenes in the centre panels. These two windows bridge the space between congregation level and gallery level, terminating just below the exposed bottom chord of the main supporting truss frames. The smaller gallery windows are replicated on the congregation level below, and slightly smaller in height to fit under the gallery soffit. The glass panels not fitted with stained glass have either been glazed in embossed diamond lattice pattern, or modern common dimpled obscure glass, and the latter has been installed at low levels as ongoing repairs caused by repeated vandalism. This is further exemplified by the use of self adhesive transparent film applied to the inner face of the lower level panels. The basement Session Rooms, Vestry, WC and Pulpit stair well all have timber sash and case windows. The three large windows have swept tops as the doors, but the smaller windows have a standard flat horizontal lintel. All timber sash windows are in good repair.

The rear tracery windows identified on the Elevation drawing (Ref: W08 & 09) would benefit from a toughened safety glass substitute replacement, with a transparent film applied to the inner face to closely match the original patterns adjacent.

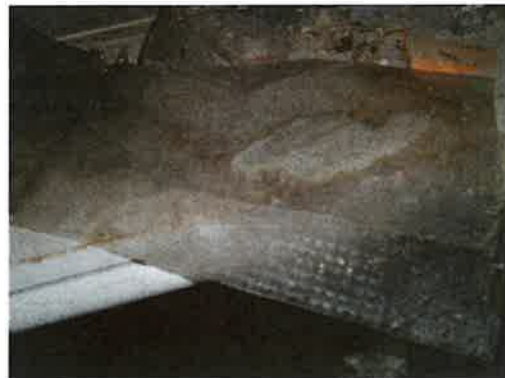
| Fig. 25 | Rear Elev. Window – Applied Film from Broken Pane |

The Kirks Lane elevation however, has not fared so well, and succumbed to vandalism during its unoccupied state and into its current owners time. Previous attempts to safeguard the glass have been futile at least, and the application of an off-the-shelf self adhesive film to the inner face has only minimised the spread of shards within the church interior.

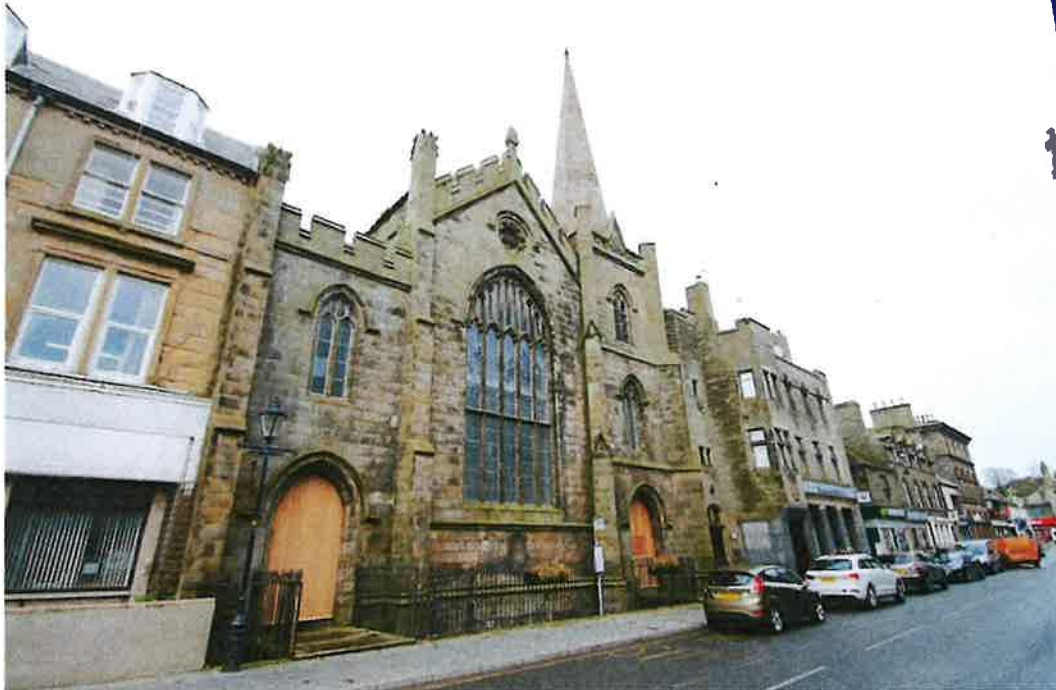
| Fig. 26 | Front Elevation showing C.I. Railings |

The Cast Iron railings along the front elevation acts as a protective barrier to pedestrians along Bridge Street, separating them from the basement access stairs, and the open pend below street level. There is a gate located at the southern end of the railings allowing access to these stairs, but the gate and hinges require a significant amount of repairs to bring them back up to an acceptable standard. The main railings are reinforced from the Church's front wall by the use of iron bracing placed at strategic centres, and were noted to be in fair to moderate condition.

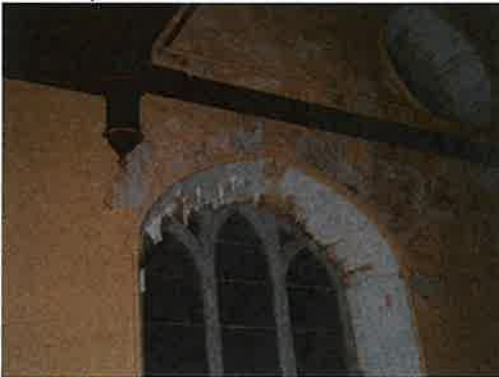
| Fig. 32 | Paint condition on West Gable |

The general finish to all walls and partitions is lathe and plaster on studs to the upper areas, with vertical vee'd timber board wainscote linings to the lower portions. The only exception to this is in the two front stair wells, where there is no wainscote detail above the stair stringers. As mentioned in the ceiling section, the paint finish to the plaster has been affected by manifesting dampness, and is now flaking severely on the east and west gable elevations, and the side walls where water ingress has occurred. The west gable looks to have suffered worse, as the dampness has affected the surface of the plaster also, and mineral salts are evident in several places.

The existing finishes are to remain and be repaired where necessary at cracks, damp spots, and unsafe hollow areas however, the finished paint colour will be a brighter white to reflect as much light around the display areas as possible. The dark timber wainscote to the periphery walls will remain, with only a wash down and re-varnish as necessary. It may be that Building Control required the varnish finish to be of an Intumescent nature (ie: Fire proofed).

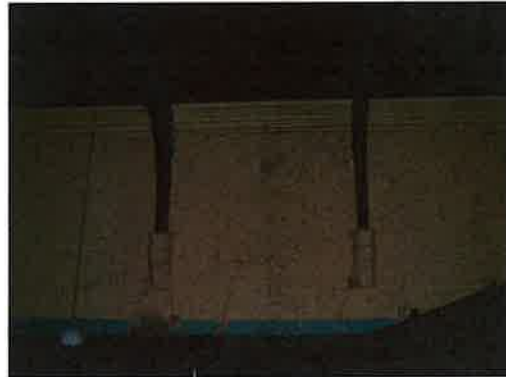
| Fig. 33 | Paint condition on North Wall (leak between truss corbels) |

Water ingress from inboard valley gutters above are noticeable between truss seats 4 & 5 on the north wall, and truss seats 1 & 2 on the south wall. The ingress has affected the plaster mildly but had a worse affect on the wainscote to the north side, and the decorative moulding between the trusses on the south. Further investigation is required to find the sources of the leaks before reparative measures can be assessed. The timber wainscote linings can still be used, as the damage has been mainly to the horizontal timber straps behind. The decorative moulding can also be repaired as the dislodged piece is intact, sound, and on site.

The existing ceilings in both Galleries, and Congregation areas, have suffered some water ingress damage, and this is being repaired with modern lathing techniques, and finished in hardwall plaster with scrim coating as the existing adjacent finishes. It is interesting to note that the areas of repair recently carried out by the current owner, are that of earlier repairs carried out under ecclesiastical use also, therefore a vigorous inspection from the roof structure down, is required to identify where the ingress originates.

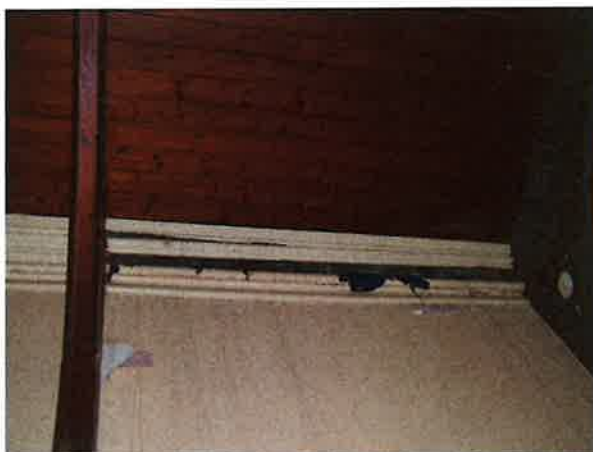
| Fig. 34 | Cornice Detail dislodged from South wall |

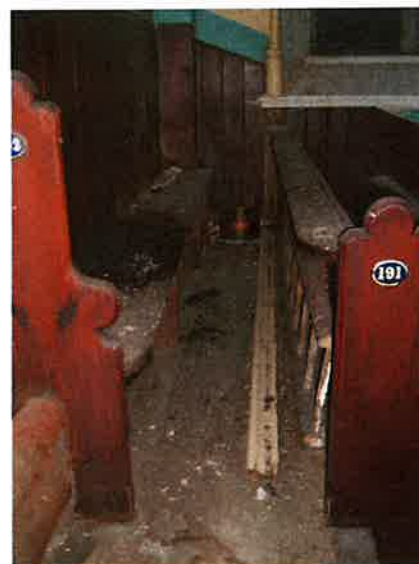
| Fig. 35 | Missing profile piece lying between pews in Gallery |

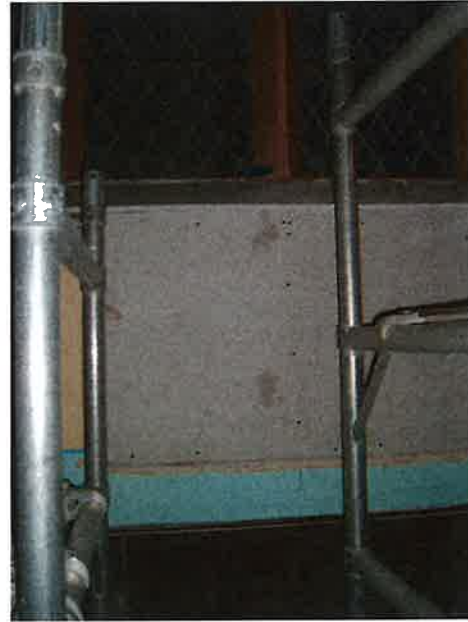
| Fig. 39 | Patching of wall where Plaque used to be |

The church clock is missing from its housing in the frontage of the gallery upstand. It is thought that the original clock was gifted to the last outgoing minister before the church's closure in March 2009. It is not known where the plaque from under the Bridge Street window went to.
