Nether Lochaber Village Hall, Onich

Purpose of My Site Visit and Preliminary Report.

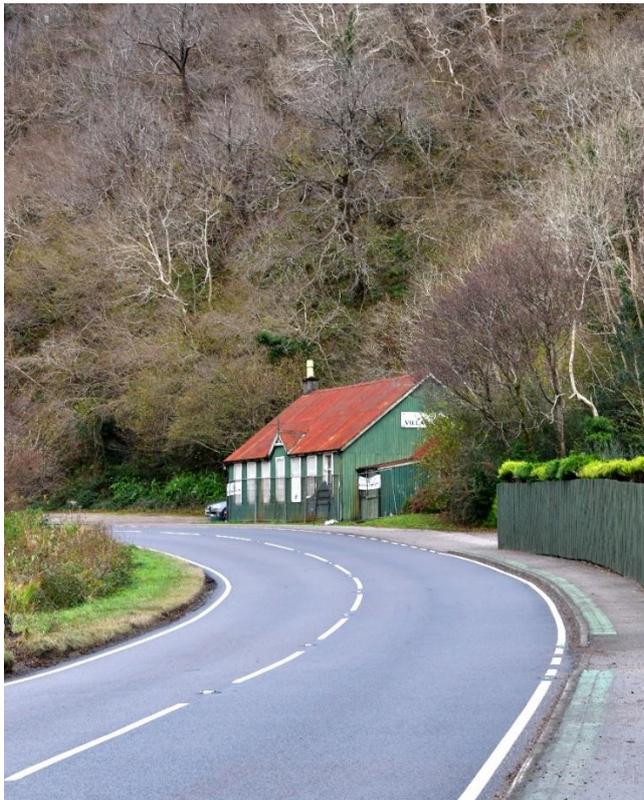
The hall is located at the west end of the village. It sits very close to the roadside. This is the main A82 to Fort William. Careful thought should be given to providing a safe working area for the conservation work. Looking to the future consideration should be given to the pedestrian and vehicular access.

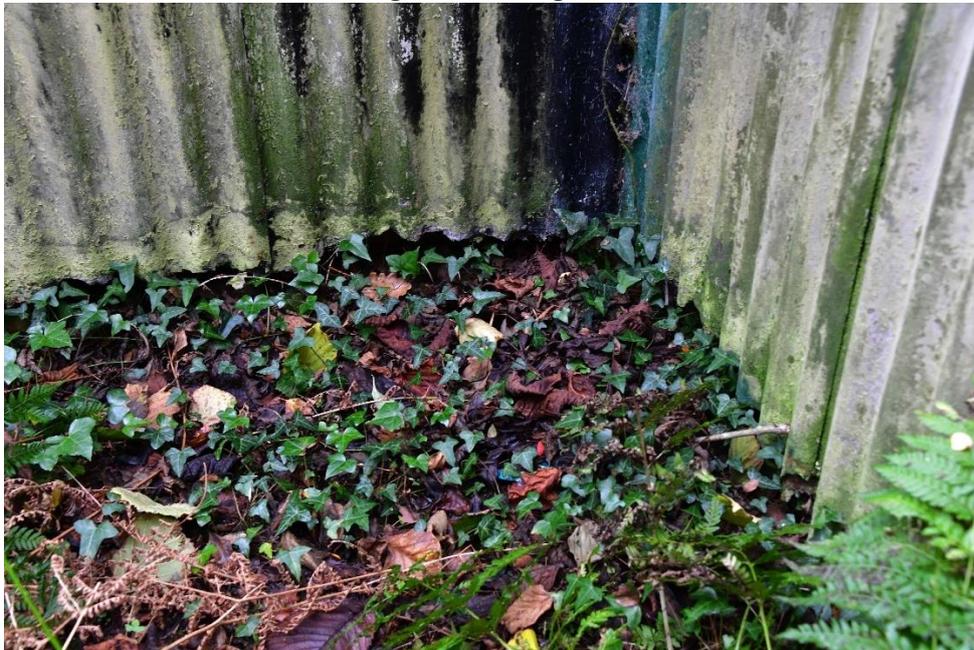
The ground levels around the hall have risen over the years. This has blocked the under floor ventilation in a number of locations. It has also accelerated the decay of the bottom edges of the corrugated iron cladding. Ground levels should be lowered around the hall.

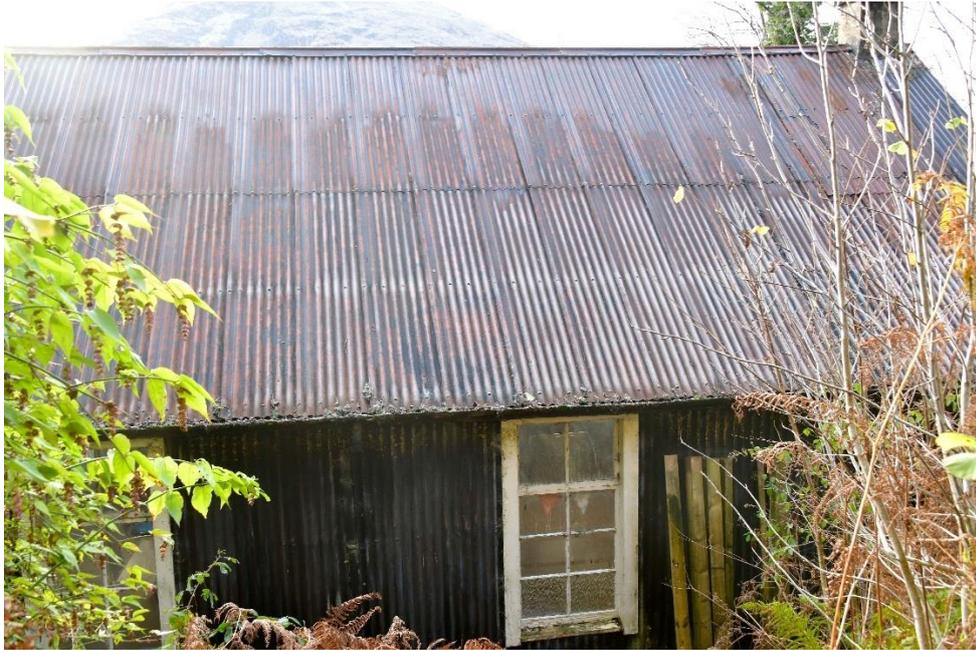
North roof Main Hall

The roof is showing signs of decay and there are a number of areas on the interior showing signs of water penetration

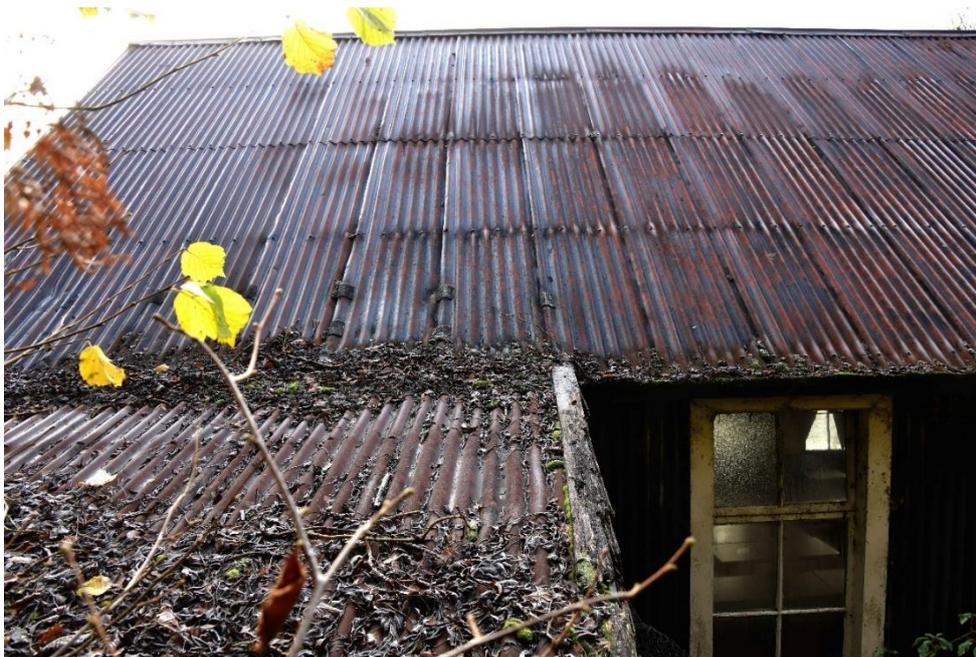
North pitch with kitchen extension

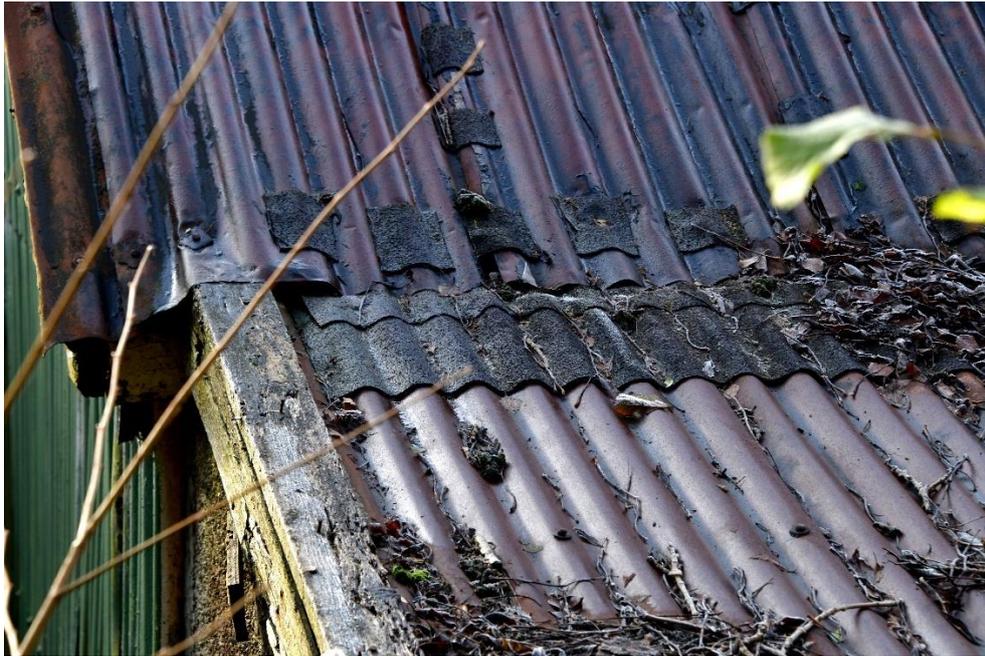
Junction of Main Roof and later Kitchen extension.

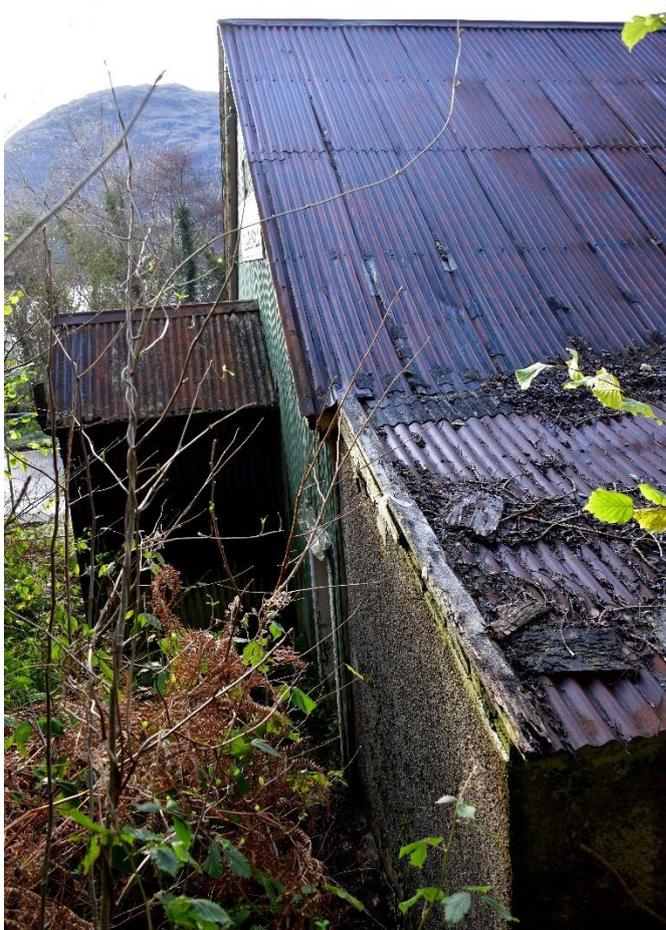
North pitch east end. Note the edge detail of the main roof.

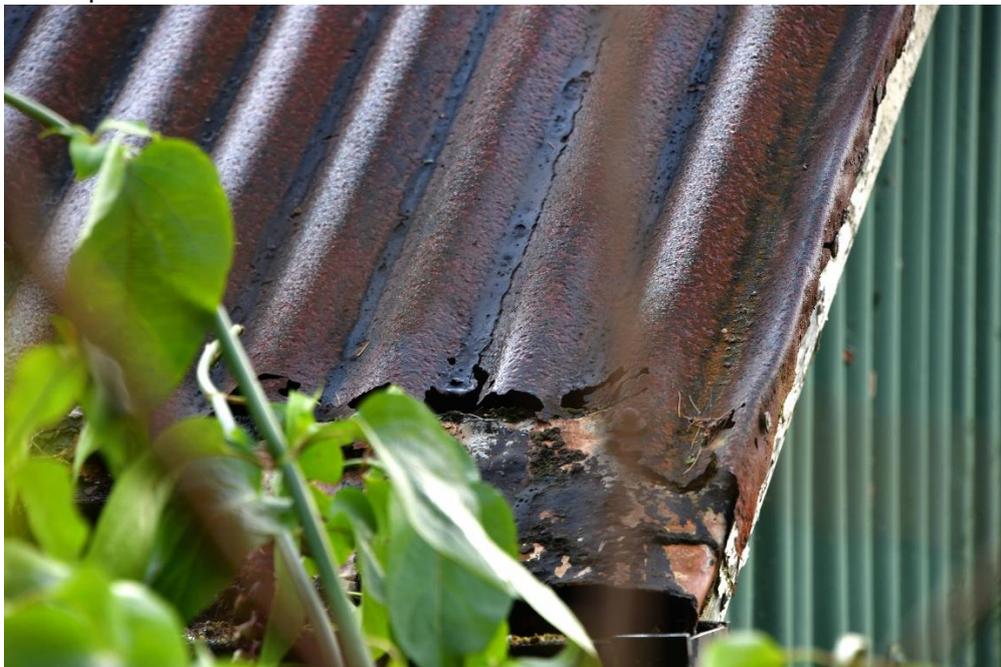
North pitch west end eaves decay. Typical edge detail with the corrugated iron sheet carried over and nailed to the barge board.

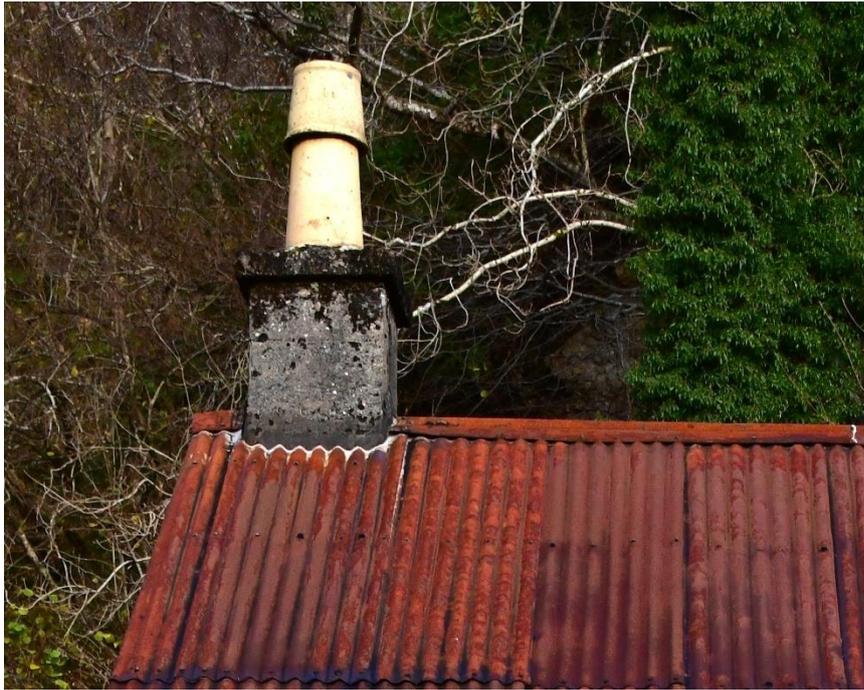
Chimney minimal or no flashing. Investigate the construction of the chimney. It may be cast concrete.

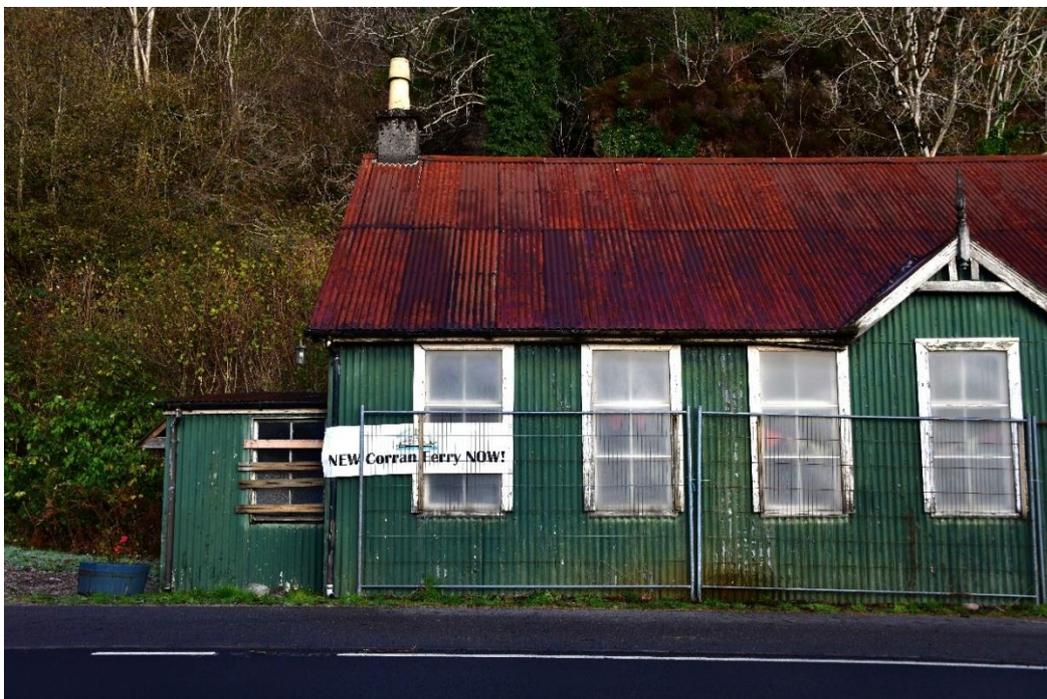
South Elevation,

The corrugated iron looks to be in a poor condition. It will require a detailed inspection to assess the condition. Replacement corrugated iron should match the original in size and gauge.

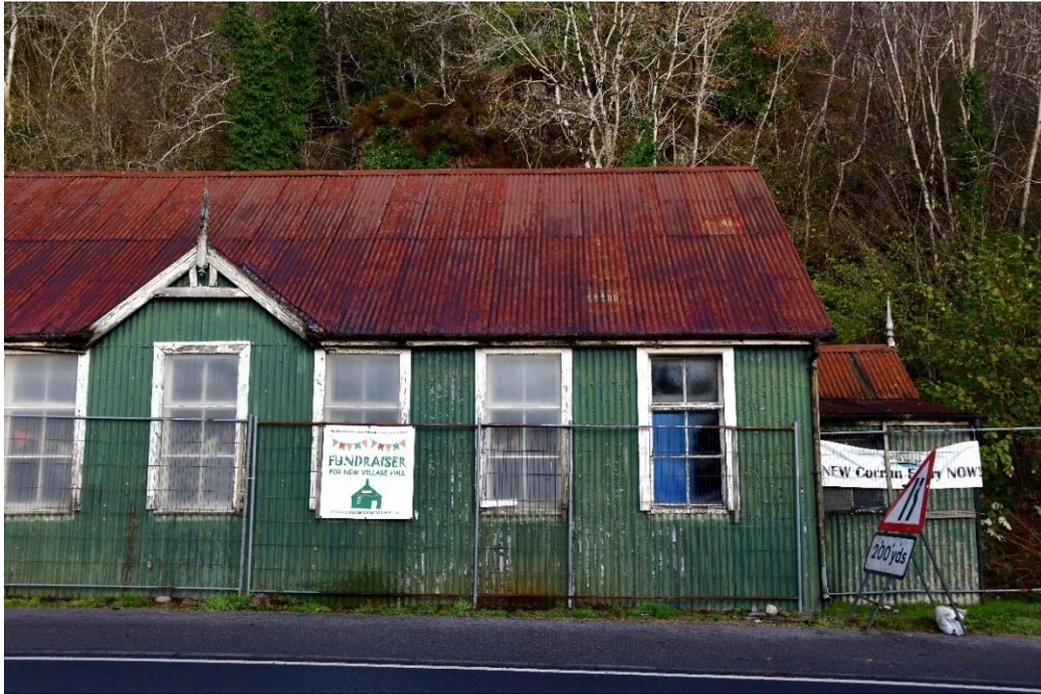
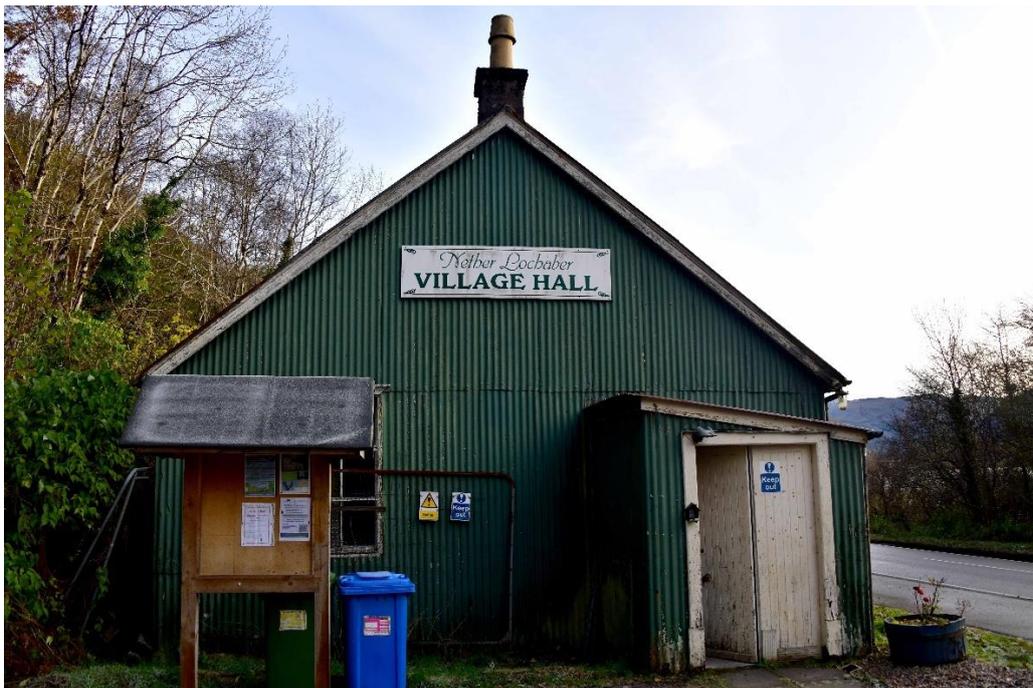
The West Gable.

Late mono pitch porch formed where there was an original window opening.

The porch is in a poor condition.

The original timber decorative elements to the upper gable have been removed from both gables

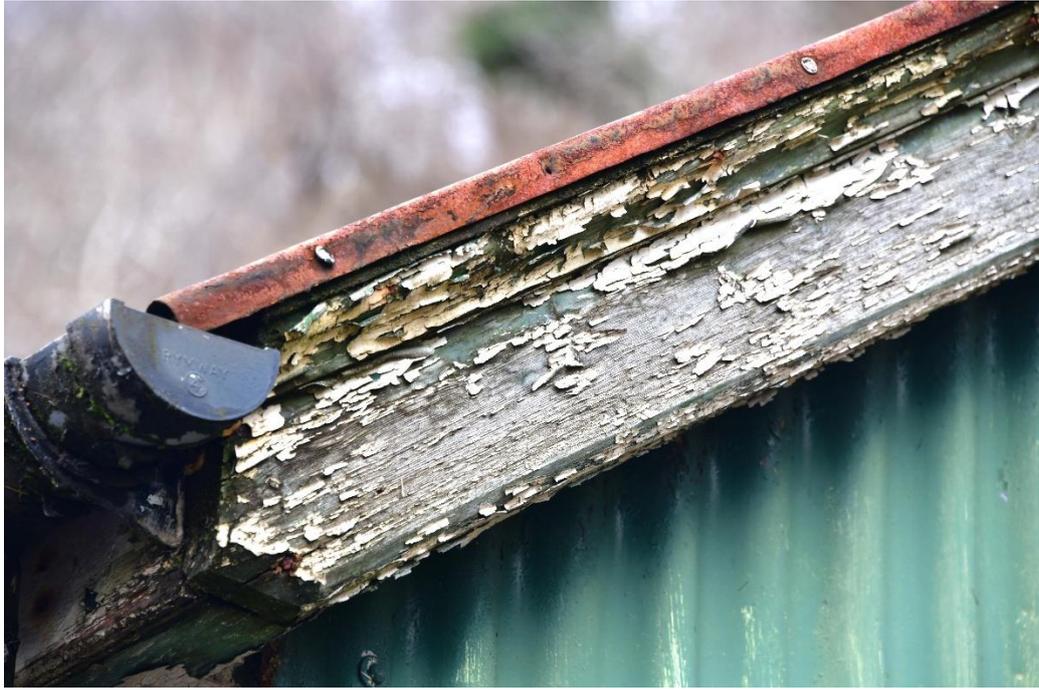
Eaves detail. Replace rainwater goods in deep flow metal.

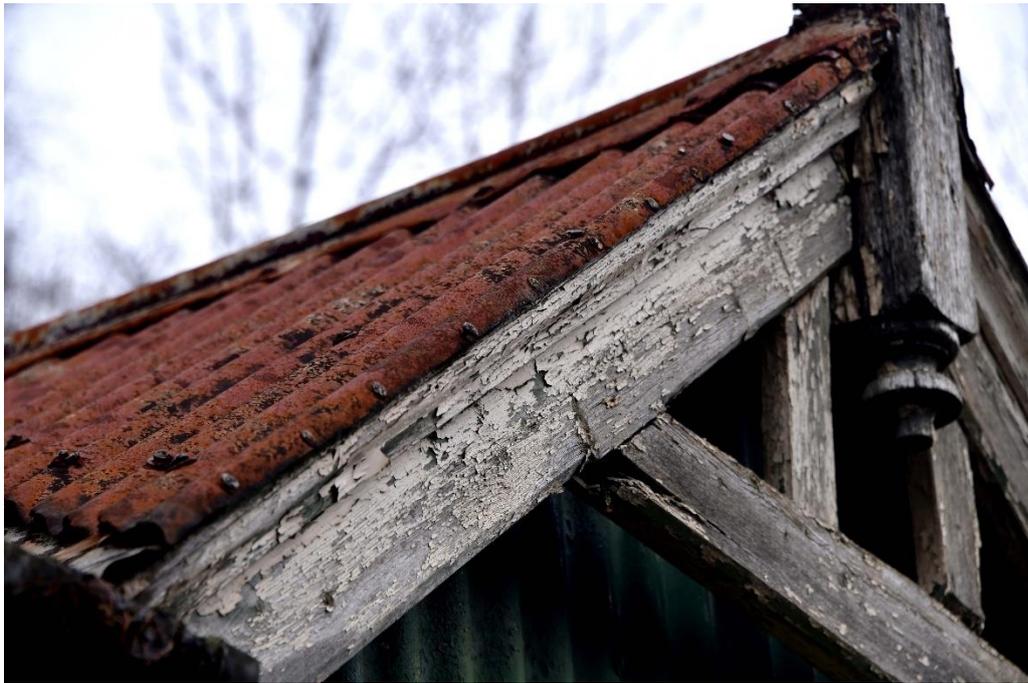
Corrugated iron and zinc flashings throughout require to be replaced

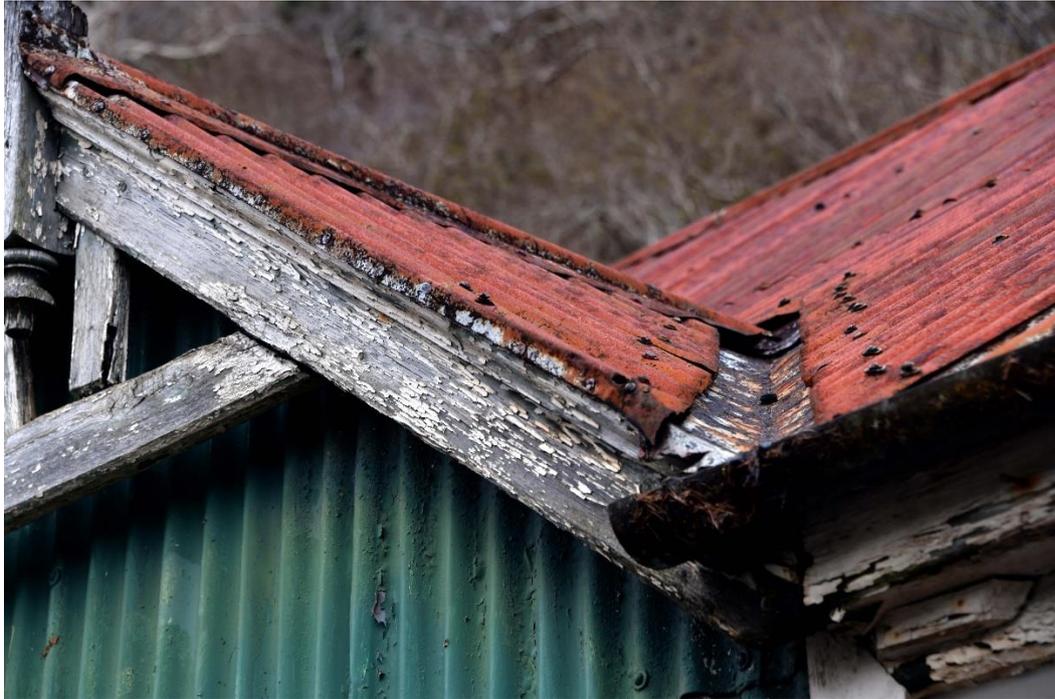
Timber work needs to be carefully inspected throughout the hall, stripped down , replaced where required and repainted.

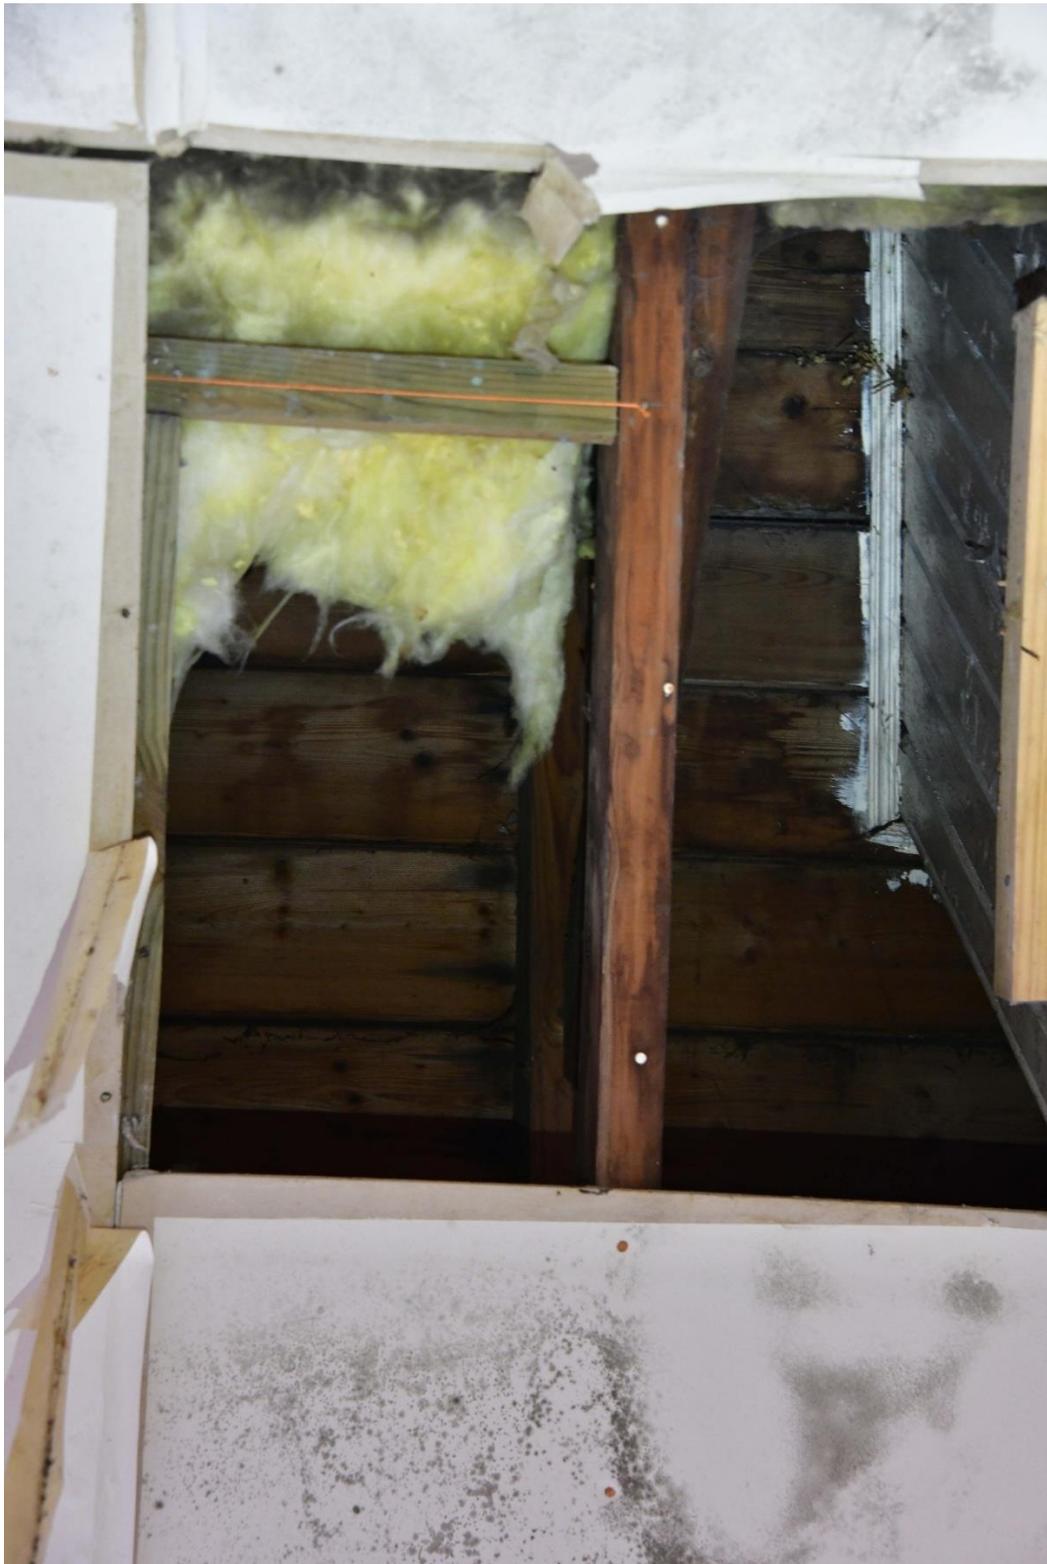
Inspection area open. The original roof/ceiling finish can be seen above the later lowered ceiling (as can be seen below in the original entrance porch, now WC) Daylight can be seen through the board adjacent to the chimney lining boards
The lowered ceiling is in a poor condition and should be removed. Careful consideration should be given to insulation options.

The preferred option would be to install a priority thin insulation layer above the original timber ceiling. There will be a need to replace sections of the original timber boarding due to rot.

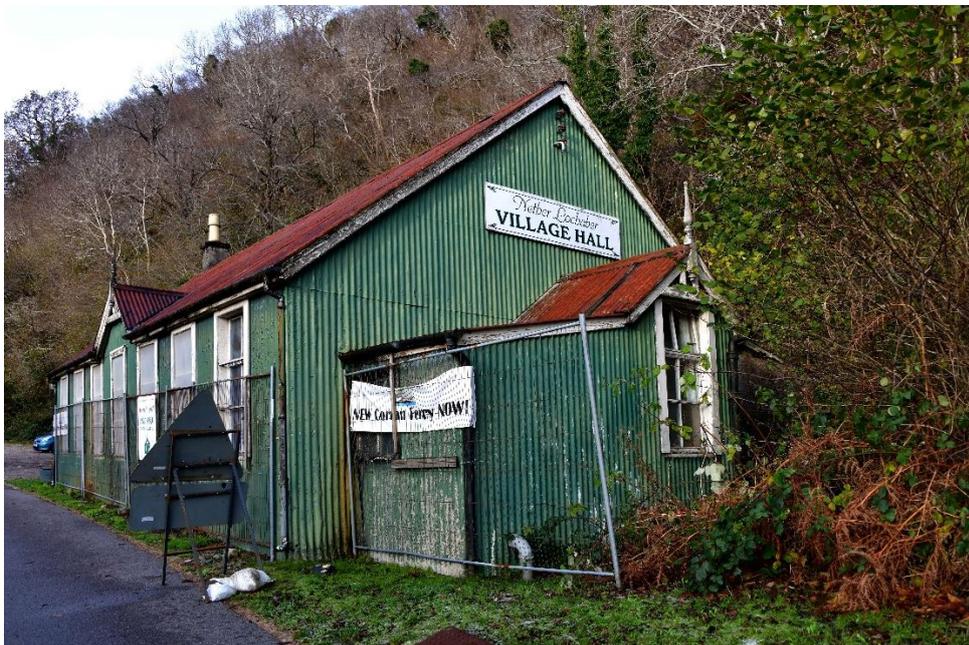
East Elevation

The later addition to the East elevation to form a WC is in a poor state of repair. Consideration should be given to removing this completely.

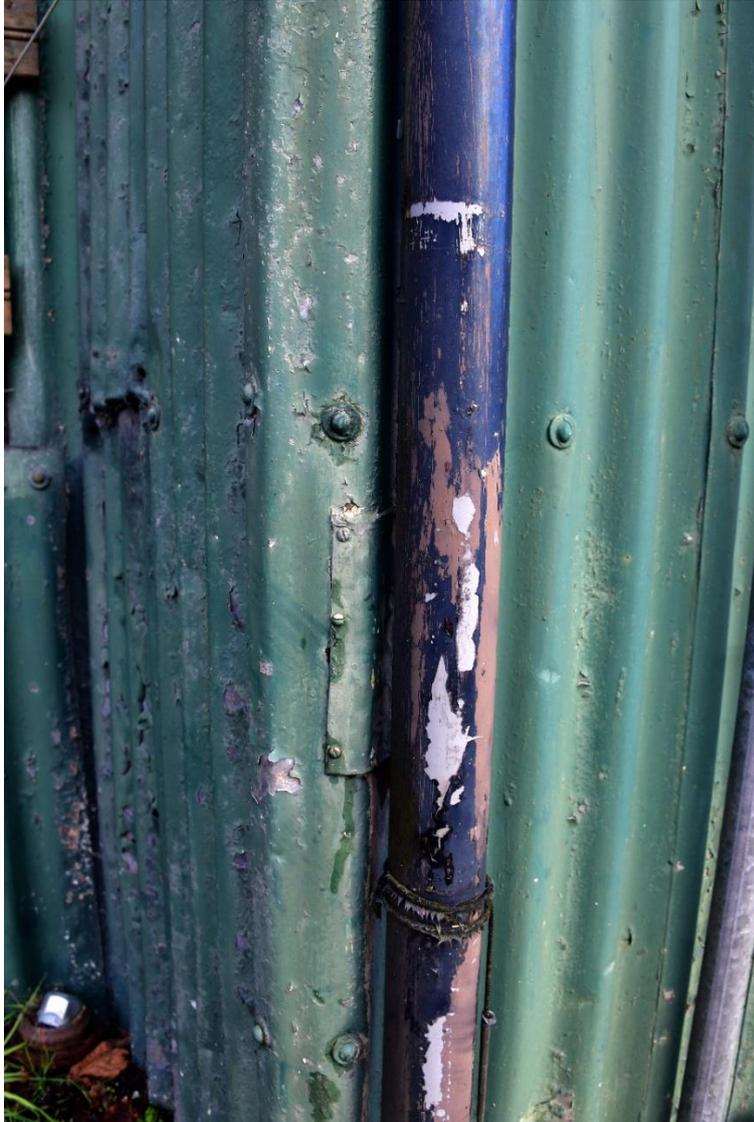
Corner detail corrugated iron sheets wrapped around the corners throughout the building. This detail should be replicated in the renovation of the building.

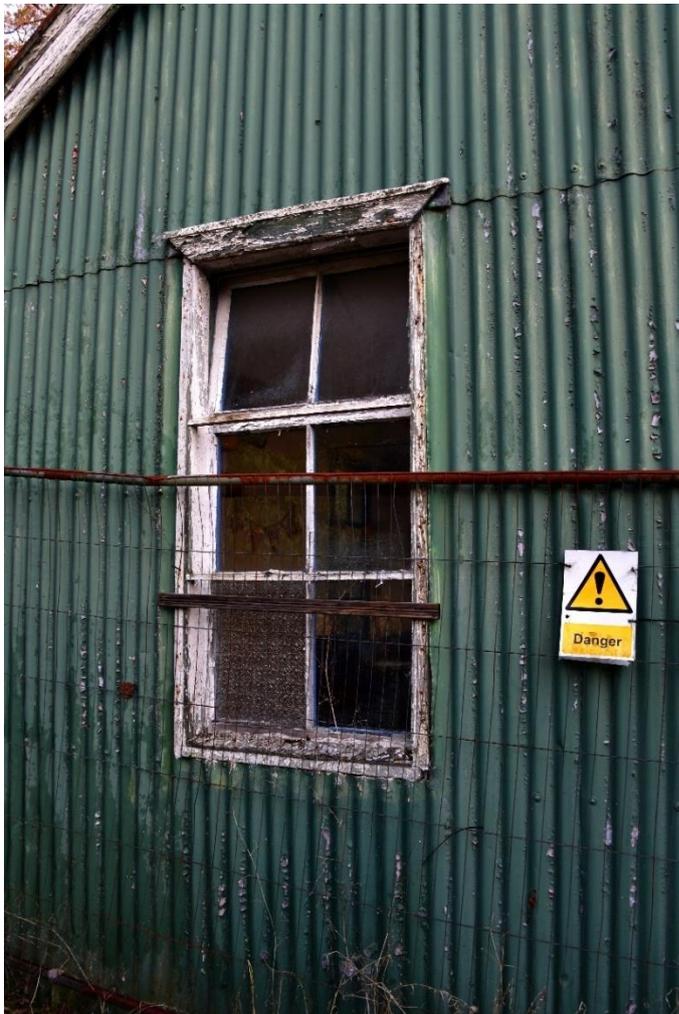
West Elevation window. Typical loss of timber facings to most windows. Sills generally in a poor condition. Most windows are six pane with a hopper opening top section. One 8 pane on the North elevation

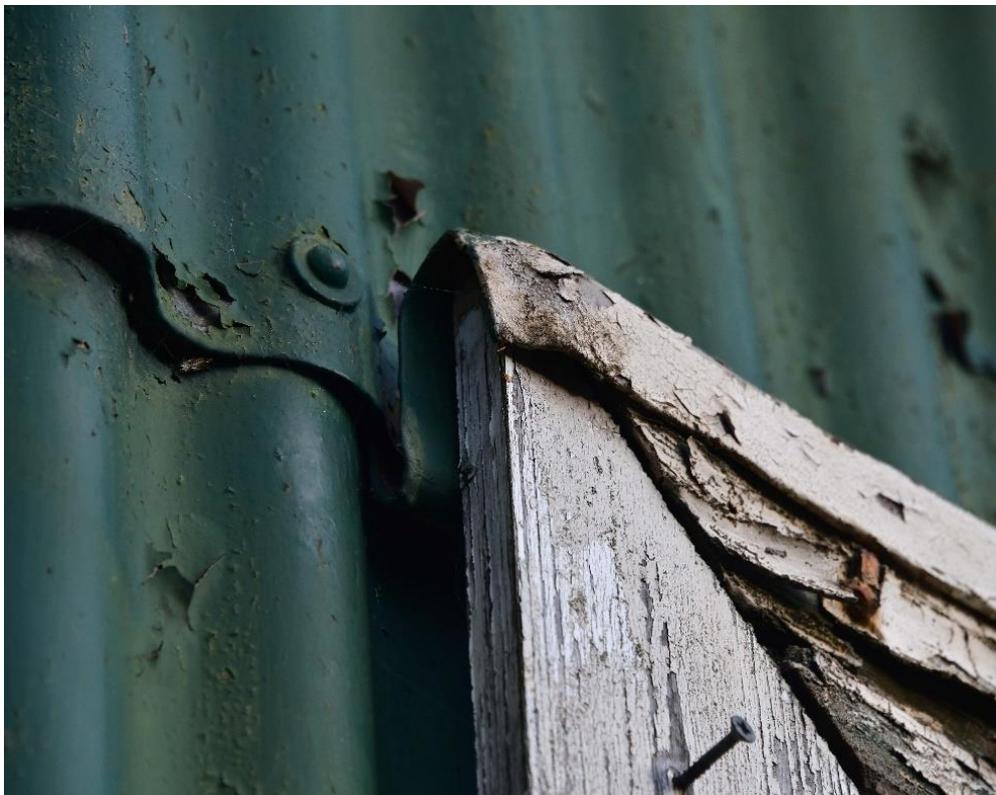
Poorly formed later fire exit on the East elevation

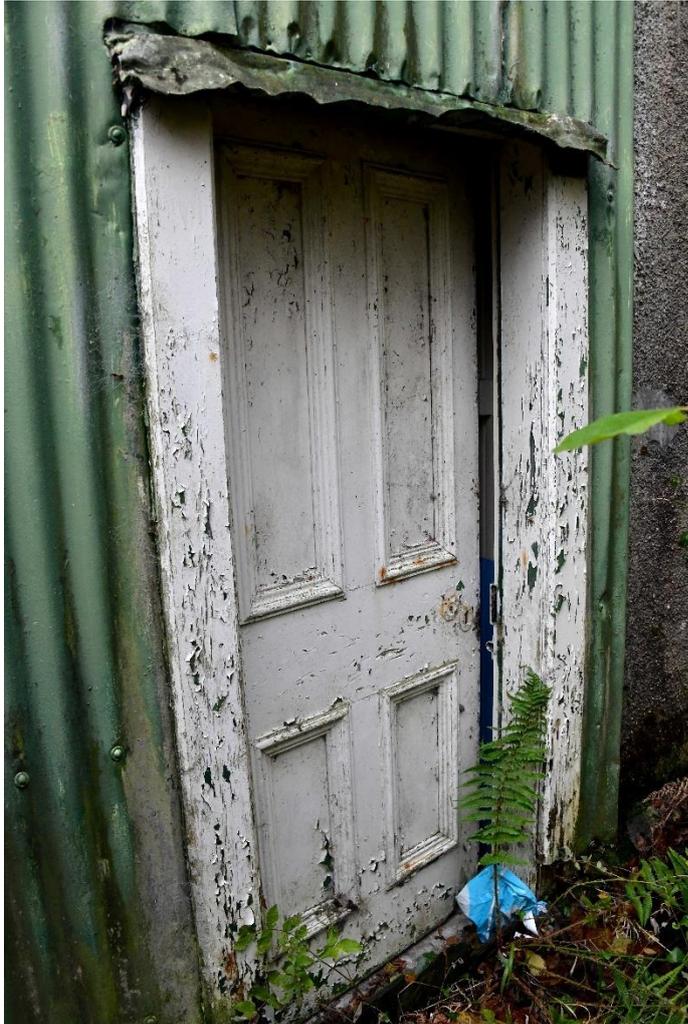
East elevation fire escape

Poorly formed cover flashing. The installation has also damaged the corrugated iron

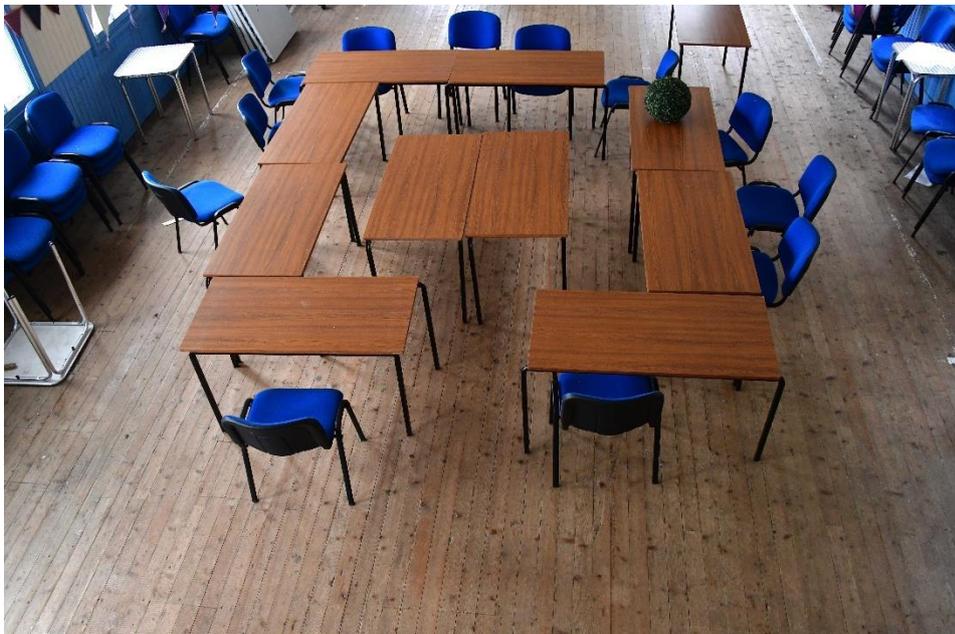
The hall floor looks to be in reasonable condition. There are defective areas identified in the earlier survey that require to be replaced.

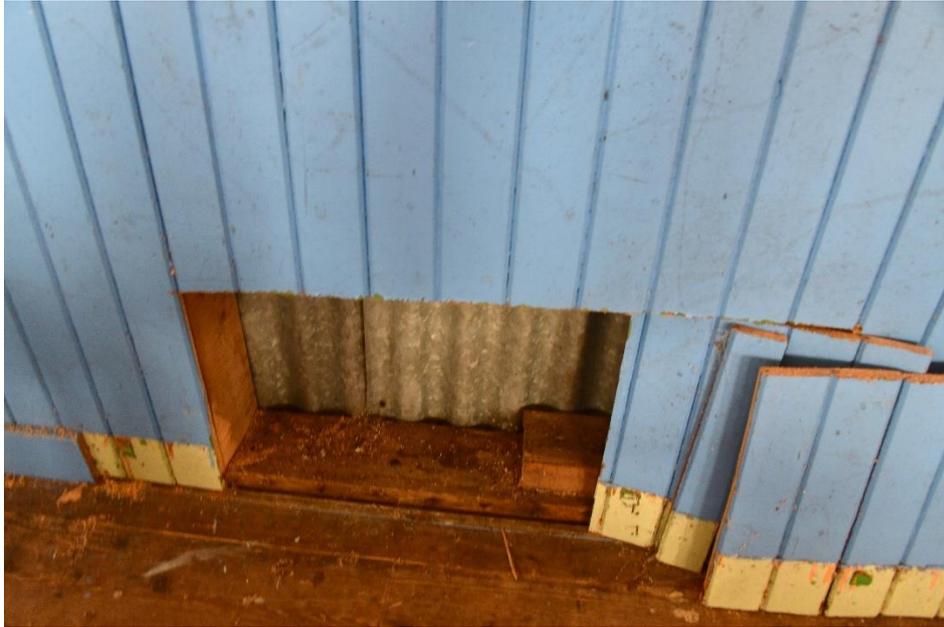
Inspection hatch in North wall to confirm construction and condition of timber base plate. Consideration should be give to the provision of an insulation system for the whole building. This will require care to maintain ventilation and the need for a vapour barrier to protect the corrugated iron and the timber linings.
