4-Mile Walk, Duror

Replacement Bridge Optioneering
Technical Note

The Highland Council

Project number: 60684495
60684495-BR-4MW-ALL-TEC-001

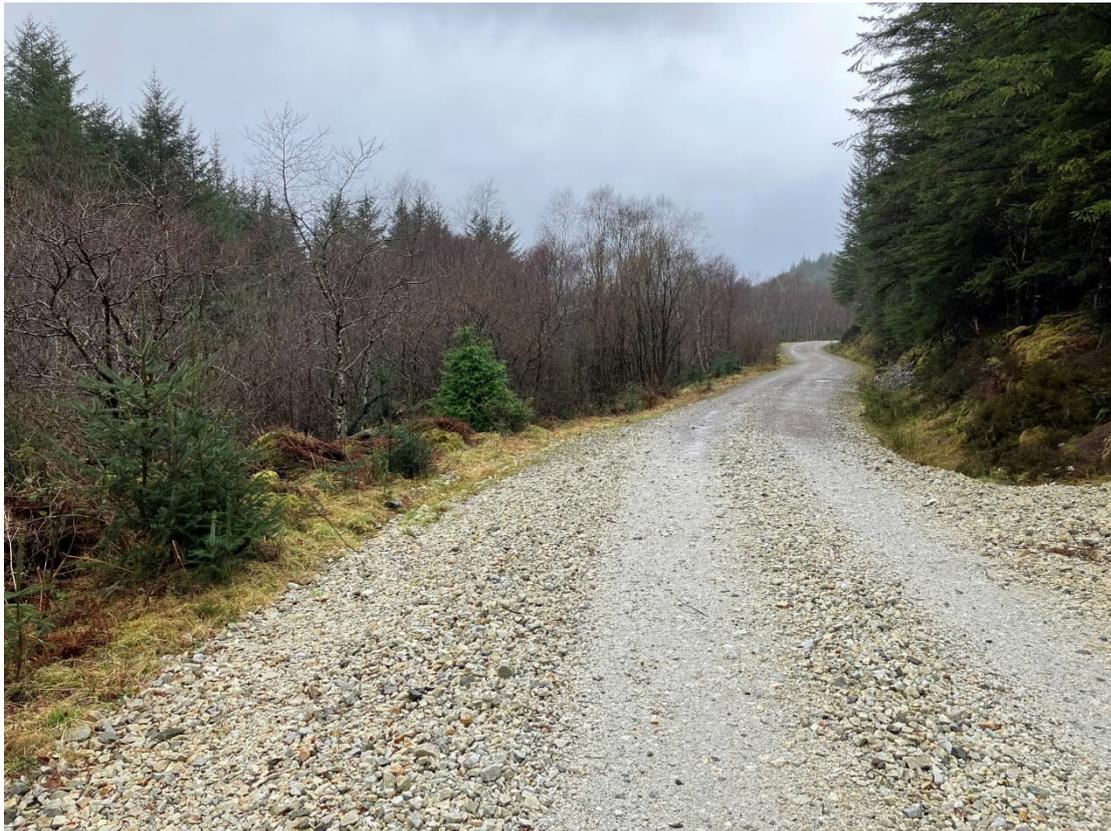
Figure 3 - Access track adjacent to previous bridge location

The previous bridge location was approached from the Glen Duror bothy car park, with 500m either side of the previous bridge location visually surveyed for potential alternate bridge locations. It is noted that the previous bridge location was partially hidden, with no obvious access track currently leading to it.

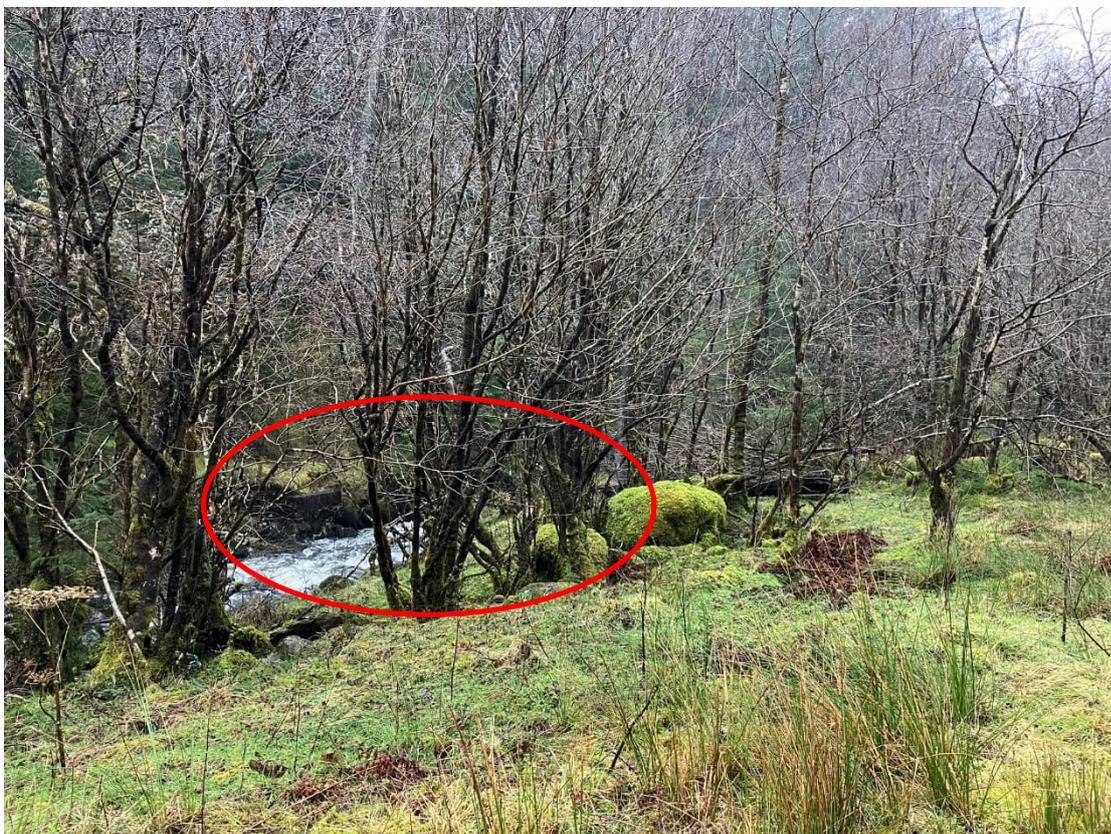
Figure 4 - View onto previous bridge location (circled)

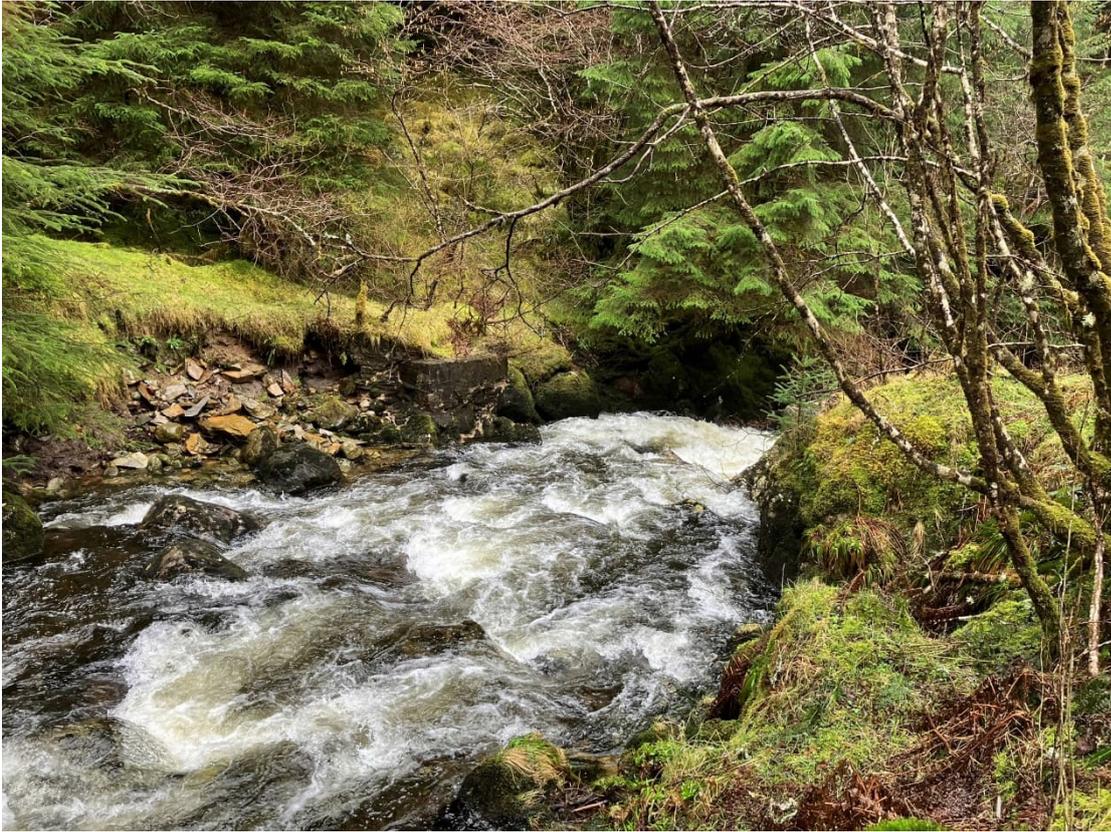
Figure 5 - Previous bridge foundations

Abutments are likely to be concrete pad footings, similar to those provided for the previous structure.

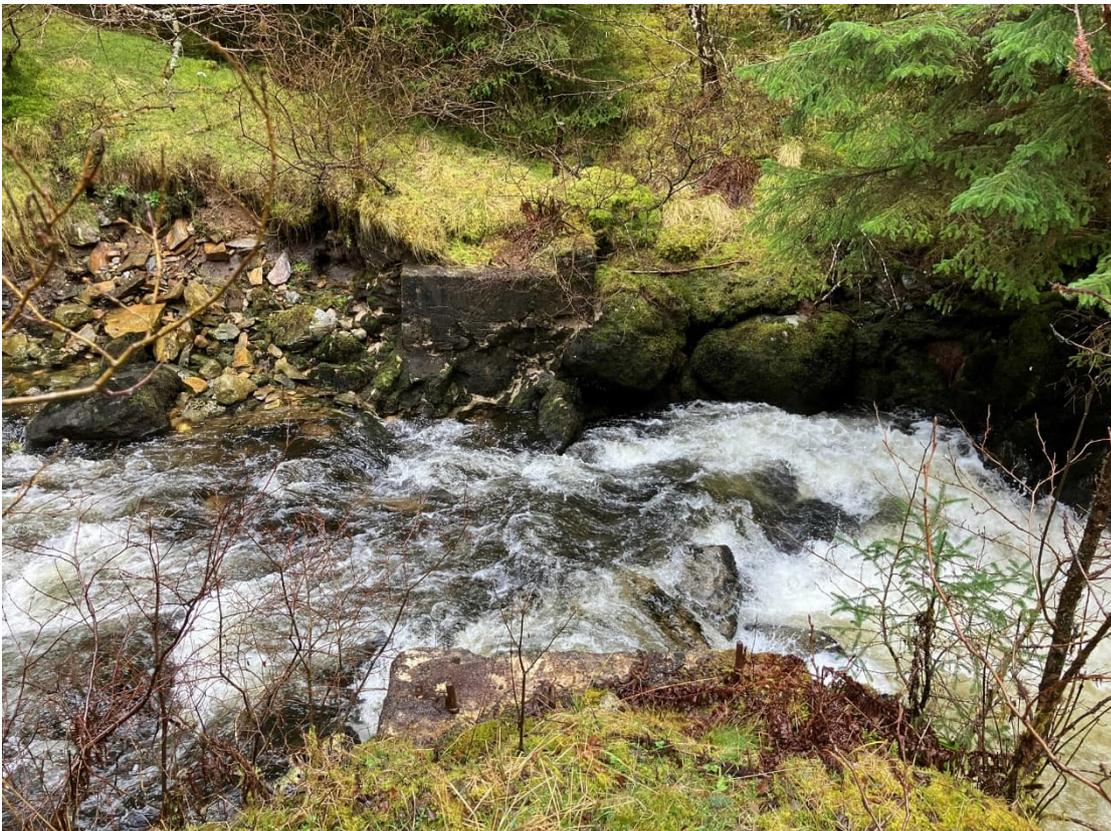
Figure 6 - Previous bridge alignment (north foundation at bottom of photo)

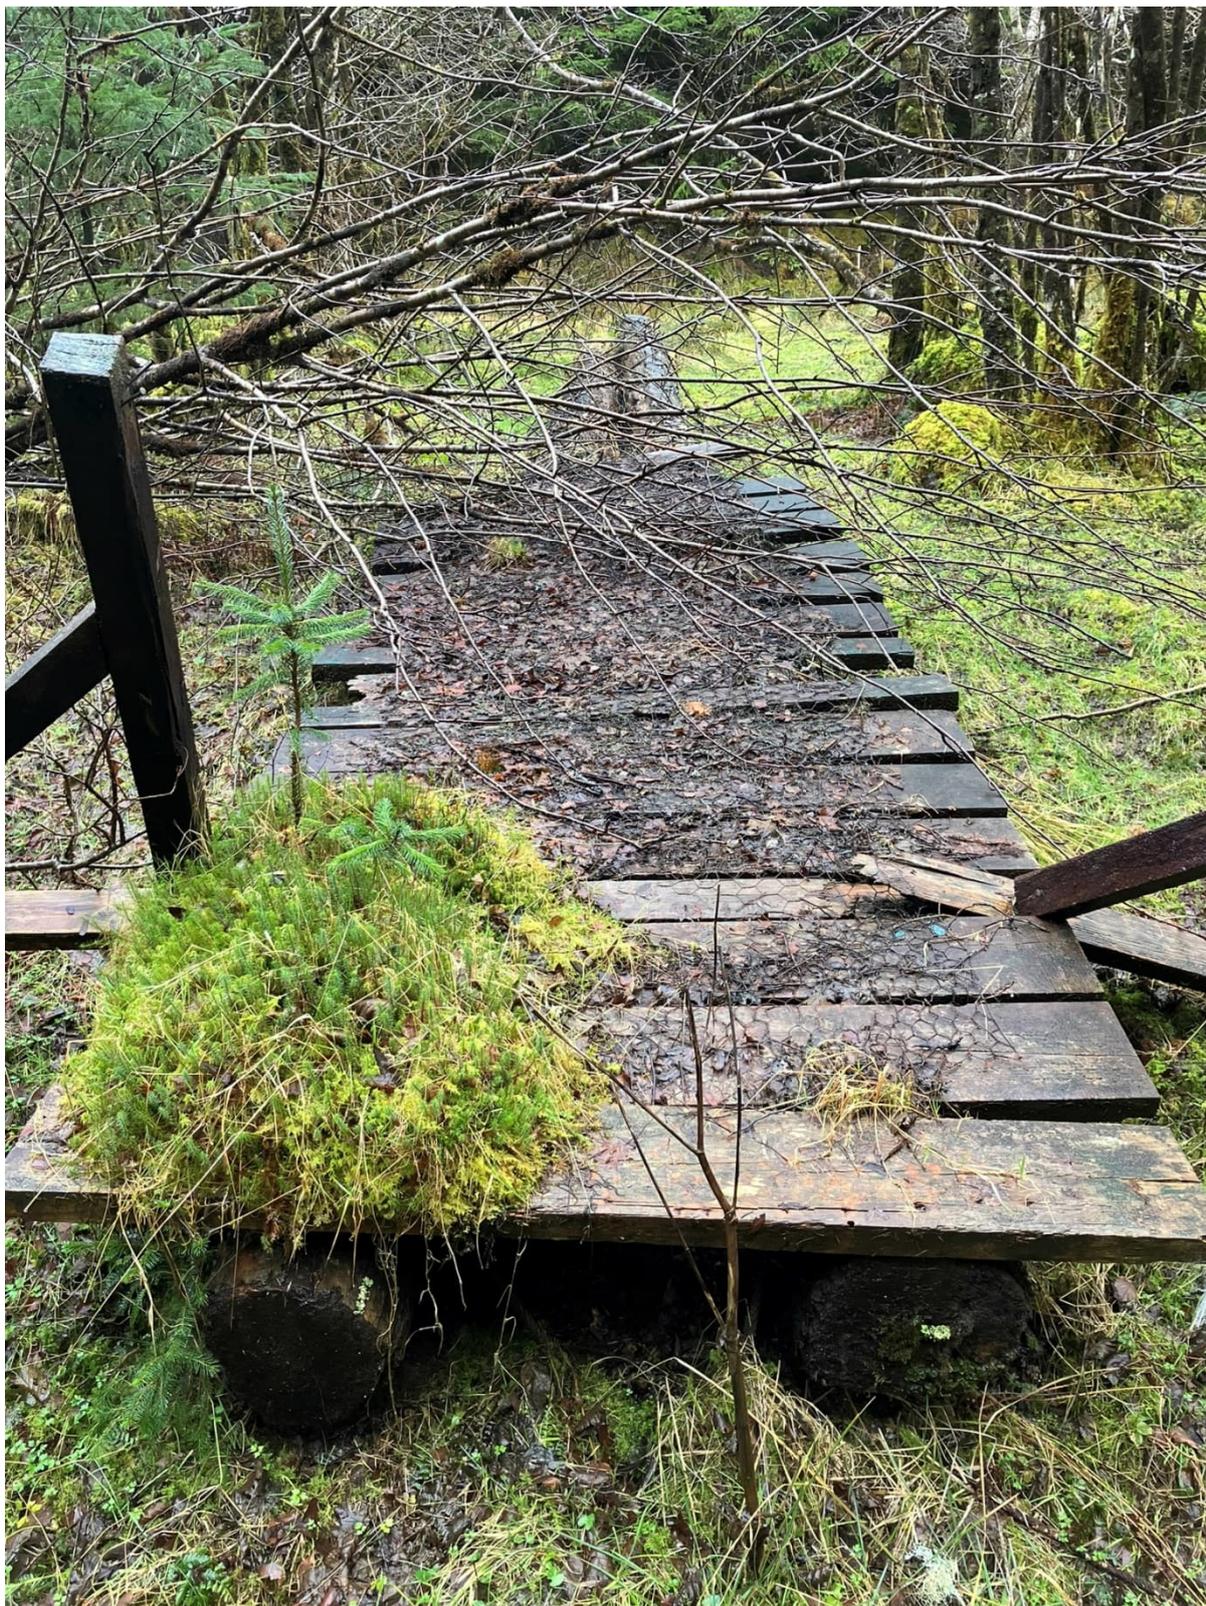
Figure 7 - Previous bridge superstructure (removed and lying on adjacent ground)

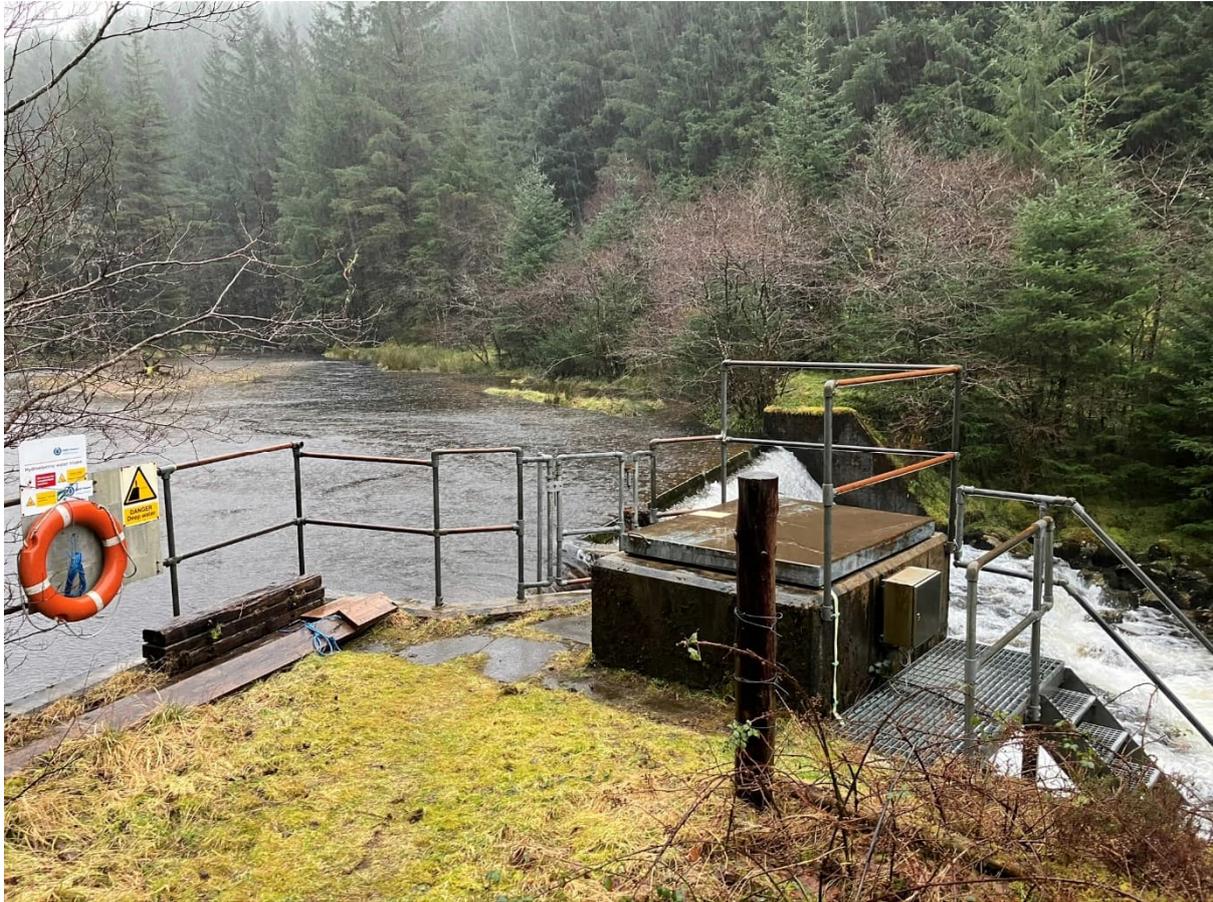
The first is at an existing weir structure. Whilst it may be possible to cross at or near the weir, and potentially draw aesthetic benefit from it, access to the weir and associated infrastructure would have to be maintained, which is likely to be a considerable constraint. Access to the south side would also have to be established through the existing forestry area.

Figure 8 - Existing weir structure

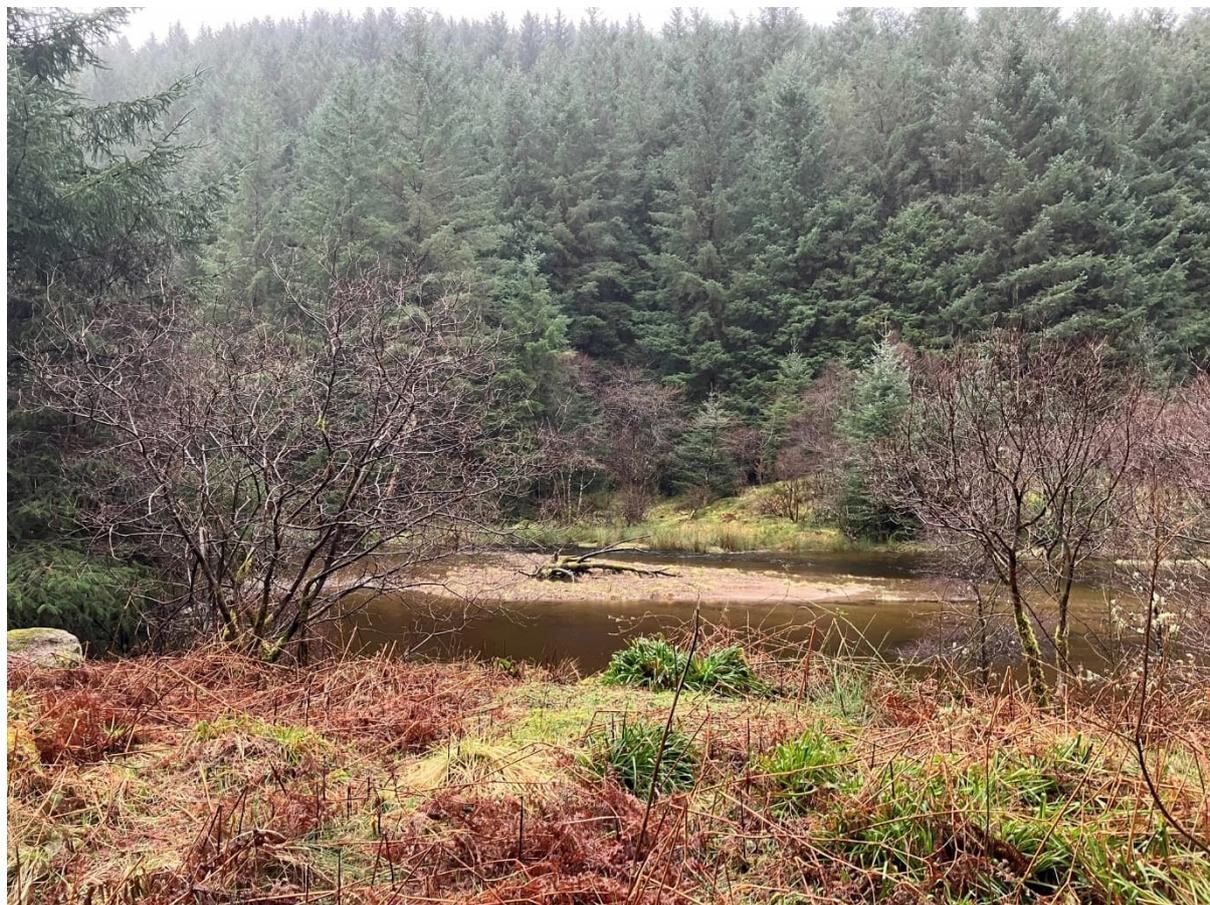
The second point is approximately 100m east of the weir, where the topography flattens. The watercourse widens at this point, so piers or other supports would likely be required in the watercourse. It is assumed this would require the agreement of SEPA and potential impact on the local flood regime would have to be carefully considered. The new supports would be susceptible to impact from debris washed down the watercourse, with design, maintenance and potential flooding implications.

Figure 9 - Area of flatter topography

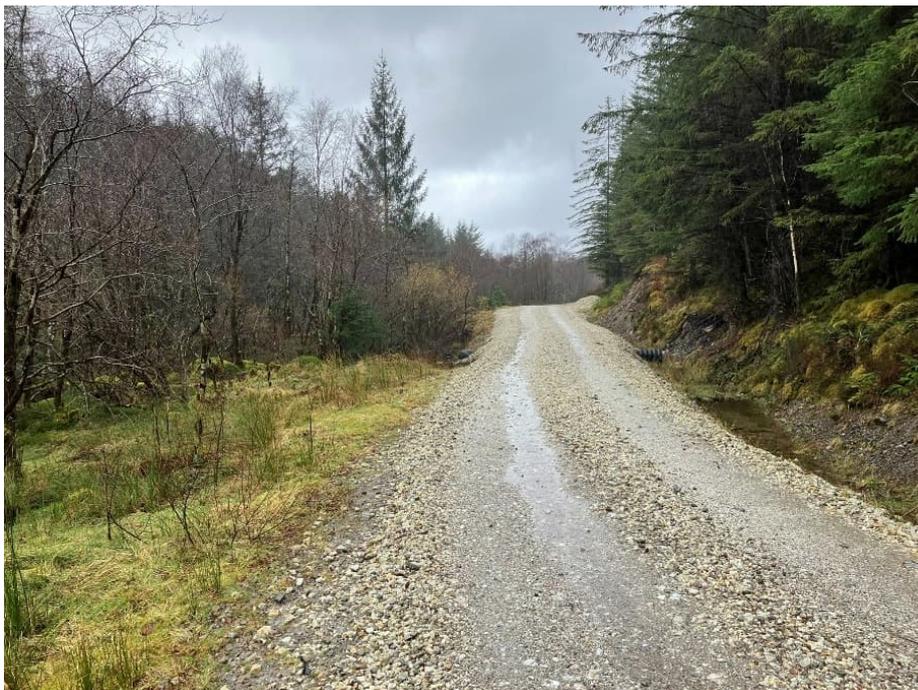
The main constraint is the presence of the watercourse and adjacent forestry plantation. Access through the forestry plantation is via a gravel path. The path appears to be in overall good condition. Rut lines in the gravel suggest the path has routinely been used by vehicle traffic, although no vehicles were seen during the site visit.

Figure 10 - Gravel access path

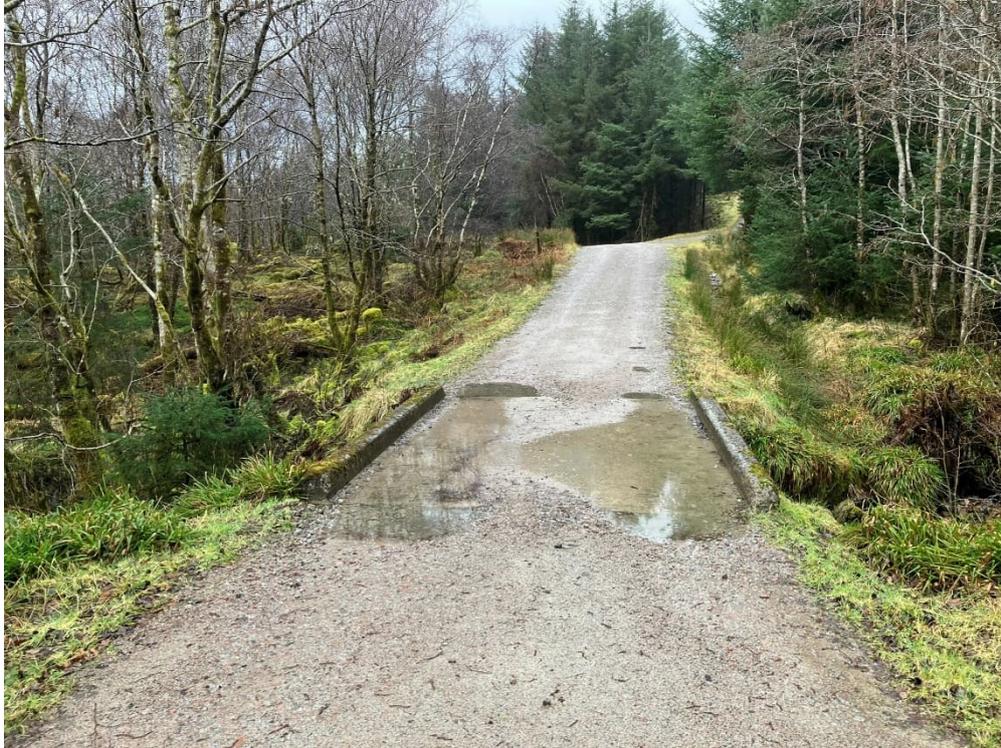
A small number of culverts and small-span underbridges carry the path at discrete points. As noted, the condition of the path suggests it has routinely been used by vehicle traffic so access for construction equipment should be possible. This should be confirmed as part of future work, once construction equipment type, weight and route to be used is known. Noted that road plates or similar may be required in places due to shallow cover to existing infrastructure.

Figure 11 - Existing small-span underbridge on access path

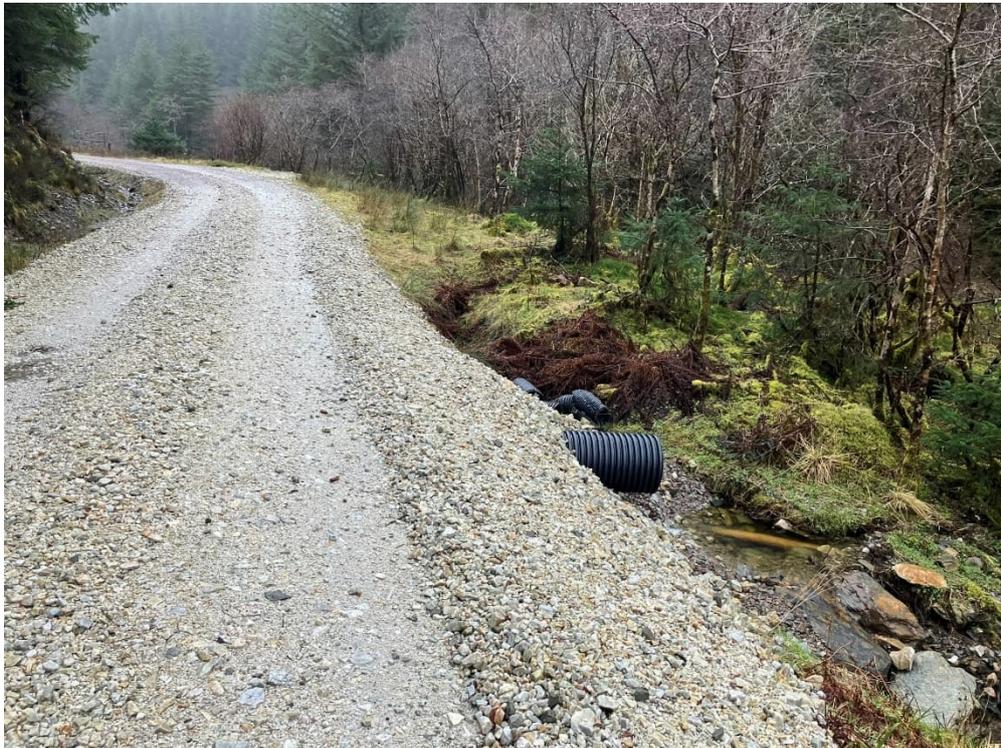
Figure 12 - Existing HDPE pipe culvert under access path

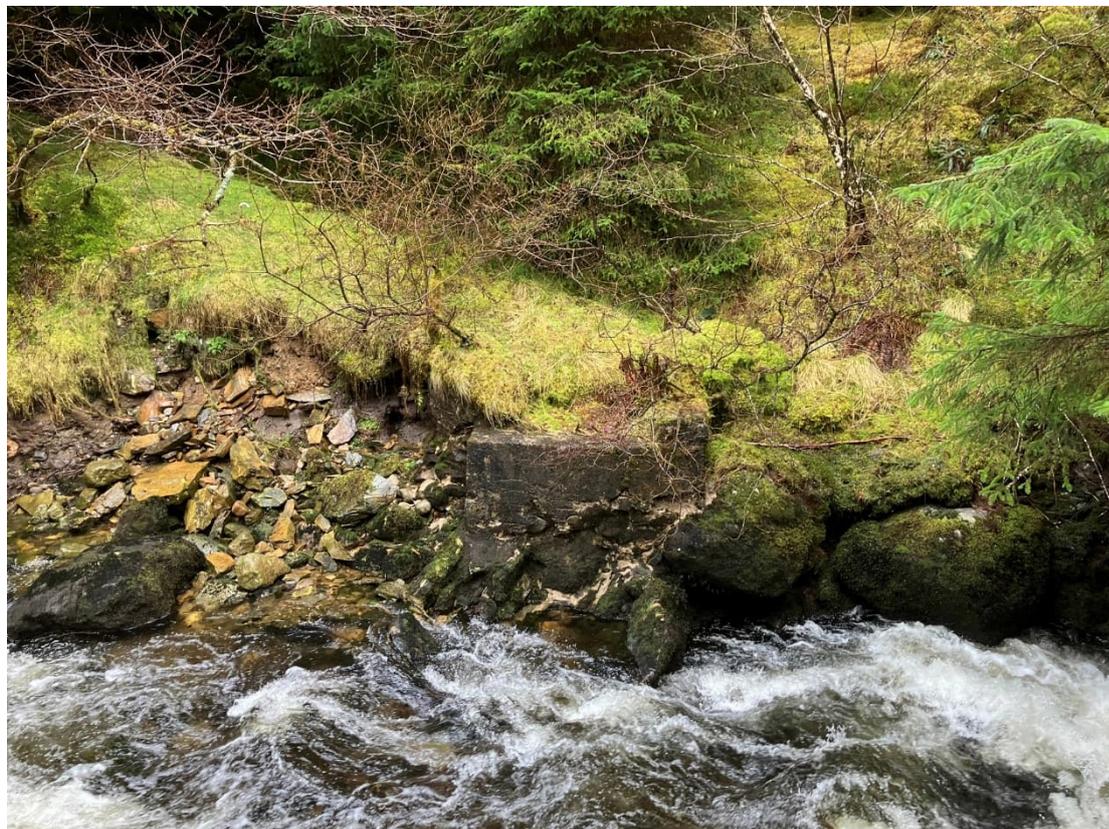
It was observed that the abutments for the previous footbridge are still there. Whilst these may or may not be reusable, their continued presence suggests that the previous location is likely to be suitable for a replacement footbridge. It is highlighted that some erosion of the adjacent watercourse bank was observed. Foundations options for any replacement bridge will need to consider this, and may be set further back due to this.

Figure 13 - Bank erosion adjacent to previous abutment

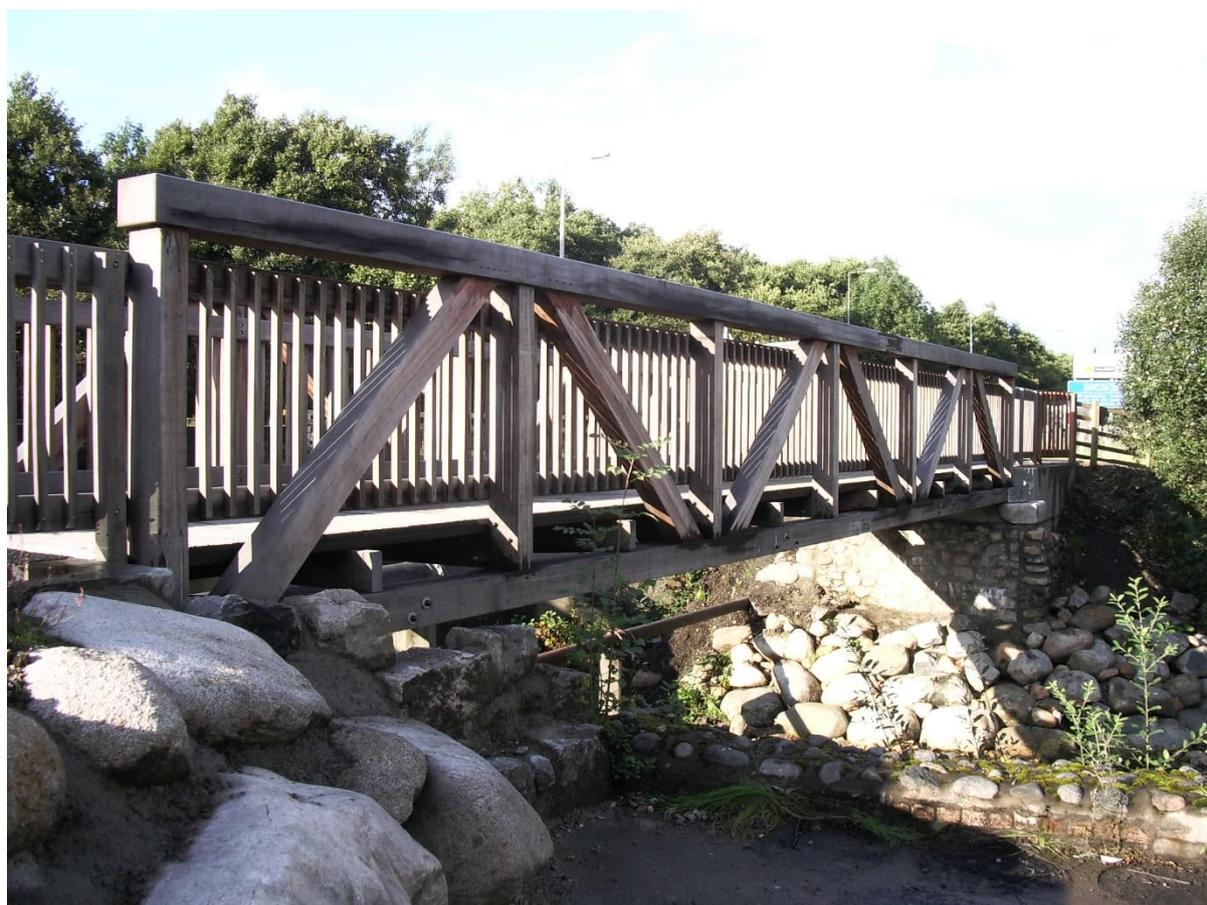
It is recommended that a single span beam & slab or through-truss structure with concrete pad foundations be considered for use at the site of the previous bridge location. It is recommended that 'off-the-shelf' solutions from industry suppliers should be considered, as bespoke designs will be more expensive for the anticipated span. An example 'off-the-shelf' solution is shown below.

Figure 17 - Example 'off-the-shelf' bridge solution

Indicative outline construction cost for an 'off-the-shelf' bridge solution is around £2k/m³. For a 10m span, estimated cost of the replacement superstructure would therefore be around £30k.
