St. Andrew's Church Condition Survey

St. Andrew's Church

Groves-Raines Architects Studios Ltd. (GRAS) have been appointed for architectural and conservation consultancy services to carry out a condition survey of St. Andrew's Church.

The intention of this report is to describe the current condition of the building fabric, identify any issues, establish a priority rating for each issue and make recommendations on the methodology for maintenance and repair where required.

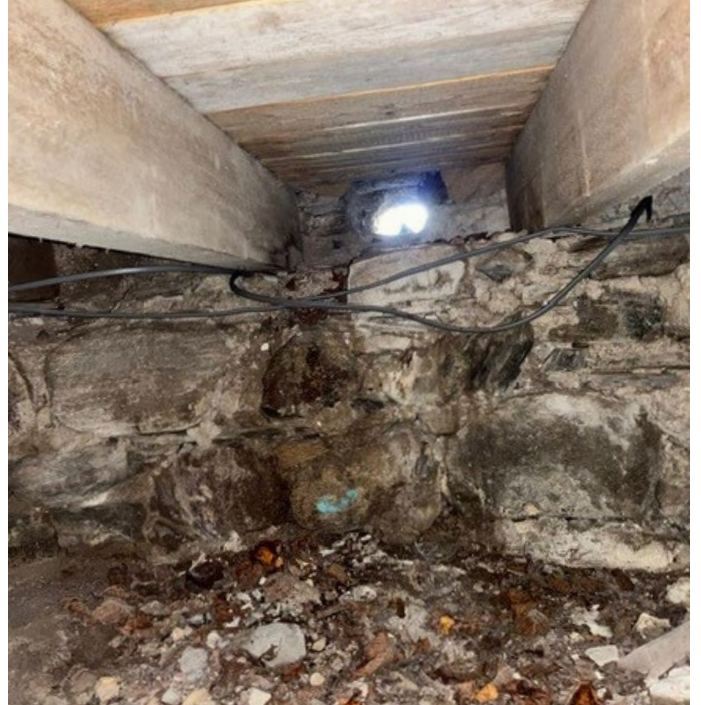
Open solum vent in the external wall (04.09.2025)

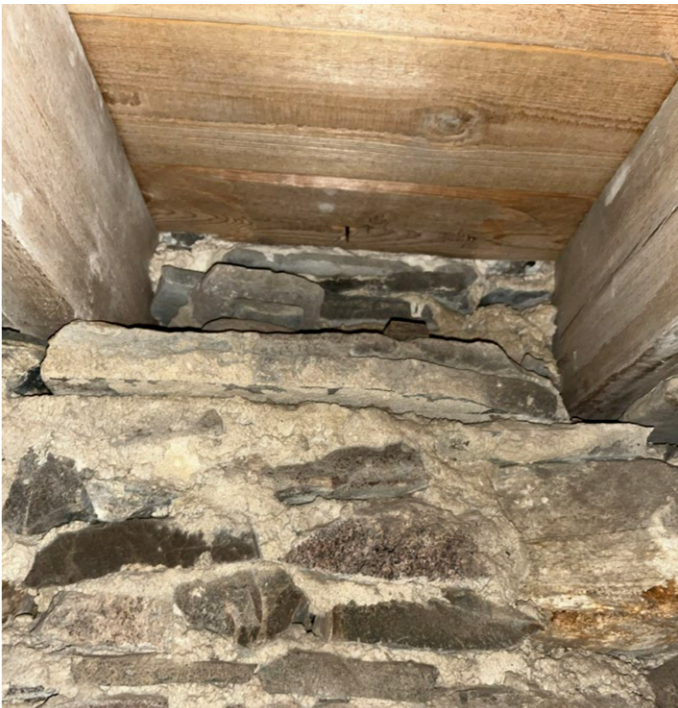
Solum, floorboards and joists appear dry

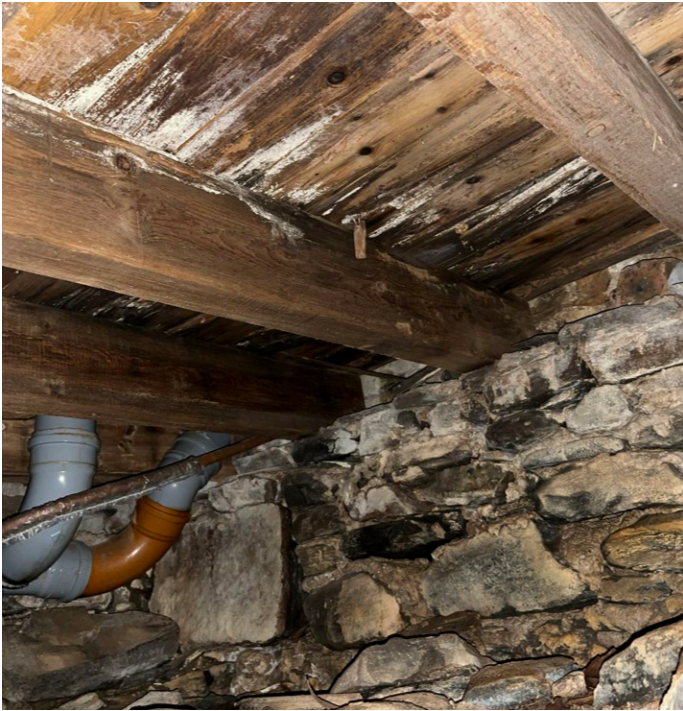
Foul drainage below the WC

1	Works to WC floor								
-	Investigate leak	2	hrs	£ 60.00	£	120	£	-	£ -
-	take up and remove floorboards	2	m2	£ 25.00	£	50	£	-	£ -
-	drainage repairs	1	sum	£ 500.00	£	500	£	-	£ -
-	joist repairs	1	sum	£ 750.00	£	750	£	-	£ -
-	Replacement of floorboards	2	m2	£ 150.00	£	300	£	-	£ -
-	New skirtings	5	m	£ 15.00	£	75	£	-	£ -
-	new ventilation	1	sum	£ 1,500.00	£	1,500	£	-	£ -
2	Work to Fanlight								
-	Broken pane to be replaced	1	sum	£ 300.00	£	-	£ -	£ 300.00	£ -

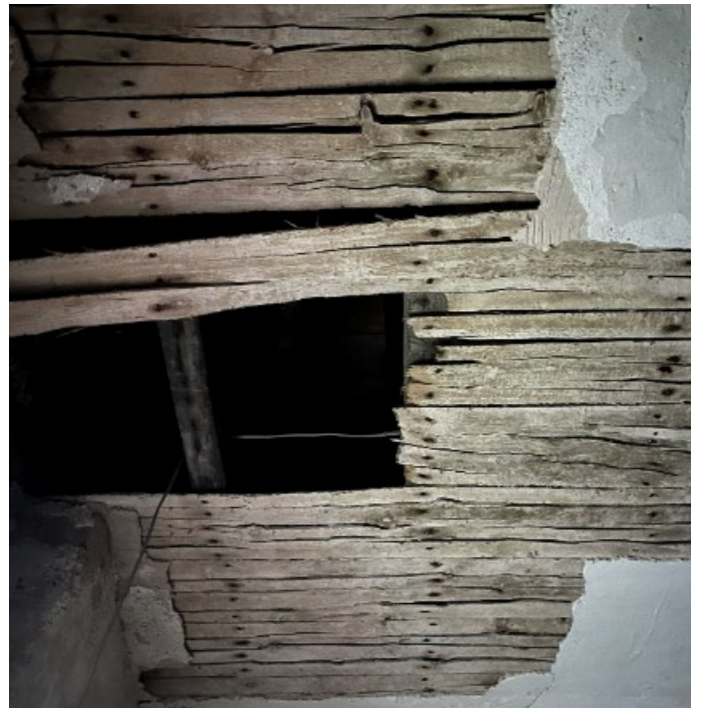
Original lath and plaster ceiling above the newer suspended ceiling of the Parish Hall

1	Remove and lay aside areas of plaster ceiling which have debonded and are currently lying on the suspended ceiling (original ceiling replacement not included)	3	hr	£ 60.00	£	-	£ 180	£ -	£ -
2	Repair crack in window pane W.05								included in external walls section
