# **CONSERVATION STATEMENT**

**BRIDGE STREET CHURCH, WICK**

**PROPOSED CHANGE OF USE  
TO  
RETAIL FURNITURE OUTLET**

**PLANNING REFERENCE: 14/04527/FUL & 14/04528/LBC**

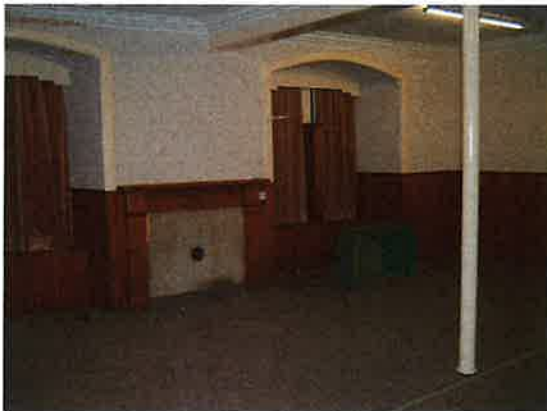
Fig. 3

Session Meeting Room (7.3m x 7.35m approx.), one access door off the entrance hall, central ceiling beam with cast iron column support at mid-span, lathe and plaster ceiling finished with Victorian style plaster cornice, two timber single glazed sash and case windows with arched tops, and walls of lathe and plaster with timber dado trim and vertical lining board wainscote all round. There is a fireplace with timber mantel located between the two windows. The mantel is of plain redwood timber construction and lacking any redeeming features. The fire place has been closed off using a panel board suspected to be of cement asbestos manufacture. There is no evidence of a decorative firebox behind. It is assumed that this fireplace would have terminated in one of the chimney cans on the west gable.

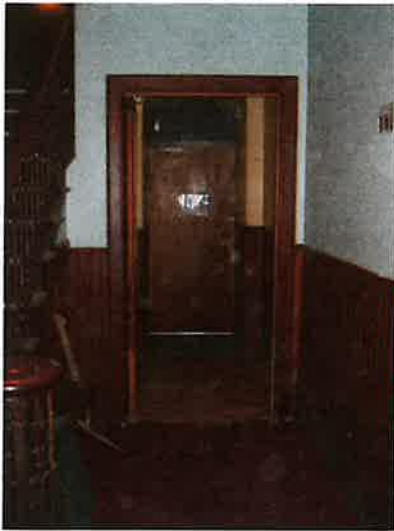
Fig. 5

Vestibule at front door (1.45m x 1.34m) with WC off entrance under the stair. The ceiling here is lowered to accommodate the stair construction under the pulpit above. All walls and ceilings are of lathe and plaster construction. The WC chinaware is of no specific historic importance, and is relatively modern. The door has been split to accommodate swing clearance of the sink.

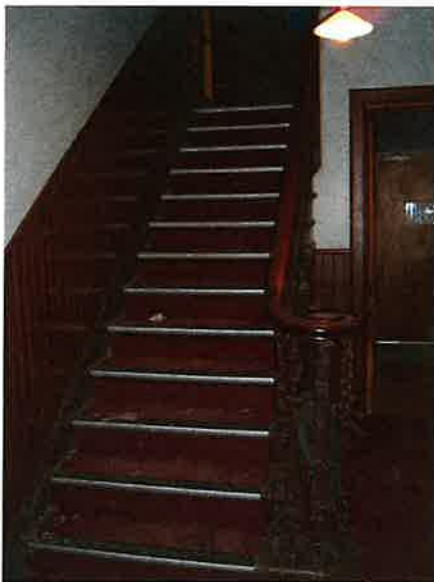
Fig. 7

Main Hallway incorporating stair up to church floor level (3.87m x 2.58m). The ceiling and wall finishes are that of the Session Room above, and the stair is finished with cast iron balusters and a standard Toad's Back handrail with full turn to bottom tread. The hall gives access to a large store, a kitchen, and the Vestry.

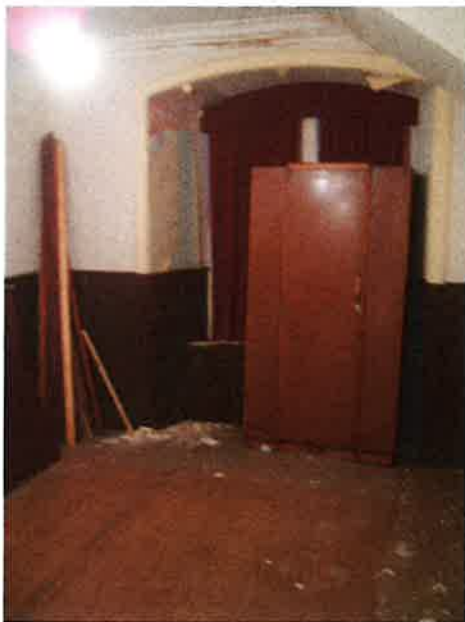
Fig.11

Vestry (4.08mx 3.09m) Accessed off the Hall Lobby, the vestry is finished in a similar fashion to the Session Room with lathe and plaster ceiling and upper walls, timber dado trim and vertical timber board wainscote to lower wall. The vestry has one single glazed sash and case window with arched top, and is complete with a fireplace on the party wall with a storage area next door. The fireplace is similar in context to the Session Room's, and is not clear where the flue may lead to in this instance but assumed to be the second chimney can on the West gable.

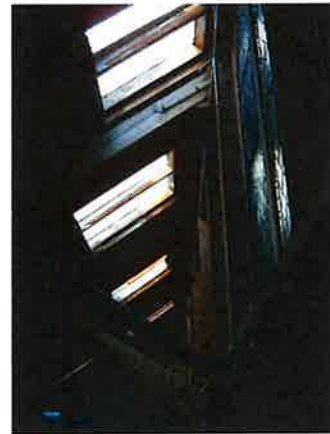
Fig. 14

The existing roof is welsh slate on timber sarking, and from visual inspection at street level, seems to be in good condition. Investigations of water ingress revealed that vegetation growth was causing capillary water movement up under the slate and over the top of the lead valley gutter's edge, and into the attic space below. There are four roof lights on either side of the roof and the light has two panes of patent glass in each. Some of the patent glazing has been replaced to make the building secure. The lead valleys require investigation after cleaning to check for expansion splits and excessive trough wear. The internal face of the sarking boards, where inspected visually from the ceiling access hatch, revealed some discolouration but on the whole, was sound and dry.

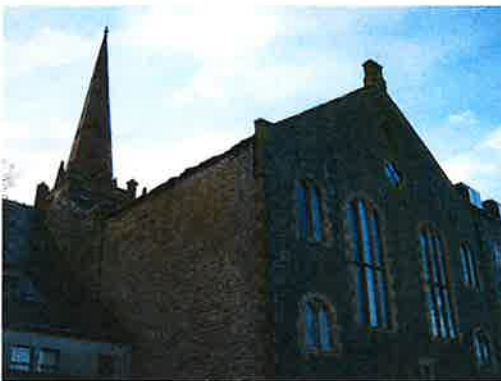
Fig. 20

The West Gable overlooking St Fergus Car Park is mainly built of coursed rubble stone with sandstone quoins, raked lintels and gothic arch tops to the rose vent, windows and doors. The gable is capped with sandstone skews and a double flue chimney, assumed to be the termination for the fireplaces in the Meeting Room and Vestry located in the basement.

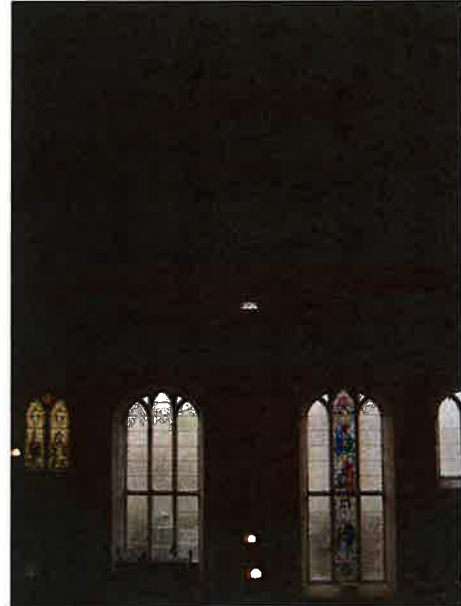
| Fig. 23 | Rear Elevation – Stained Glass Windows |

The rear tracery windows identified on the Elevation drawing (Ref: W08 & 09) would benefit from a toughened safety glass substitute replacement, with a transparent film applied to the inner face to closely match the original patterns adjacent.

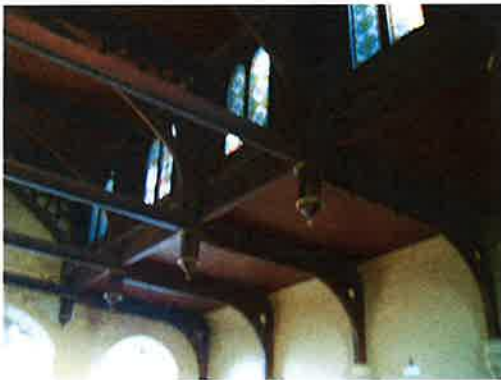
| Fig. 27 | Congregational Ceiling showing Light Well above Gallery |

The main congregation area ceiling is varnished timber vee'd lining boards between six main supporting trusses. The attic style structural trusses have been ornately fashioned with arch bracing and carved infill panels of four and eight petal rose wheels. The trusses step down in line with the gallery extents running from front to back, and this forms a light well in which six stain glass panels on each side, emitting natural light into the centre of the building. The floor of this light well then forms the timber lined ceiling above the two sides of the gallery. The remaining area of ceiling between the two stair wells is finished in lathe and plaster, and painted out. The paint is now flaking badly mainly due to dampness manifesting itself while the building was unoccupied. The varnished timber is bearing up well even though there has been water ingress at two distinct locations within the congregational space.

The existing ceilings in both Galleries, and Congregation areas, have suffered some water ingress damage, and this is being repaired with modern lathing techniques, and finished in hardwall plaster with scrim coating as the existing adjacent finishes. It is interesting to note that the areas of repair recently carried out by the current owner, are that of earlier repairs carried out under ecclesiastical use also, therefore a vigorous inspection from the roof structure down, is required to identify where the ingress originates.

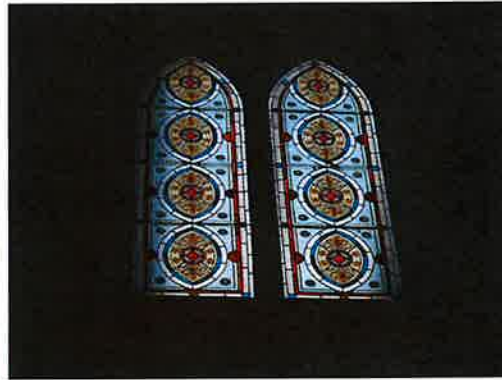
| Fig. 28 | Stain Glass Panels in Light Well |

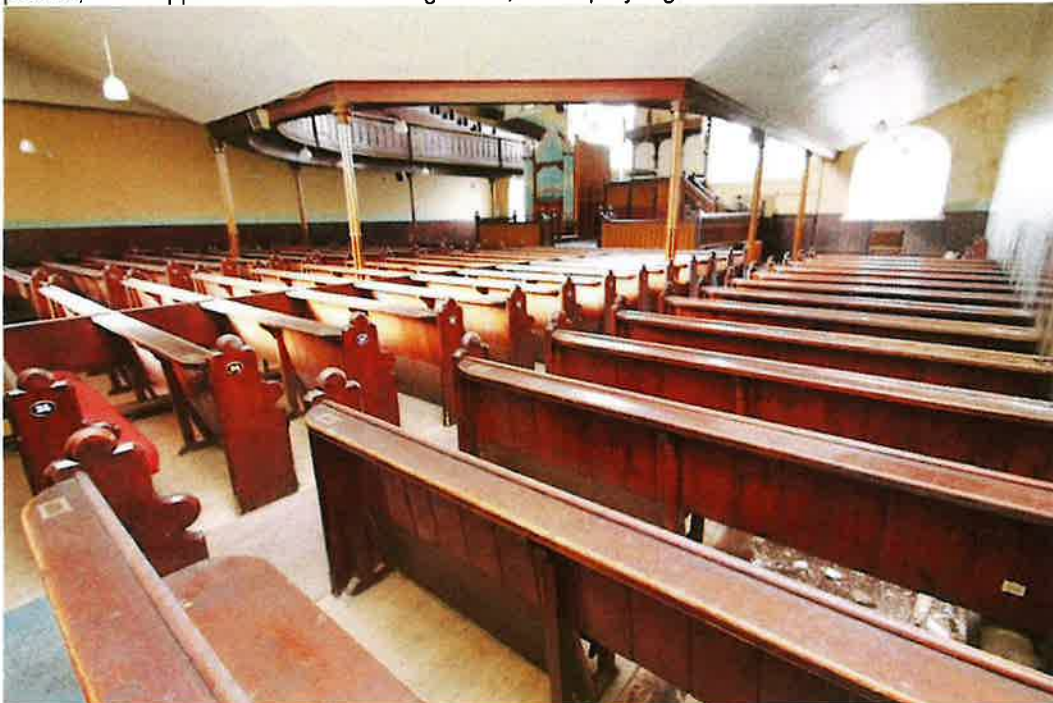
Fig. 29

The main congregation space under the gallery is formed with raked joists clad in lathe and plaster, and supported on the main ring beam, held up by eight fluted cast iron columns.

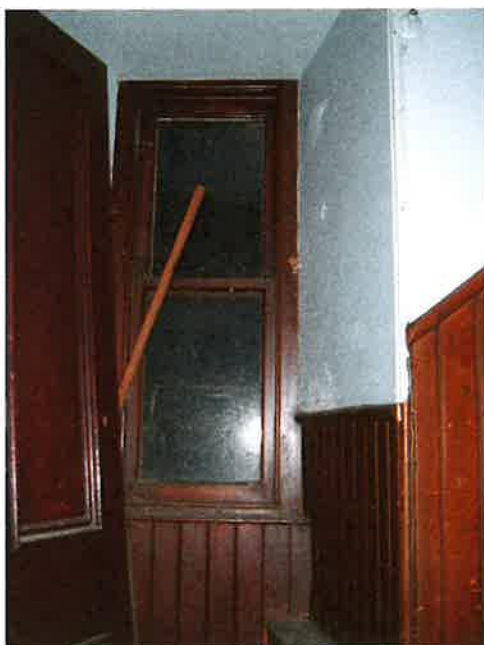
| Fig. 36 | Window under pulpit at access stair to Vestry |

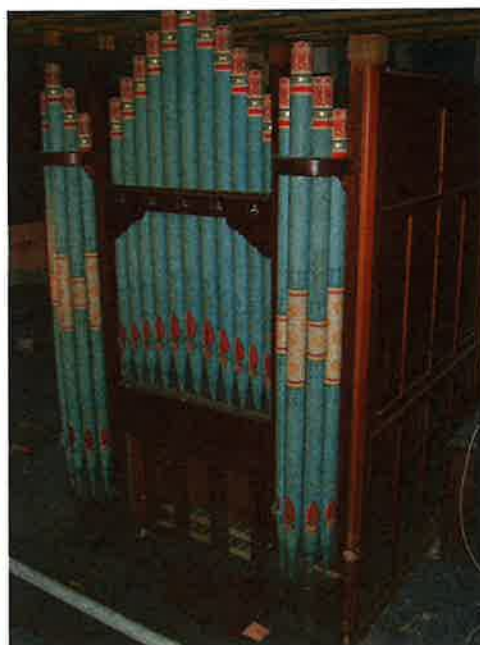
Fig. 37

The pipe organ currently situated beside the pulpit started its life in the Wick Congregational Church (now Sam's Furniture Shop), High Street. The Johnston Collection has some photographs of this organ in its original location (ref: JN23484B029), and it was later relocated to the Bridge Street Church in 1961.

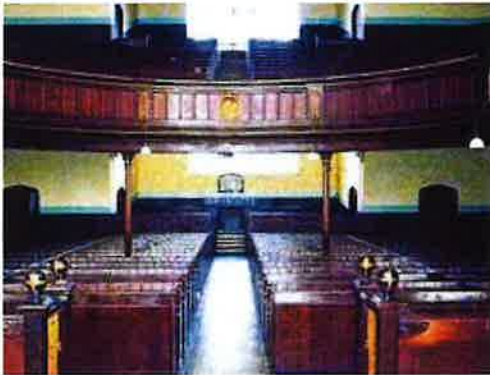
Fig. 38

The church clock is missing from its housing in the frontage of the gallery upstand. It is thought that the original clock was gifted to the last outgoing minister before the church's closure in March 2009. It is not known where the plaque from under the Bridge Street window went to.
