Nether Lochaber Village Hall, Onich

Purpose of My Site Visit and Preliminary Report.

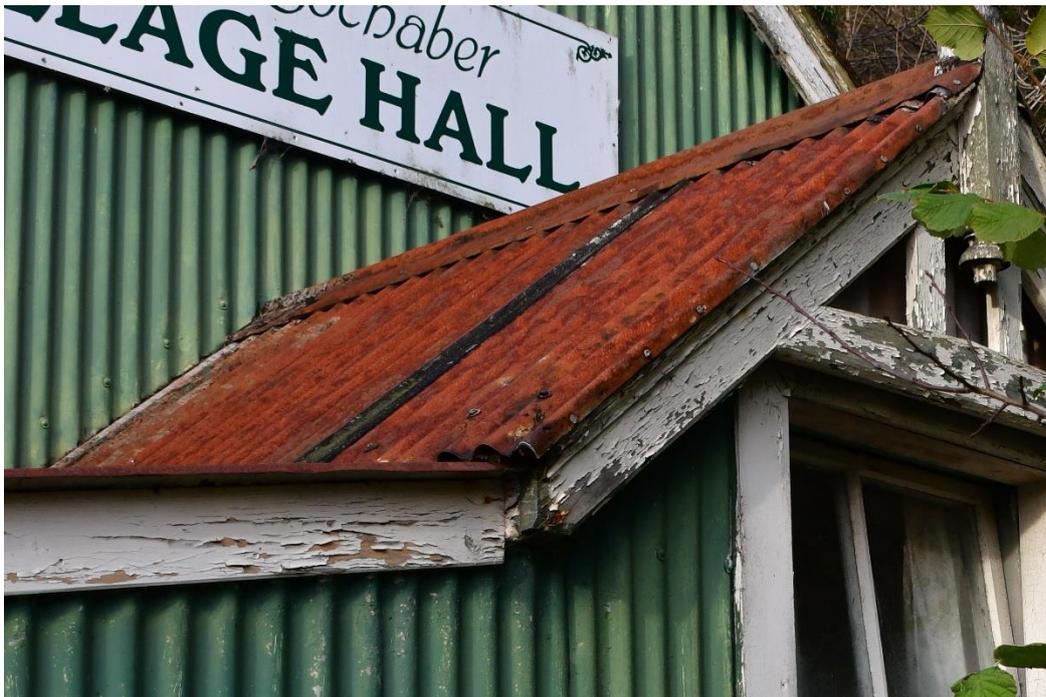
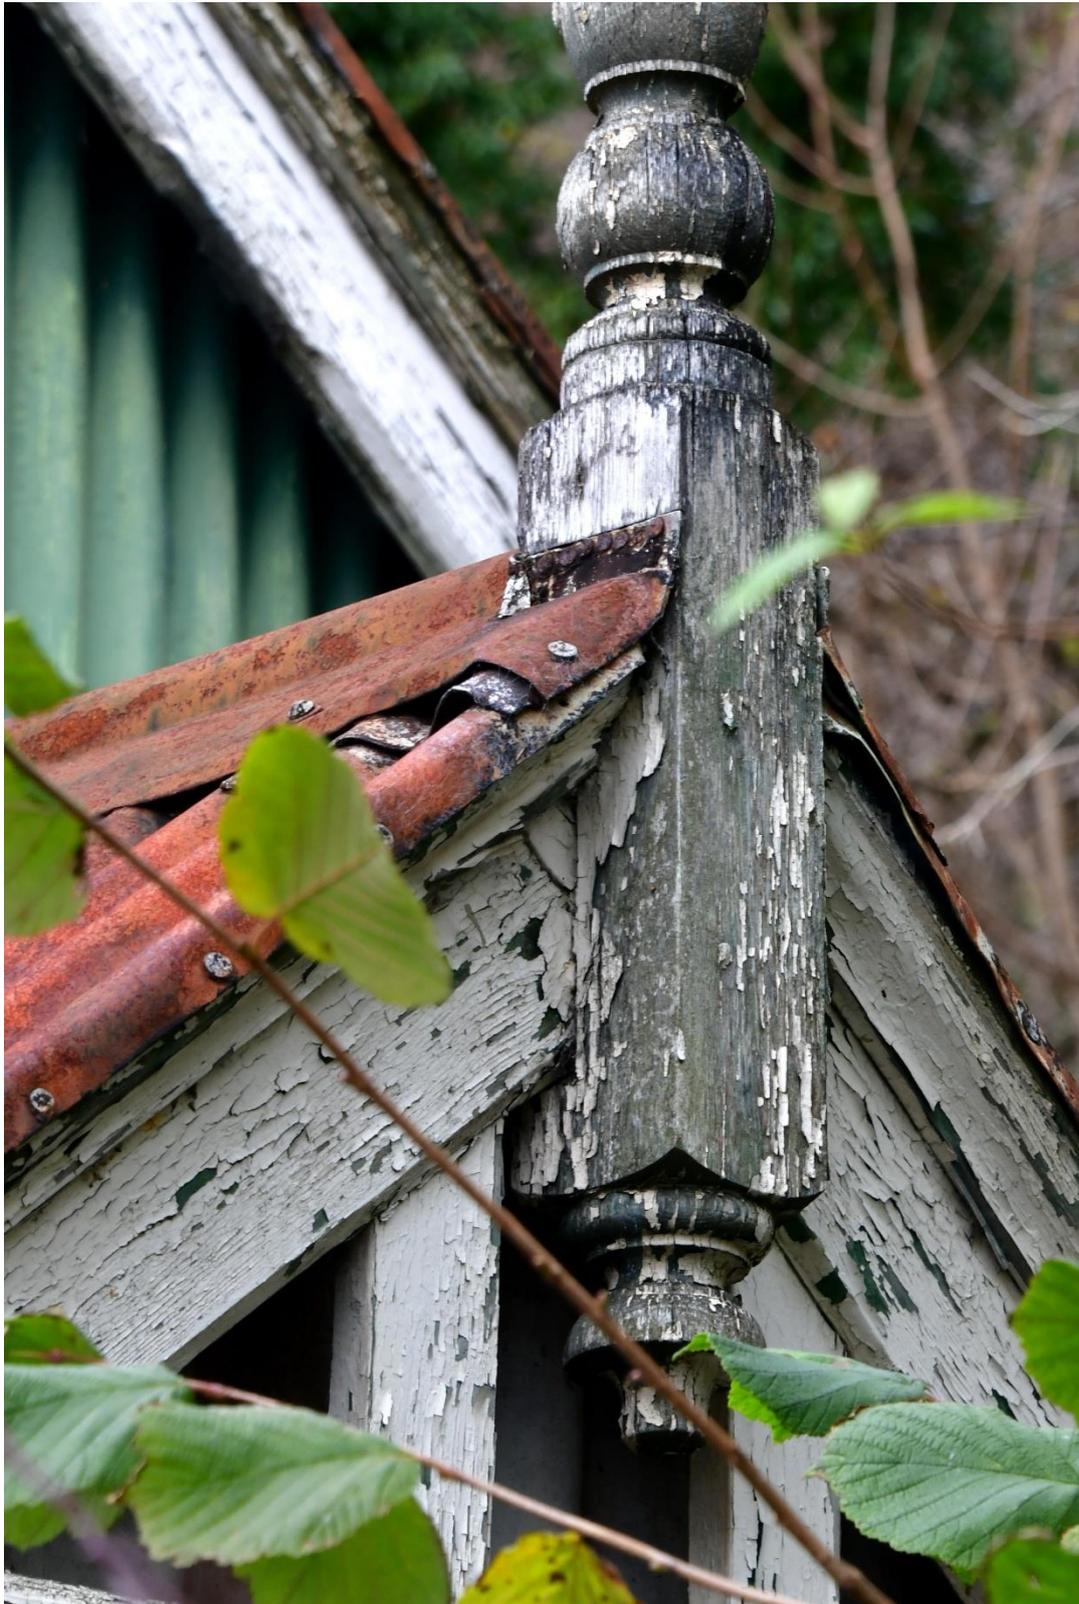
The east elevation porch details of the central timber finial

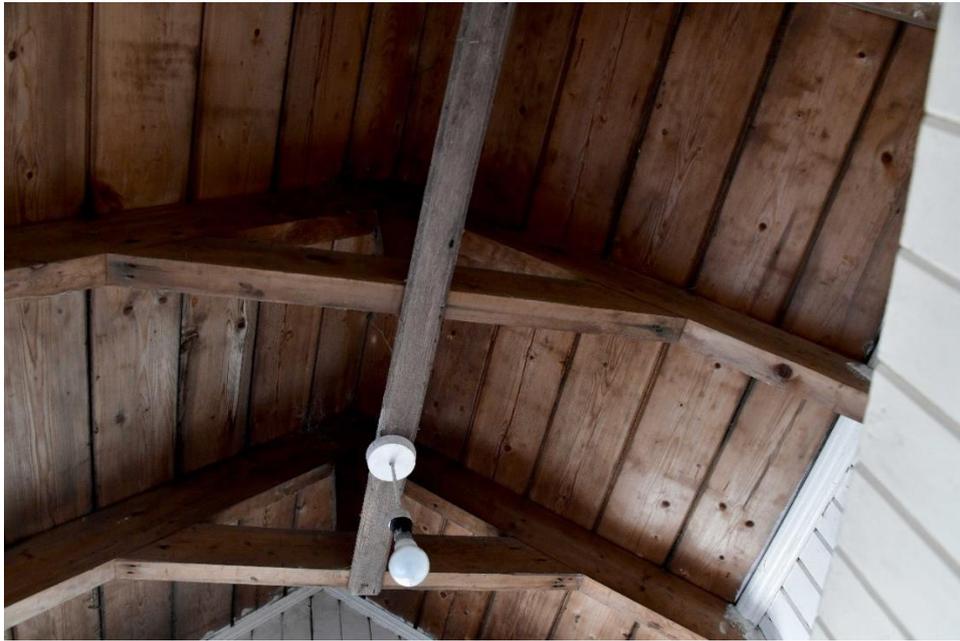
Original entrance porch ceiling

Inspection area open. The original roof/ceiling finish can be seen above the later lowered ceiling (as can be seen below in the original entrance porch, now WC) Daylight can be seen through the board adjacent to the chimney lining boards
The lowered ceiling is in a poor condition and should be removed. Careful consideration should be given to insulation options.

The preferred option would be to install a priority thin insulation layer above the original timber ceiling. There will be a need to replace sections of the original timber boarding due to rot.

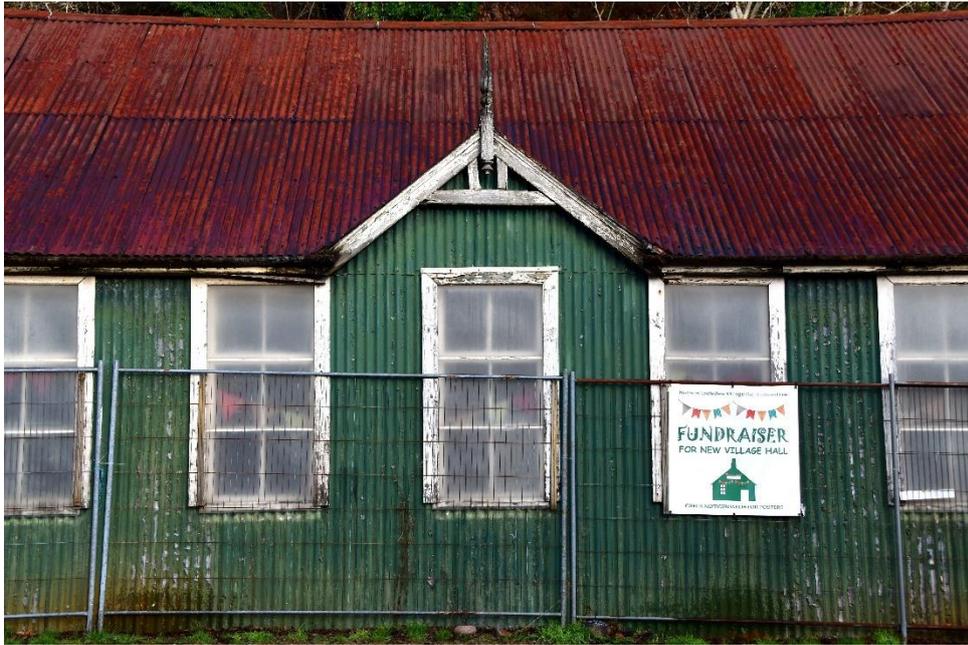
West Elevation window. Typical loss of timber facings to most windows. Sills generally in a poor condition. Most windows are six pane with a hopper opening top section. One 8 pane on the North elevation

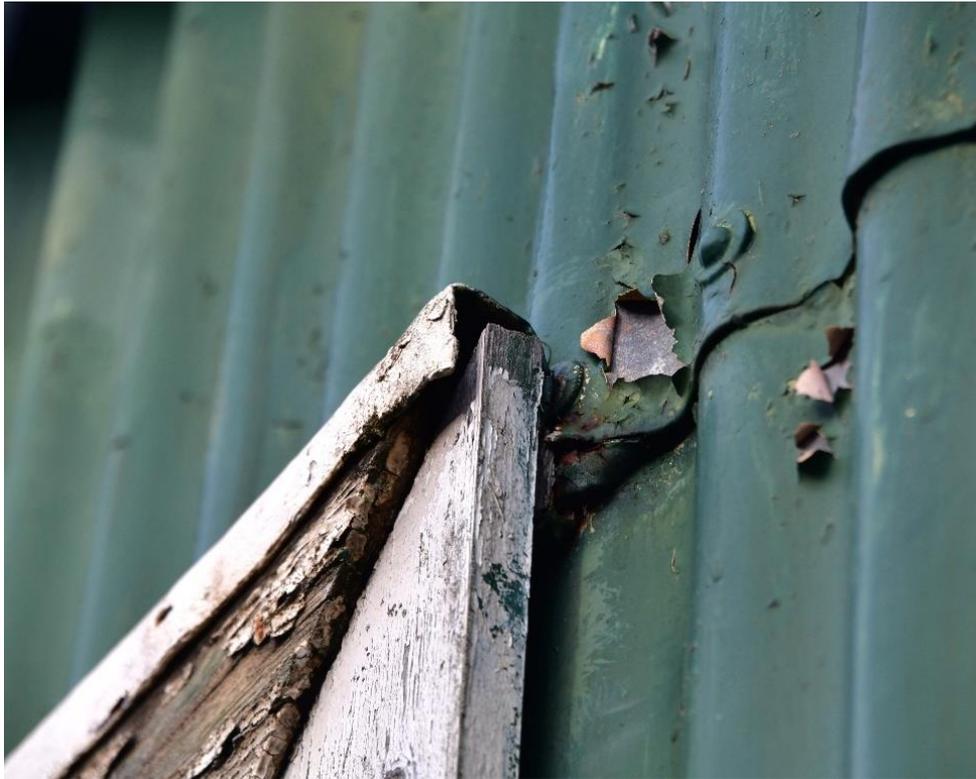
Lead cover flashing to all windows apart from the five windows on the south elevation that are protected by the eaves. The lead flashing is taken up the back of the corrugated iron joint and dressed over the top of the timber window facings.

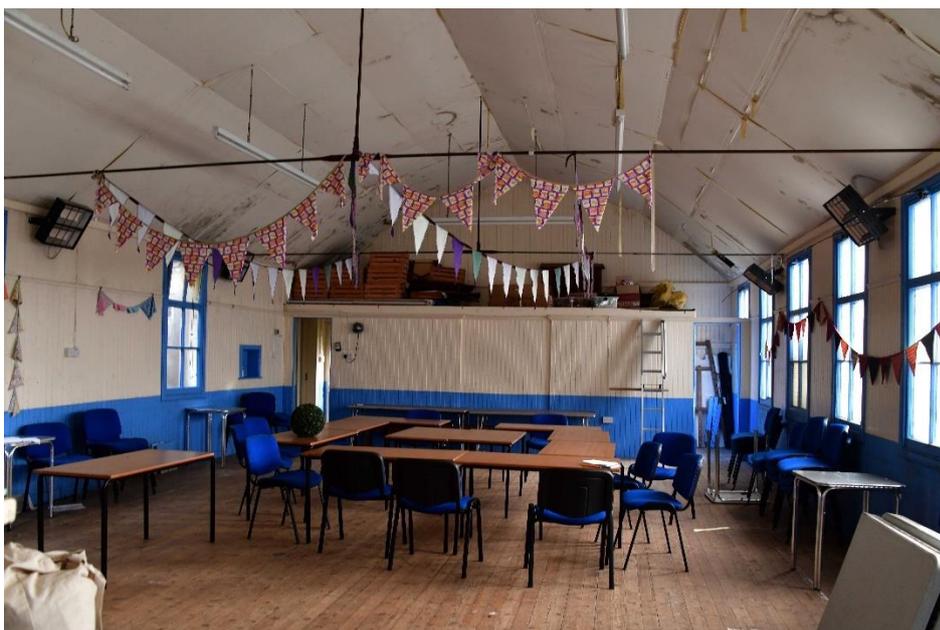
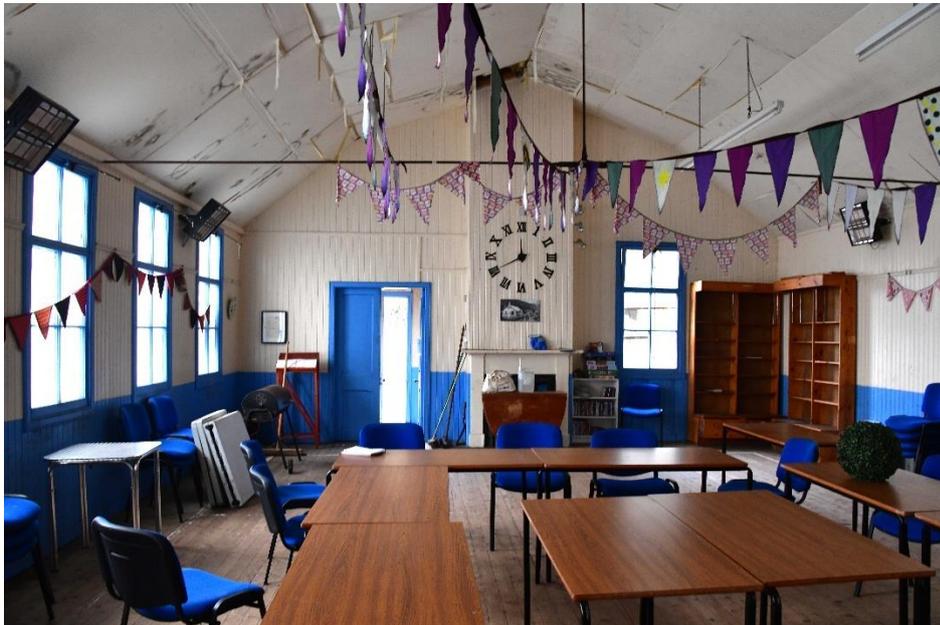
The hall floor looks to be in reasonable condition. There are defective areas identified in the earlier survey that require to be replaced.

The later ceiling and glass wool insulation should be removed. Careful consideration will be required when re-roofing and the installation of an insulation system
